Client/Project	January 2011
SAMSUNG C&T	160960577
GRAND RENEWABLE ENERGY PARK

Title
HEMLOCK CREEK SUBWATERSHED PHOTOS

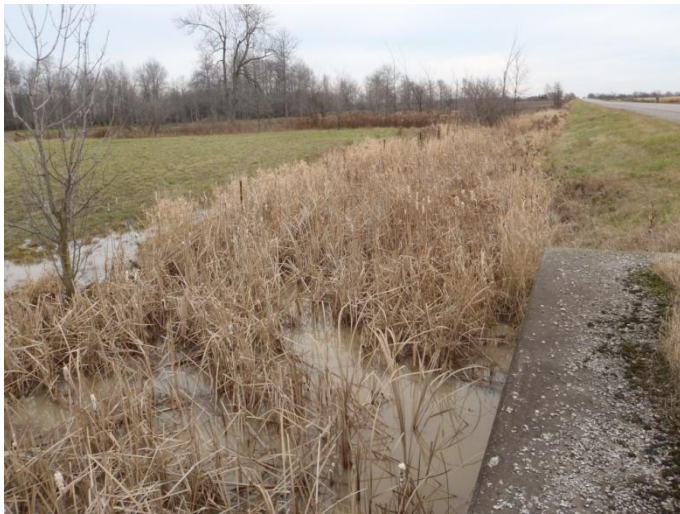
Photo 1: Ston-a (tile 19) - Looking upstream (southeast) from concrete culvert at flooded vegetation and roadside drain. Site is located on Haldimand Road 20 between Concession 10 and Concession 11 W-1.

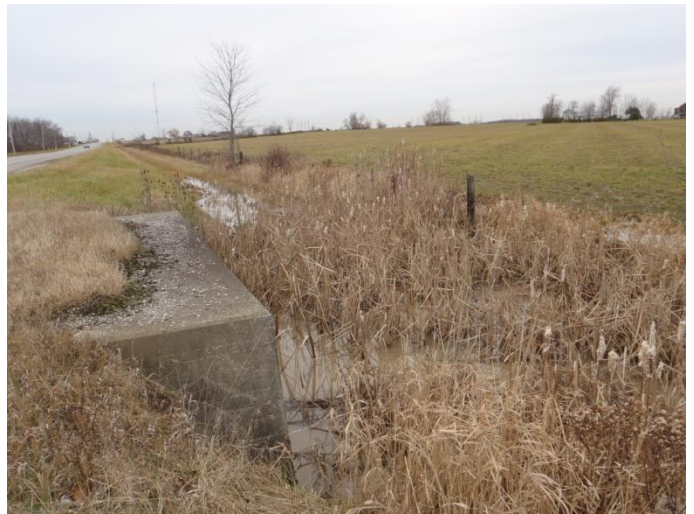
Photo 2: Ston-a (tile 19) - Looking upstream (northwest) from concrete culvert at flooded vegetation and roadside drain. Site is located on Haldimand Road 20 between Concession 10 and Concession 11 W-1.

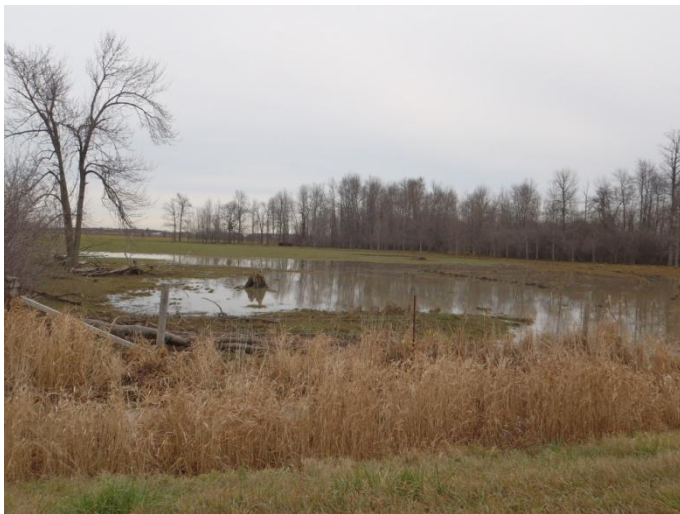
Photo 3: Ston-a (tile 19) - Looking upstream (northeast) from concrete culvert at flooded pasture. Site is located on Haldimand Road 20 between Concession 10 and Concession 11 W-1.

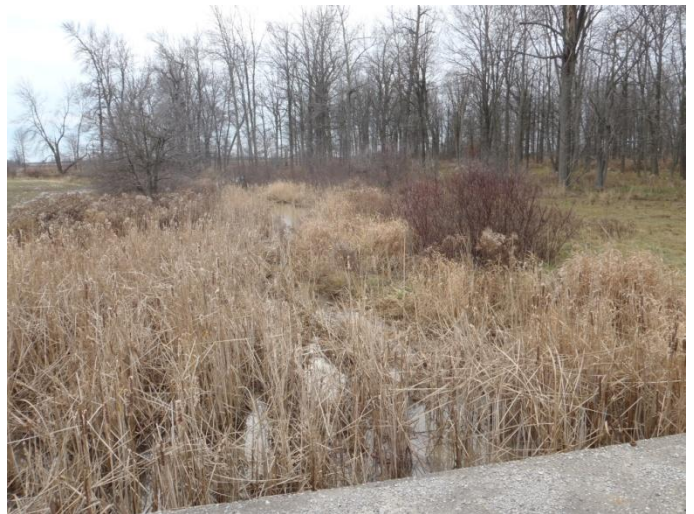
Photo 4: Ston-a (tile 19) - Looking downstream (southwest) from concrete culvert at flooded vegetation. Site is located on Haldimand Road 20 between Concession 10 and Concession 11 W-1.

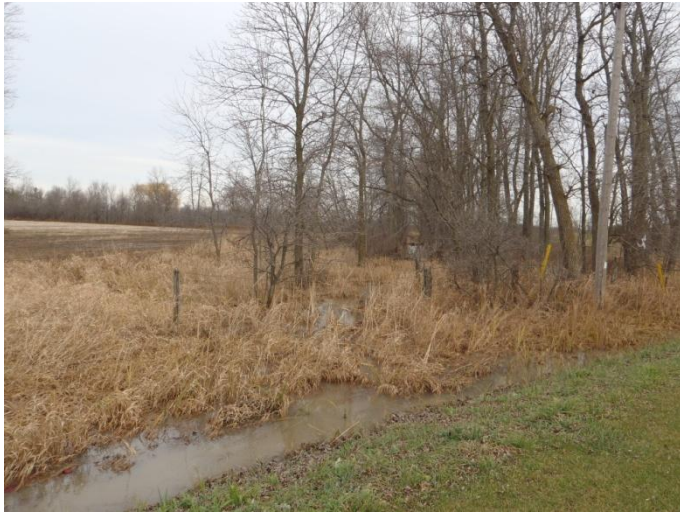
Photo 5: Ston-b (tile 19) - Looking upstream (southeast) from concrete culvert at agriculture field and roadside drain. Site is located on Haldimand Road 20 between Haldimand Road 53 and Concession 10.

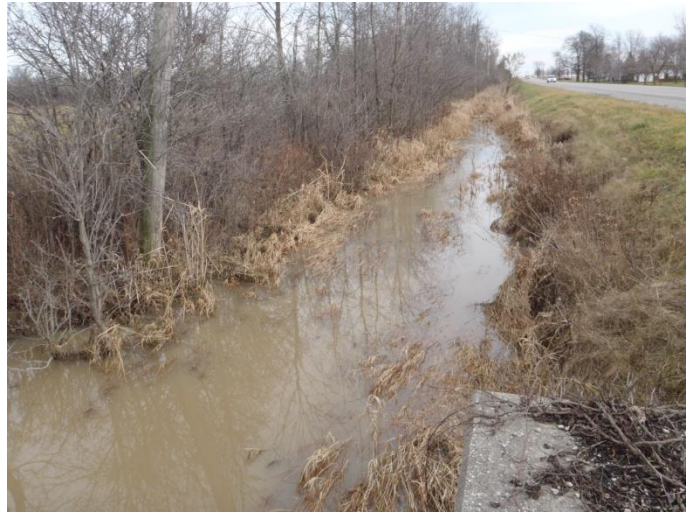
Photo 6: Ston-b (tile 19) - Looking upstream (east) from concrete culvert at flooded vegetation in roadside drain. Site is located on Haldimand Road 20 between Haldimand Road 53 and Concession 10.

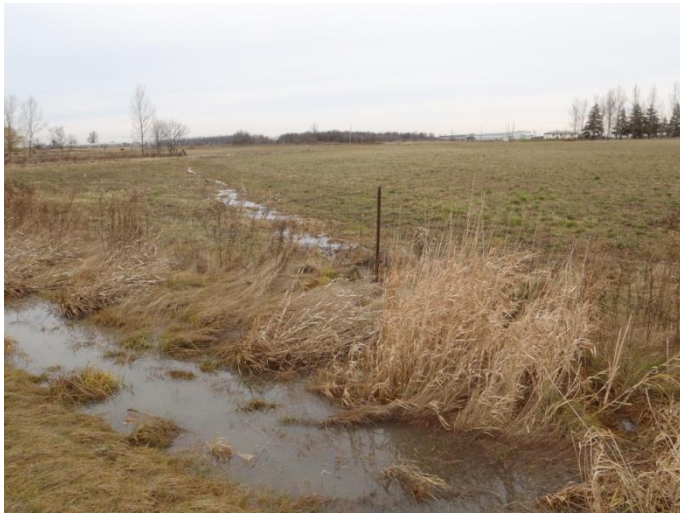
Photo 7: Ston-b (tile 19) - Looking upstream (north) from concrete culvert at agriculture field and roadside drain. Site is located on Haldimand Road 20 between Haldimand Road 53 and Concession 10.

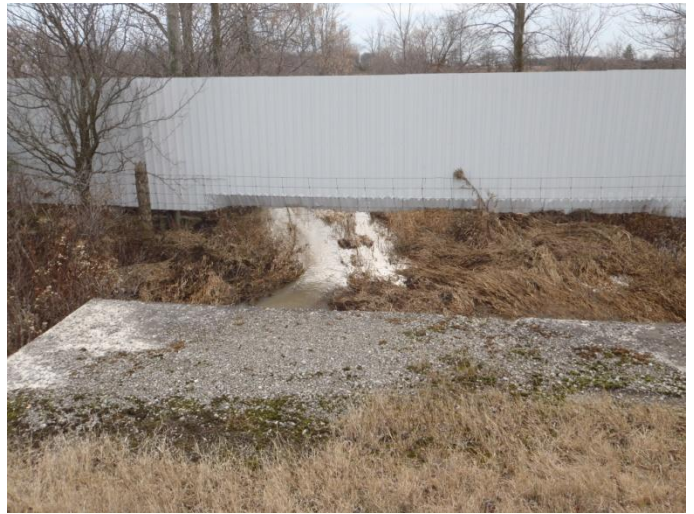
Photo 8: Ston-b (tile 19) - Looking downstream (southwest) from concrete culvert at flooded vegetation. Site is located on Haldimand Road 20 between Haldimand Road 53 and Concession 10.

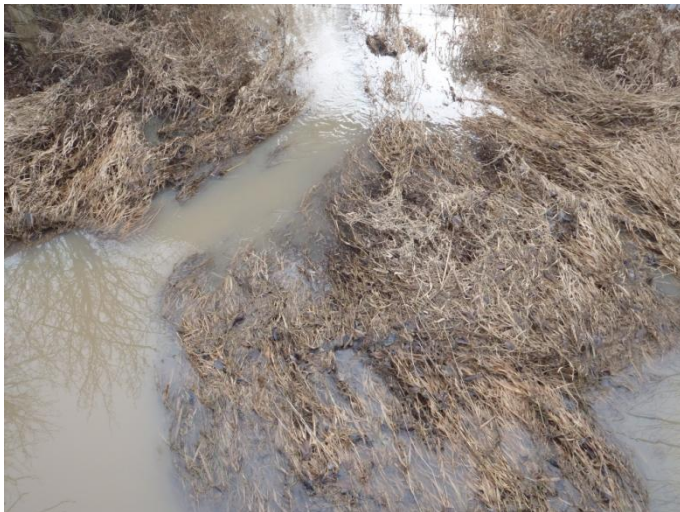
Photo 9: Ston-b (tile 19) - Existing substrate conditions at concrete culvert. Site is located on Haldimand Road 20 between Haldimand Road 53 and Concession 10.

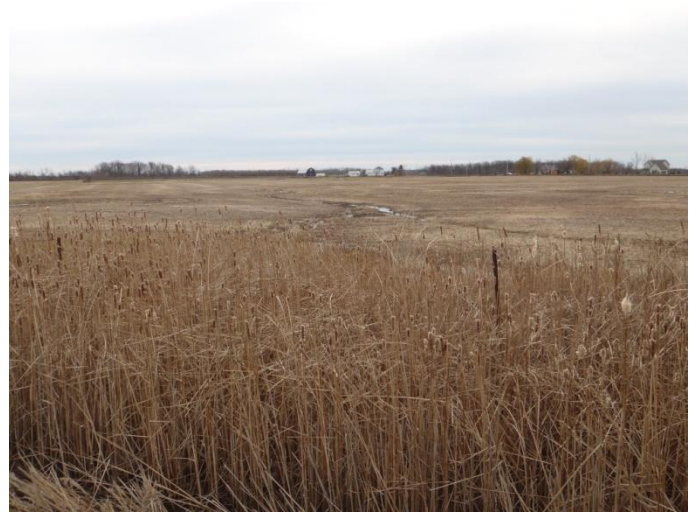
Photo 11: Ston-c (tile 18) - Looking downstream (west) from concrete culvert at cattail vegetation in roadside drain and channel flowing through agriculture field in the distance. Site is located on Haldimand Road 20 between Old Talbot Road and Haldimand Road 53.

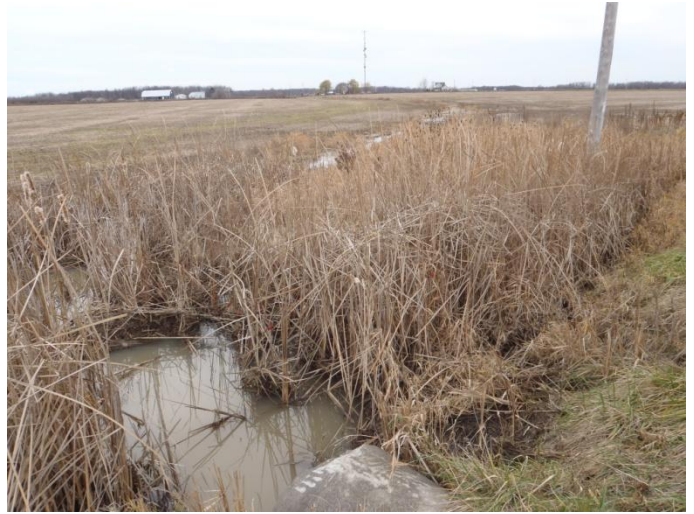
Photo 13: Ston-d (tile 18) - Looking downstream (west) from concrete culvert at channel flowing through agriculture field. Site is located on Haldimand Road 20 between Old Talbot Road and Haldimand Road 53.

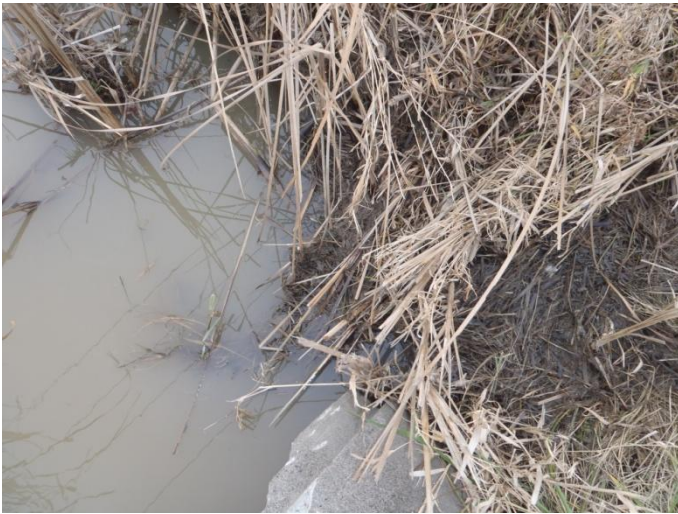
Photo 14: Ston-d (tile 18) - Existing substrate conditions downstream of concrete culvert. Site is located on Haldimand Road 20 between Old Talbot Road and Haldimand Road 53.

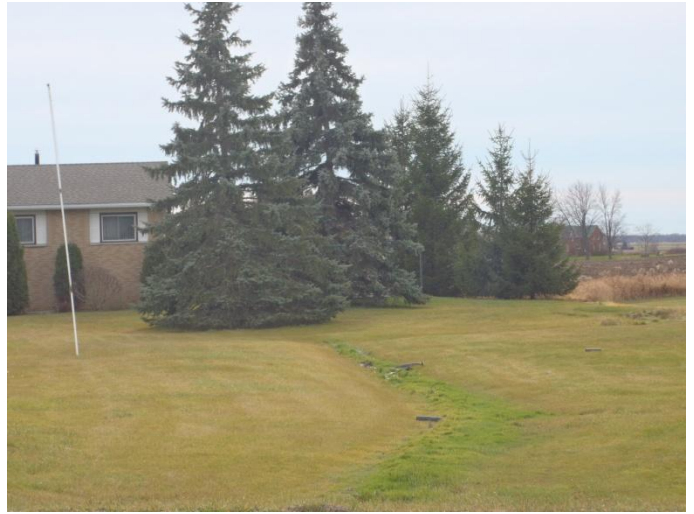
Photo 16: Ston-e (tile 18) - Looking downstream (southwest) from concrete culvert at channel flowing through a residential property. Site is located on Haldimand Road 20 between Dry Lake Road and Highway 3.

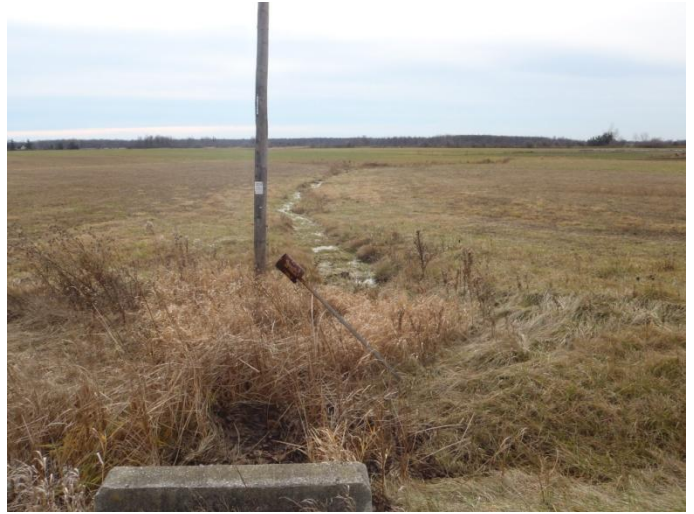
Photo 18: Ston-f (tile 18) - Looking downstream (southwest) from concrete culvert at channel flowing through agriculture field. Site is located on Haldimand Road 20 between Dry Lake Road and Highway 3.

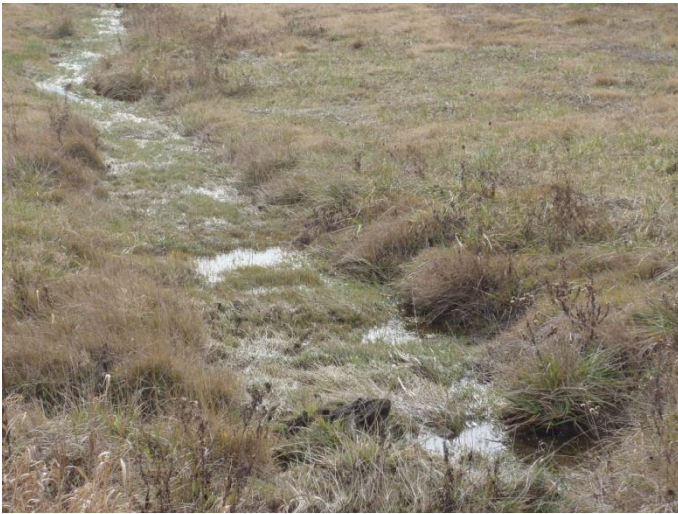
Photo 19: Ston-f (tile 18) - Existing substrate conditions downstream of concrete culvert. Site is located on Haldimand Road 20 between Dry Lake Road and Highway 3.

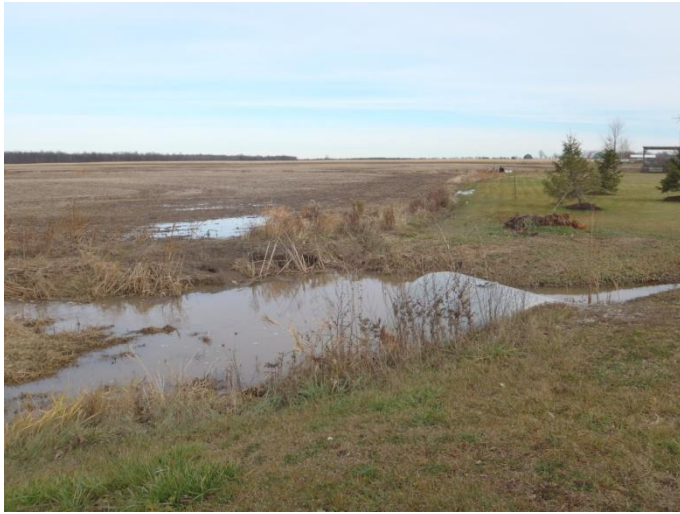
Photo 20: Ston-g (tile 18) - Looking upstream (northeast) at channel. Site is located on Concession 8 at the intersection of Haldimand Road 20.

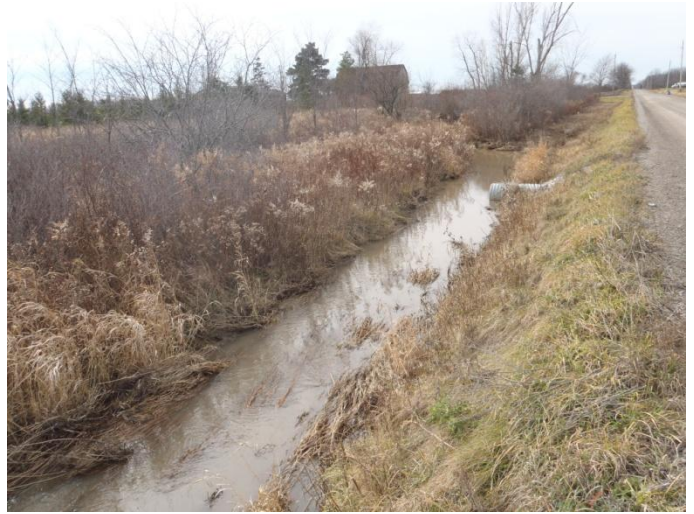
Photo 21: Ston-g (tile 18) - Looking downstream (south) at channel. Site is located on Concession 8 at the intersection of Haldimand Road 20.

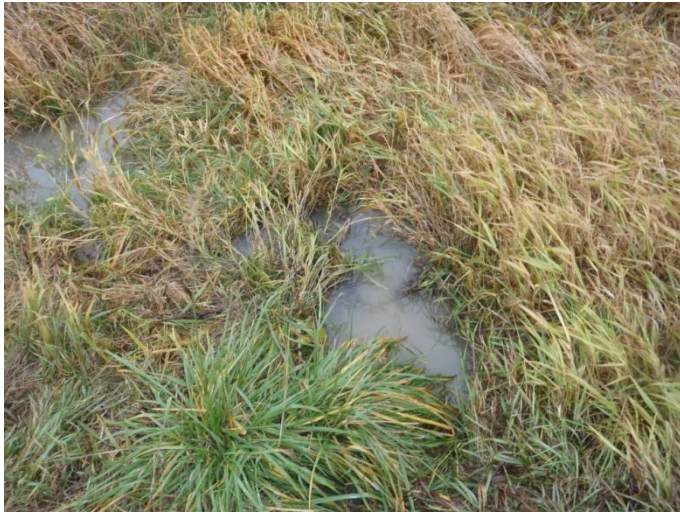
Photo 7: Hem-a (tile 4) - Existing substrate conditions in upstream area. Site is located 100 m south of Haldimand Road 20 between Concession 6 and Link Road.

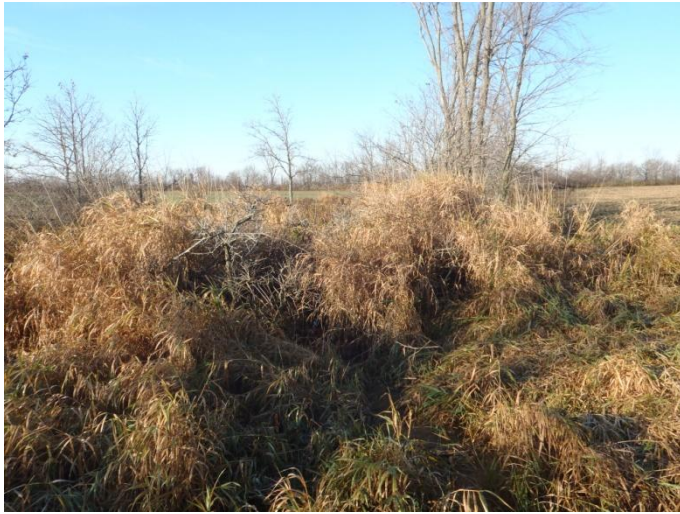
Photo 8: Photo 0099- Hem-b (Tile 3) (field data sheet 10.0) - Looking downstream (east) at undefined channel flowing adjacent an agriculture field. Site is located north of Concession 6 between Haldimand Road 12 and Haldimand Road 20.

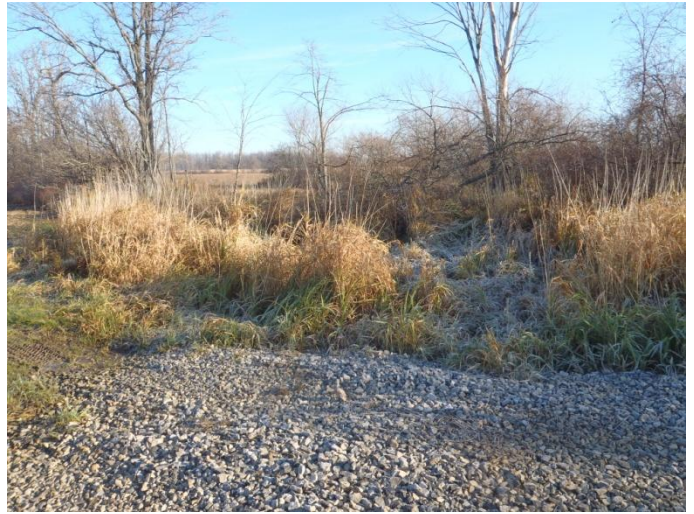
Photo 9: Photo 0100- Hem-b (Tile 3) (field data sheet 10.0) - Looking upstream (west) at channel flowing through an agriculture field. Site is located north of Concession 6 between Haldimand Road 12 and Haldimand Road 20.

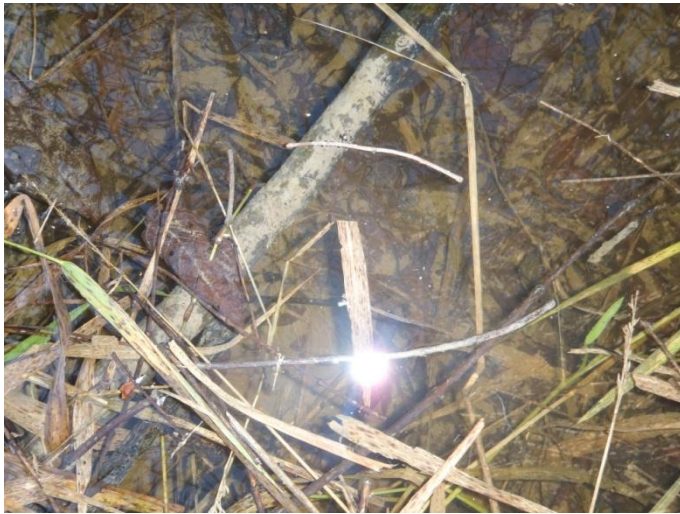
Photo 10: Photo 0098- Hem-b (tile 3) (field data sheet 10.0) - Existing substrate conditions in channel. Site is located north of Concession 6 between Haldimand Road 12 and Haldimand Road 20.

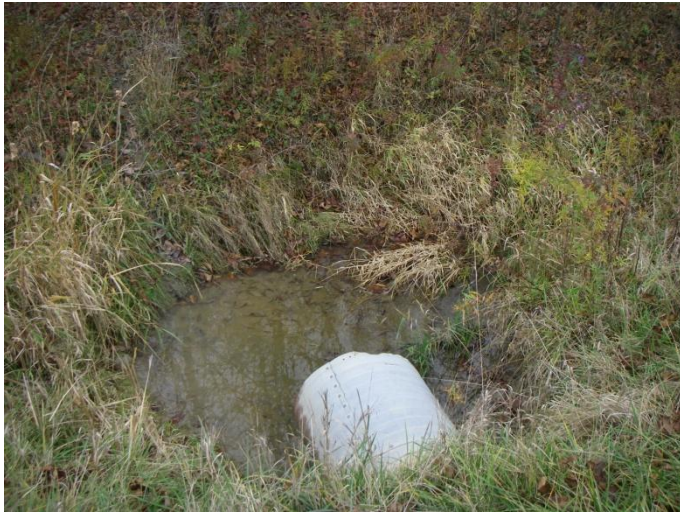
Photo 11: Hem-c (tile 4) - Looking downstream (west) at small pool in roadside drain associated with CSP culvert. This site is on Haldimand Road 20 between Concession 5 and Concession 6.

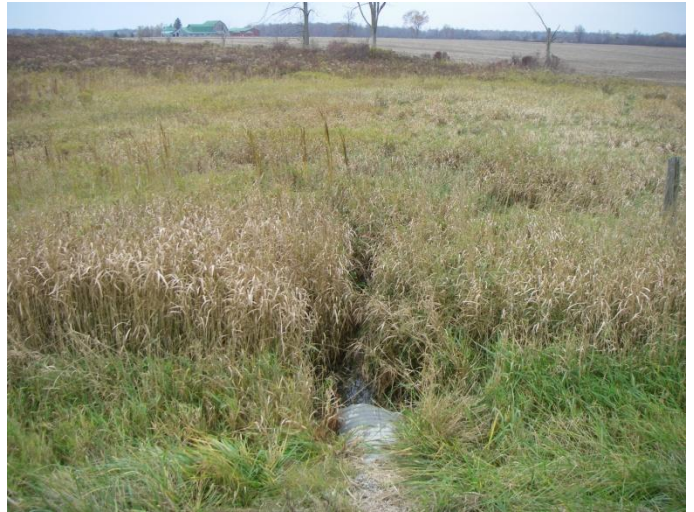
Photo 14: Hem-d (tile 4) - Looking downstream (southwest) at drain feature associated with CSP culvert flowing low-laying area. This site is on Haldimand Road 20 near the intersection with Kohler Road. The racetrack can be seen in the distance.

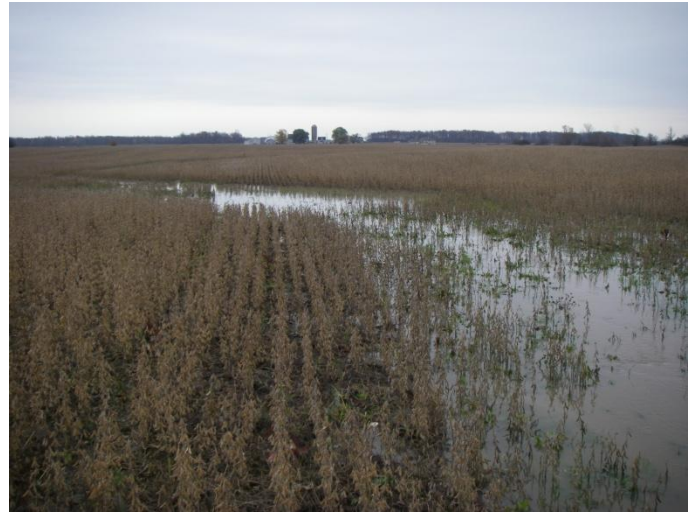
Photo 17: Hem-e (tile 6) - Looking downstream (south) from crop field at shallow drain feature flowing through agricultural field (soy). This site is on Haldimand Road 20 between Richert Road and Meadows Road.

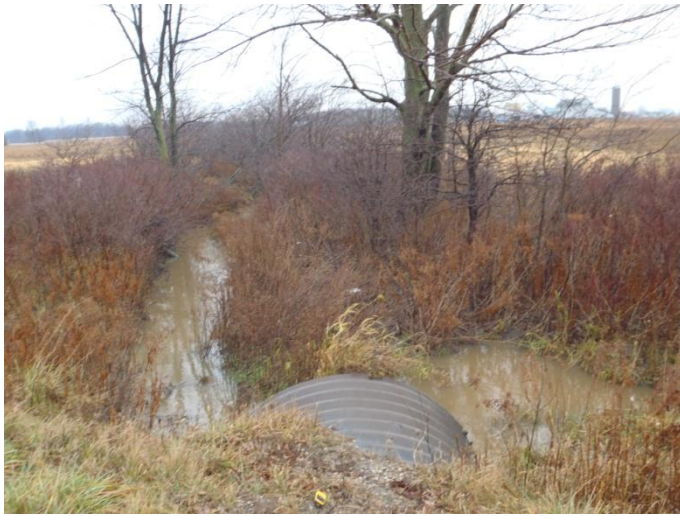
Photo 19: Hem-g (tile 4) - Looking upstream (northeast) at channel from CSP culvert. Site is located on Haldimand Road 20 between Concession 6 and Link Road.

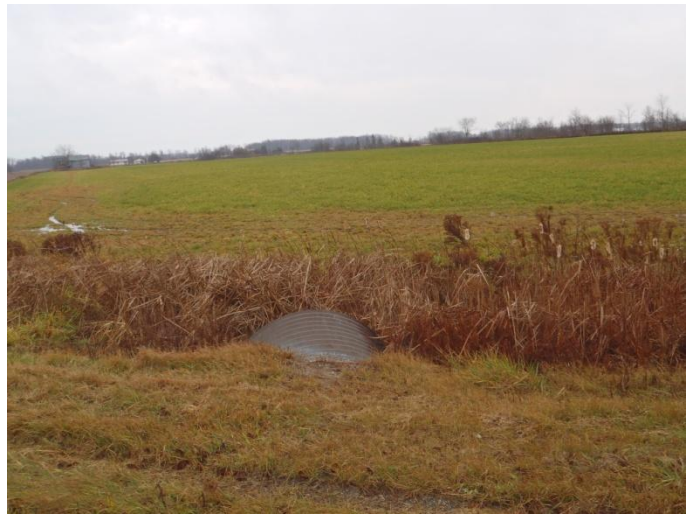
Photo 20: Hem-g (tile 4) - Looking downstream (south) at channel from CSP culvert. Site is located on Haldimand Road 20 between Concession 6 and Link Road.

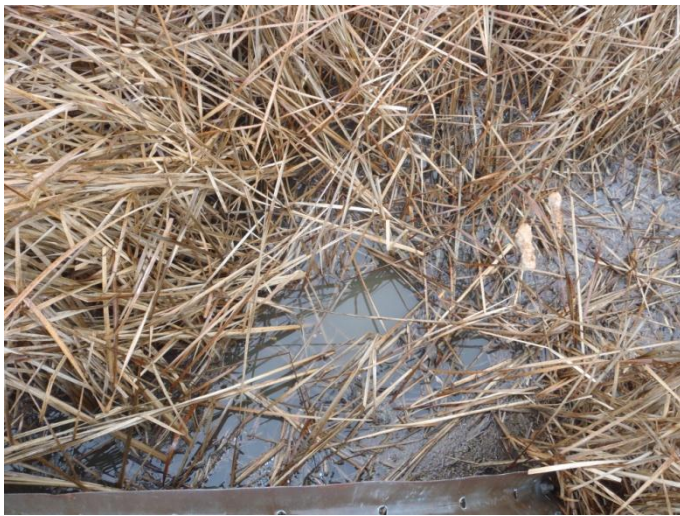
Photo 21: Hem-g (tile 4) - Existing substrate conditions at CSP culvert. Site is located on Haldimand Road 20 between Concession 6 and Link Road.

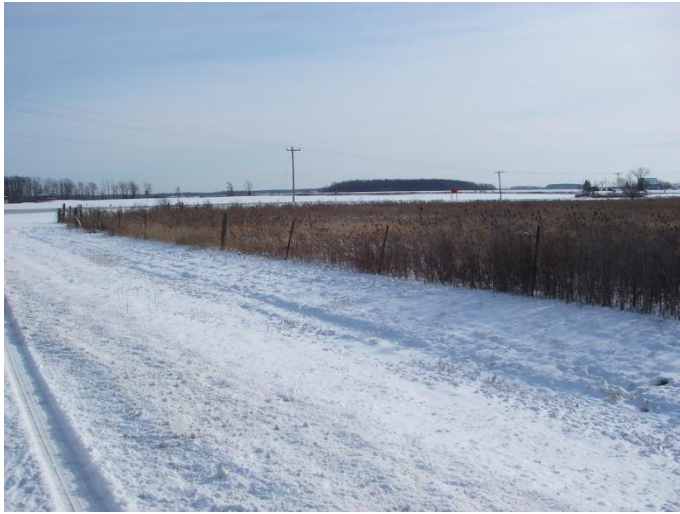
Photo 27: Hem-j (tile 4) - Looking upstream (southeast) at agricultural field. Site is located on Haldimand Road 20 between Kohler Road and Concession 6.

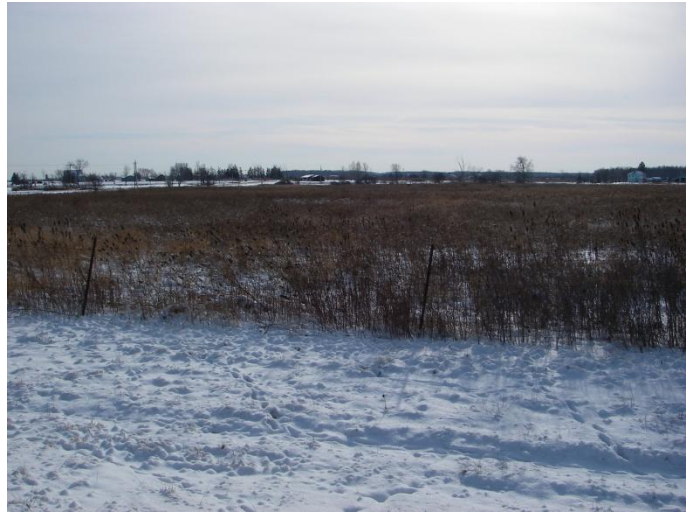
Photo 28: Hem-j (tile 4) - Looking upstream (south) at agricultural field. Site is located on Haldimand Road 20 between Kohler Road and Concession 6.

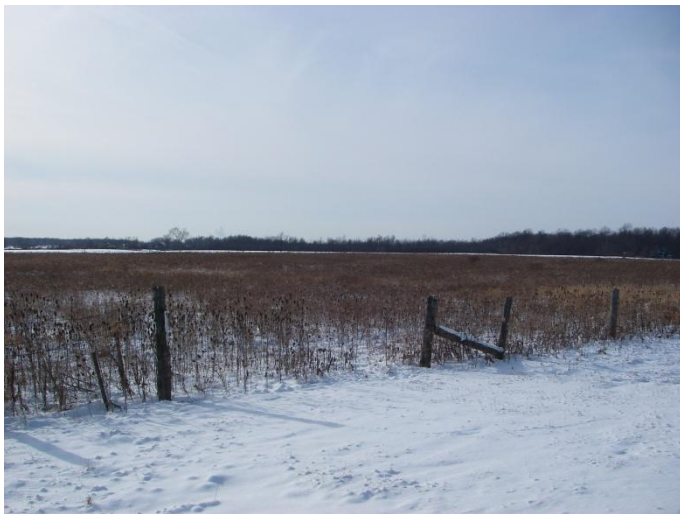
Photo 29: Hem-j (tile 4) - Looking upstream (southwest) at agricultural field. Site is located on Haldimand Road 20 between Kohler Road and Concession 6.

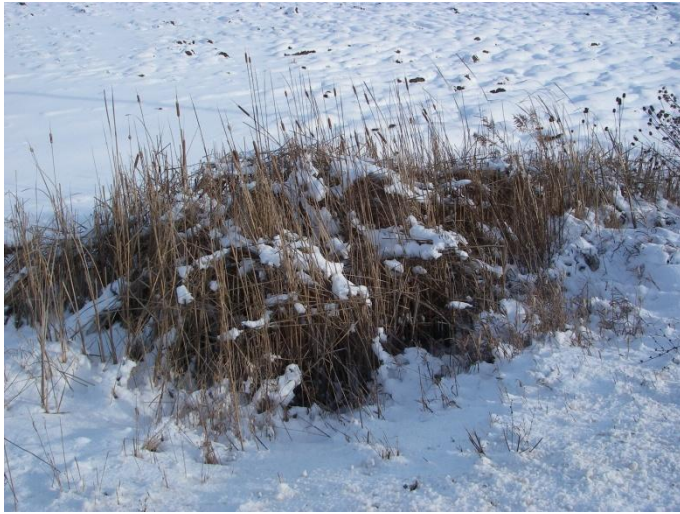
Photo 30: Hem-k (tile 4) - Looking upstream (east) at cattails and agricultural field. Site is located on south of Concession 5 on Kohler Road, between Haldimand Road 20 and Haldimand Road 12.

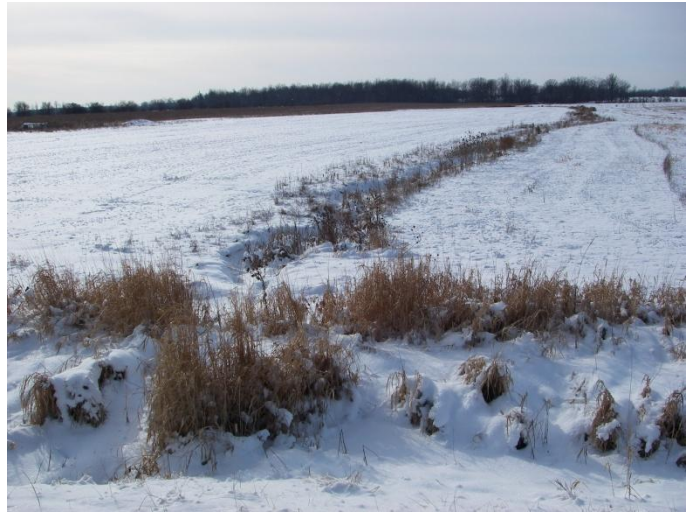
Photo 31: Hem-k (tile 4) - Looking downstream (west) from Kohler road at channel flowing through agricultural field. Site is located on south of Concession 5 on Kohler Road, between Haldimand Road 20 and Haldimand Road 12.

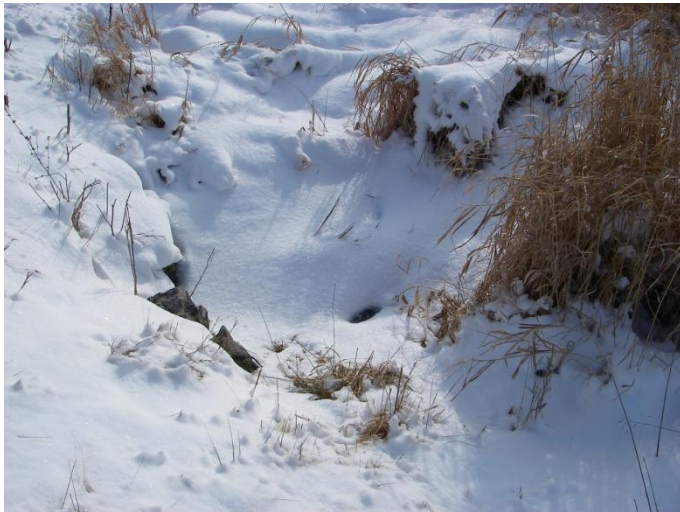
Photo 32: Hem-k (tile 4) - Looking at in-stream conditions along Kohler road. Site is located on south of Concession 5 on Kohler Road, between Haldimand Road 20 and Haldimand Road 12.

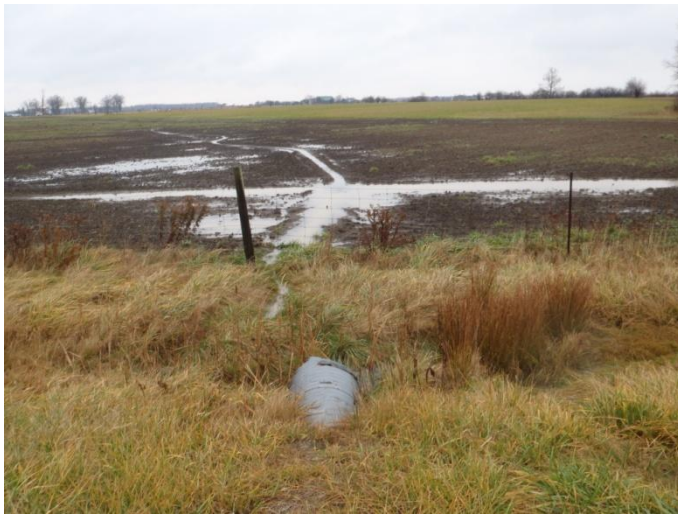
Photo 33: Hem-i (tile 3) - Looking upstream (north) at channel from CSP culvert. Site is located on Haldimand Road 20 between Concession 7 and Haldimand Road 12.

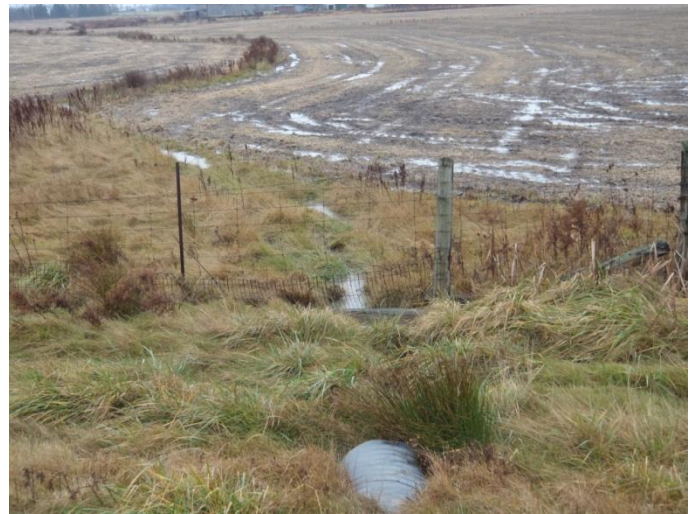
Photo 34: Hem-i (tile 3) - Looking downstream (south) at channel from CSP culvert. Site is located on Haldimand Road 20 between Concession 7 and Haldimand Road 12.

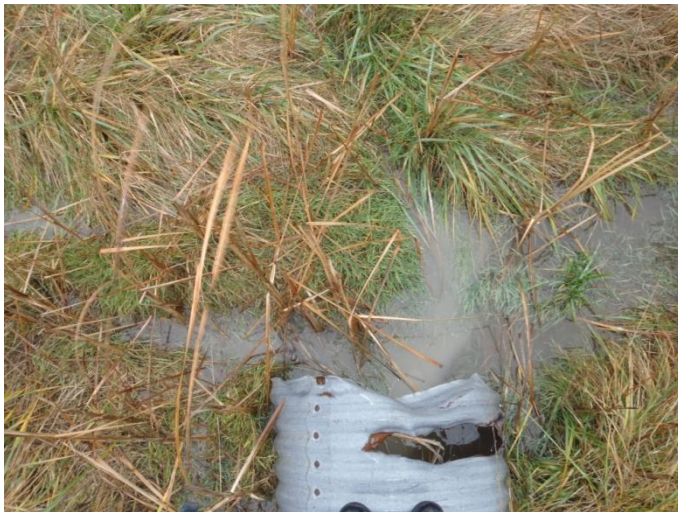
Photo 35: Hem-i (tile 3) - Existing substrate conditions at upstream end of CSP culvert. Site is located on Haldimand Road 20 between Concession 8 and Link Road.

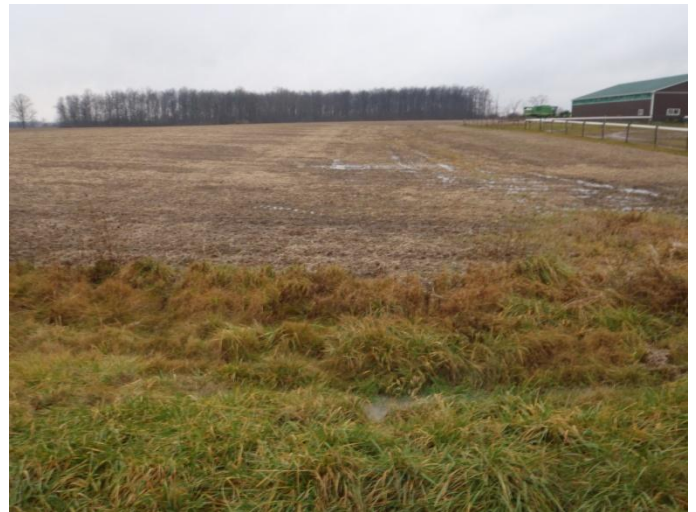
Photo 36: Hem-i (tile 3) - Looking upstream (north) at channel. Site is located 100 m south of Haldimand Road 20 between Concession 8 and Link Road.

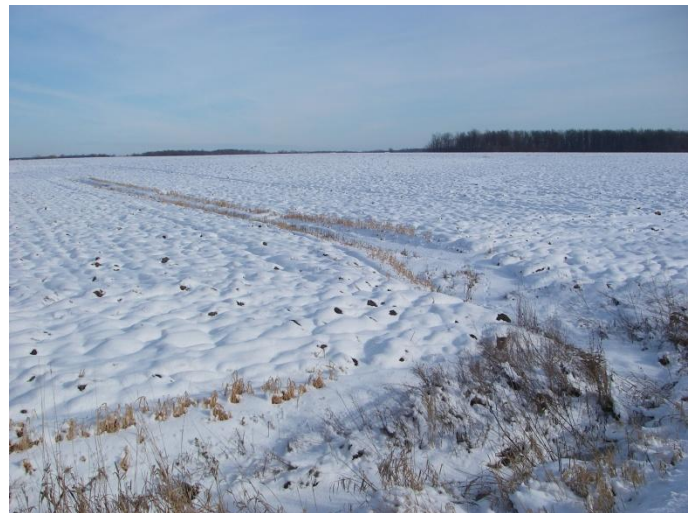
Photo 38: Hem-i (tile 6) - Looking upstream (west) channel flowing through agricultural field. Site is located on Kohler Road between Concession 4 and Concession 5.

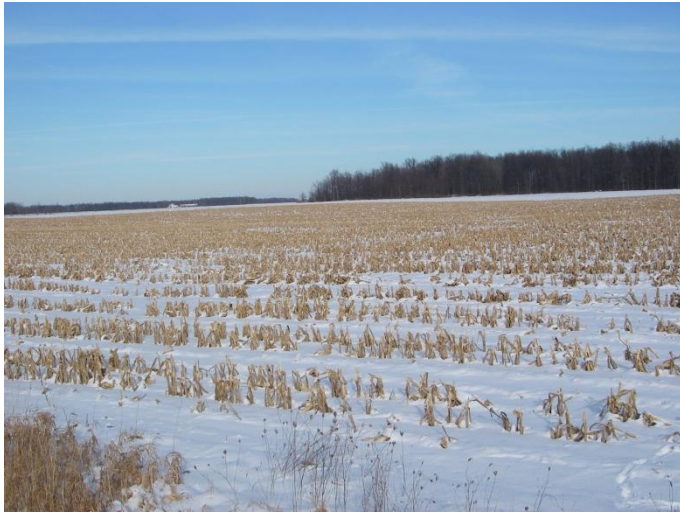
Photo 40: Hem-m (tile 6) - Looking upstream (northeast) at channel in agricultural field. Site is located on Kohler Road between Concession 4 and Concession 5.

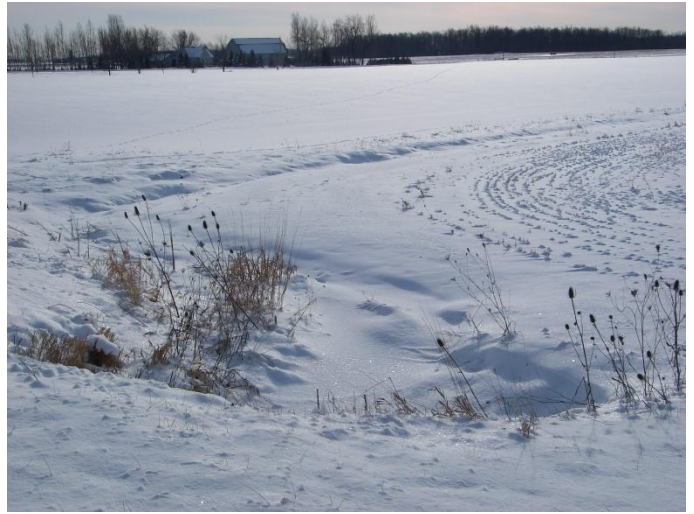
Photo 41: Hem-m (tile 6) - Looking downstream (southwest) at roadside drain and channel flowing through an agricultural field. Site is located on Kohler Road between Concession 4 and Concession 5.

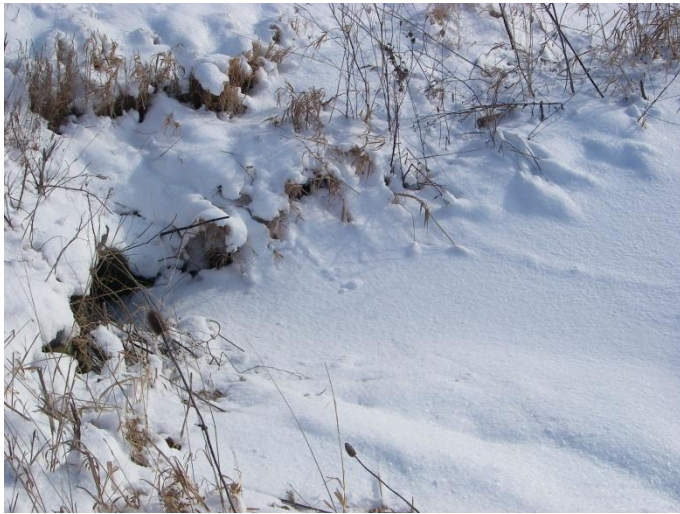
Photo 42: Hem-m (tile 6) - Looking southwest at roadside drain on Kohler Road. Site is located on Kohler Road between Concession 4 and Concession 5.

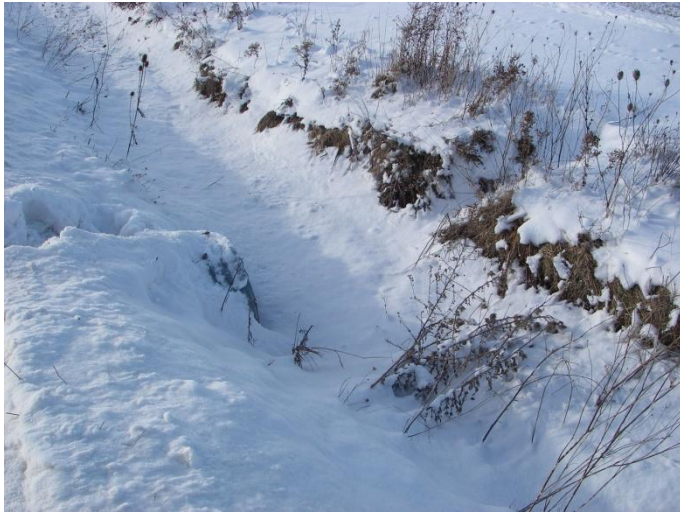
Photo 43: Hem-n (tile 6) - Looking at CSP culvert and roadside drain on north side of Concession 4. Site is located on Concession 4, between Kohler Road and Haldimand Road 20.

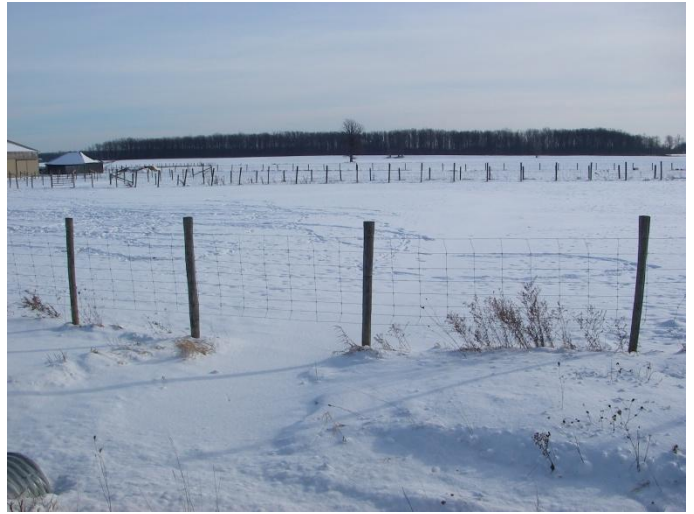
Photo 44: Hem-n (tile 6) - Looking south at outflow of CSP culvert into pasture lands. Site is located on Concession 4, between Kohler Road and Haldimand Road 20.

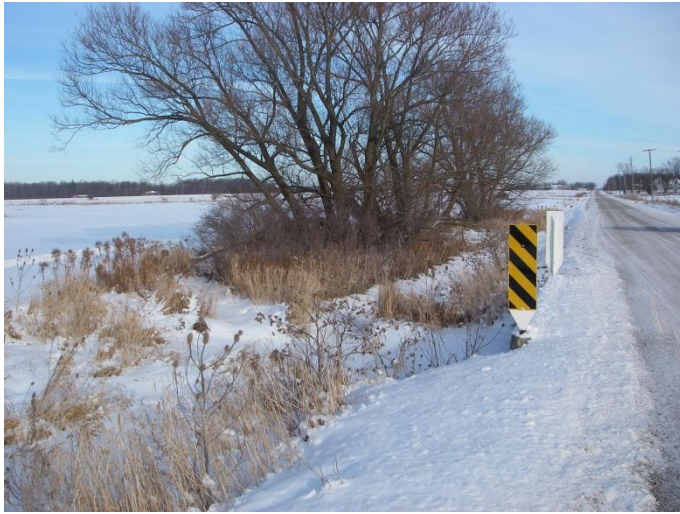
Photo 45: Hem-o (tile 6) - Looking east at upstream end of concrete culvert on north side of Concession 4. Site is located on Concession 4, between Kohler Road and Haldimand Road 20.

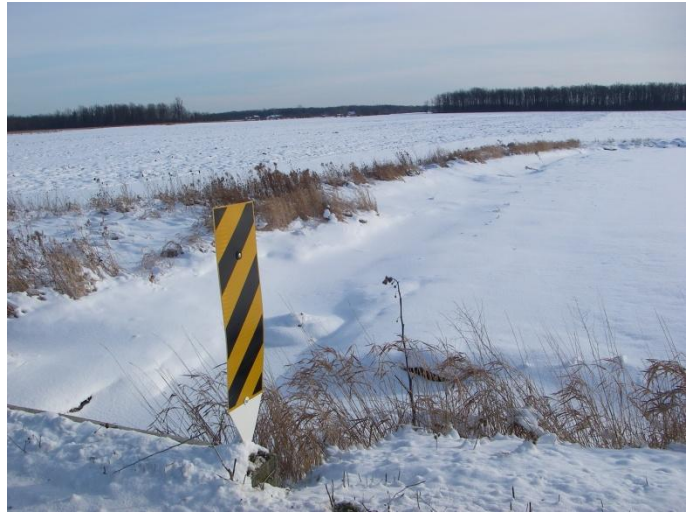
Photo 46: Hem-o (tile 6) - Looking south at outflow of concrete culvert and channel flowing through agriculture lands. Site is located on Concession 4, between Kohler Road and Haldimand Road 20

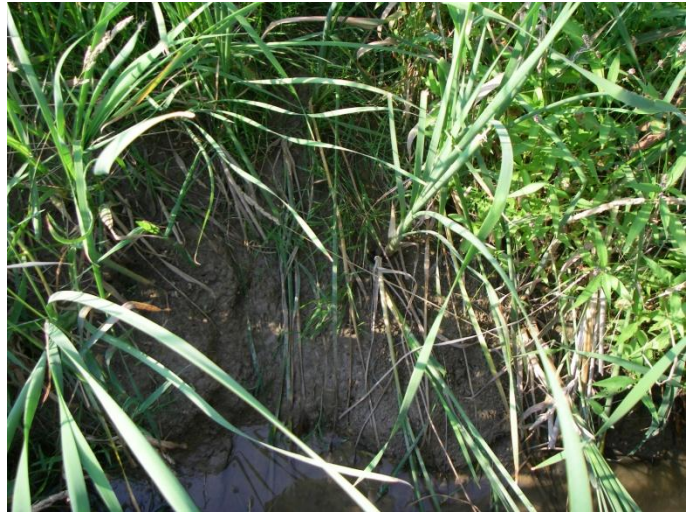
Photo 2: Ward-a (solar tile) - Looking downstream (east) channel through agricultural field. Site is located on Haldimand Road 20 between Wilson Road and Mount Olivet Road.

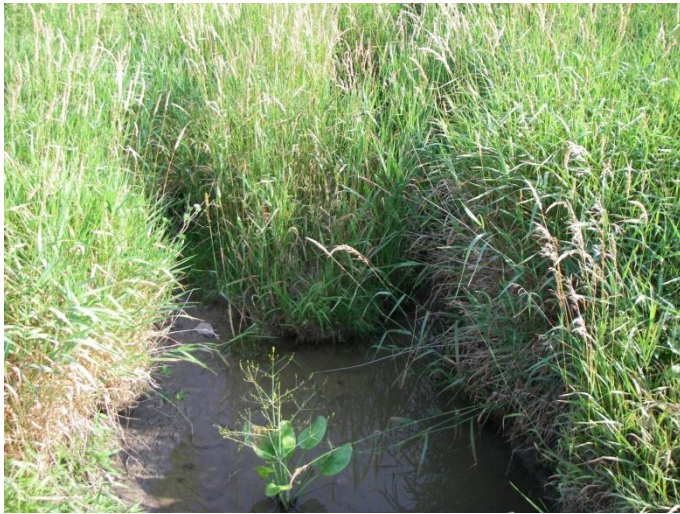
Photo 3: Ward-a (solar tile) - Existing substrate conditions. Site is located on Haldimand Road 20 between Wilson Road and Mount Olivet Road.

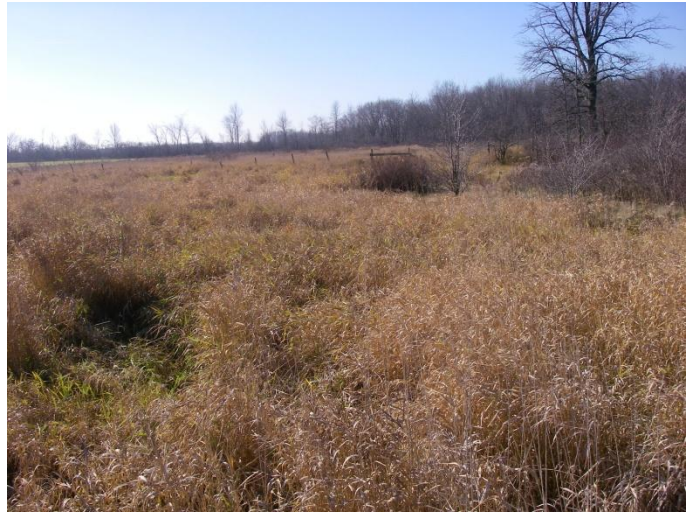
Photo 5: Ward-b (tile 6) - Looking downstream (west) from concrete culvert on Bains Road, between Haldimand Road 20 and Wilson Road.

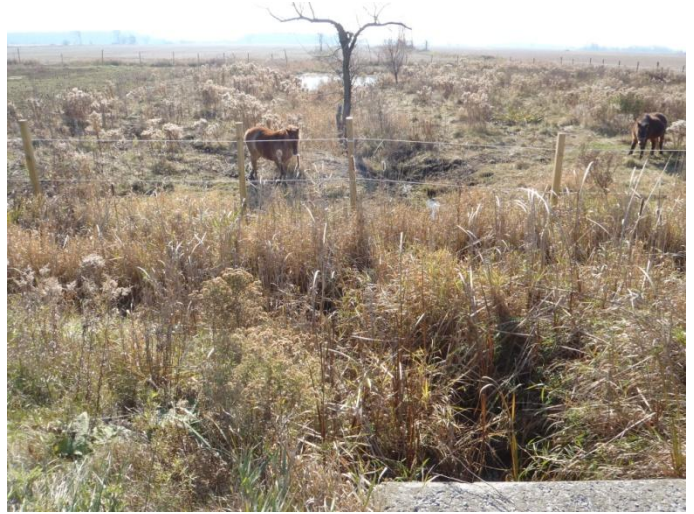
Photo 7: Ward-c (tile 8) - Looking downstream (east) at concrete culvert on south side of Haldimand Road 20, between Wilson Road and Sutor Road.

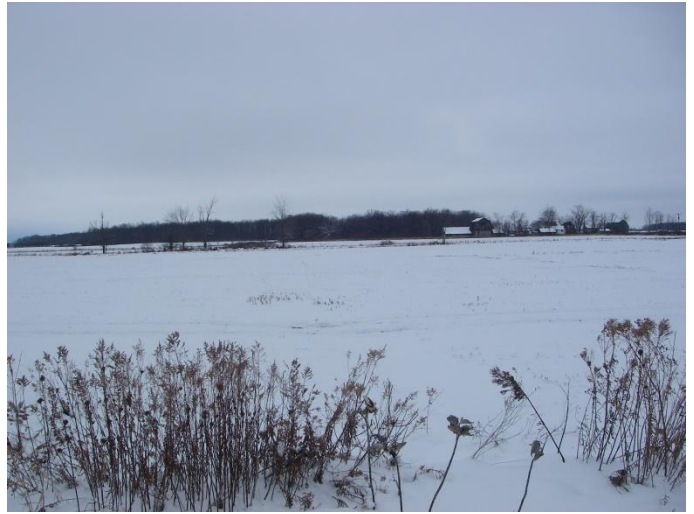
Photo 9: Ward-d (tile 8) - Looking upstream (east) from Sutor Road at channel location. Site is located on Sutor Road, south of Haldimand Road 20.

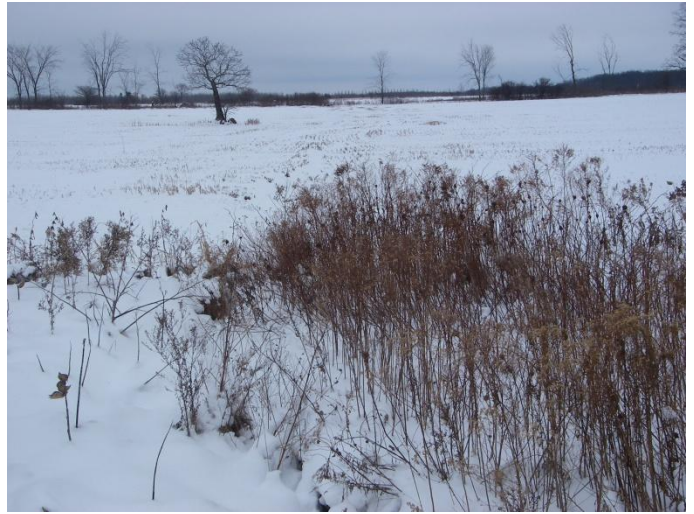
Photo 11: Ward-e (tile 8) - Looking downstream from Sutor Road at channel location. Site is located on Sutor Road, south of Haldimand Road 20.

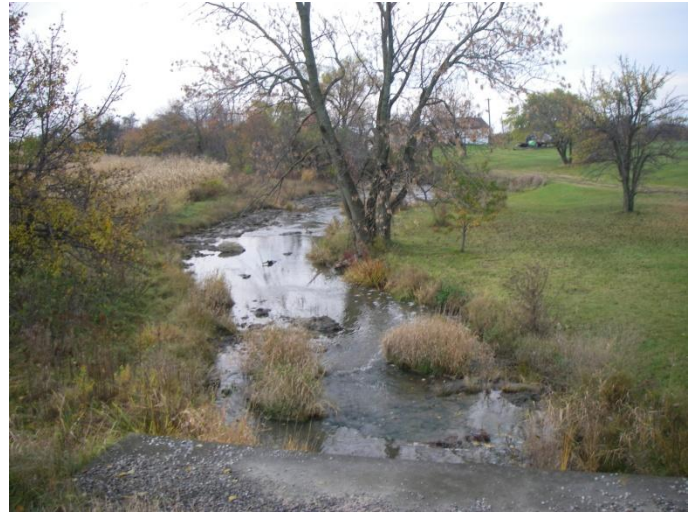
Photo 13: Ward-f (tile 8) - Looking downstream (southeast) at water body flowing from concrete culvert and adjacent to agriculture and residential land uses. This site is located on Bains Road between Wilson Road and Haldimand Road 50.

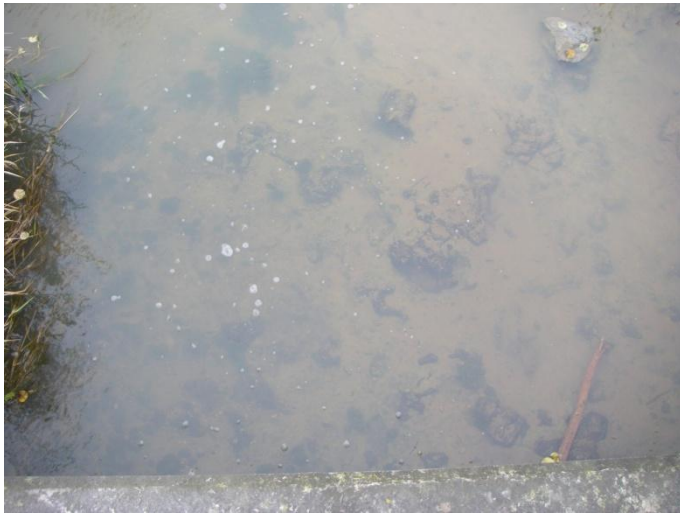
Photo 14: Ward-f (tile 8) - Existing substrate conditions in water body at downstream end of concrete culvert. This site is located on Bains Road between Wilson Road and Haldimand Road 50.

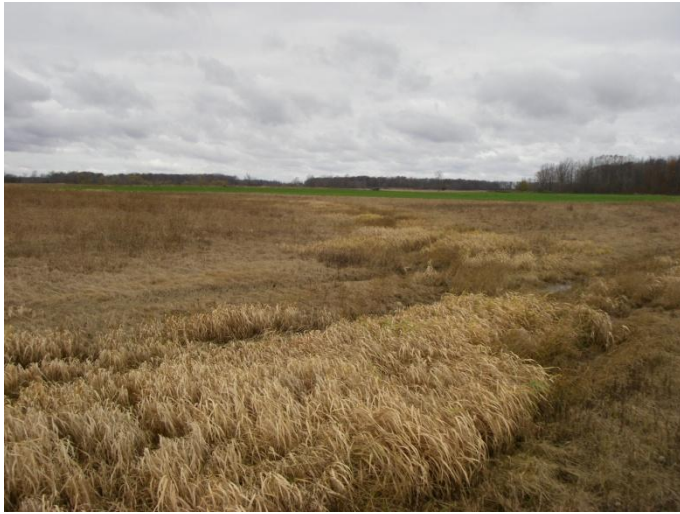
Photo 15: Ward-g (tile 8) - Looking upstream at grassy wetted area in a field. Site is located west of Sutor Road and north of Bains Road.

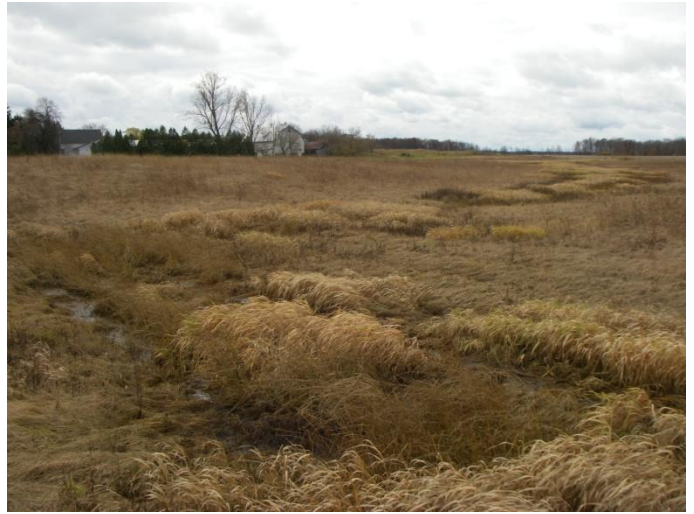
Photo 16: Ward-g (tile 8) - Looking downstream at grassy wetted area in a field. Site is located west of Sutor Road and north of Bains Road.

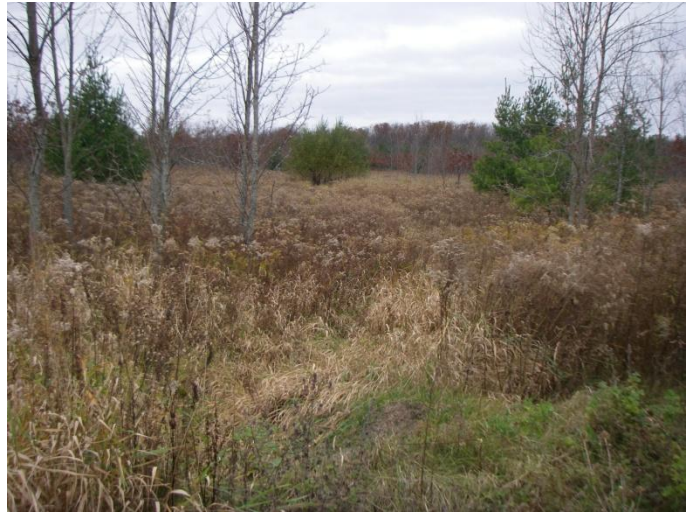
Photo 20: Ward-j (tile 8) - Looking upstream (northeast) at grassy swale from a CSP culvert in a field. Site is located west of Haldimand Road 50 between Haldimand Road 20 and Bains Road.

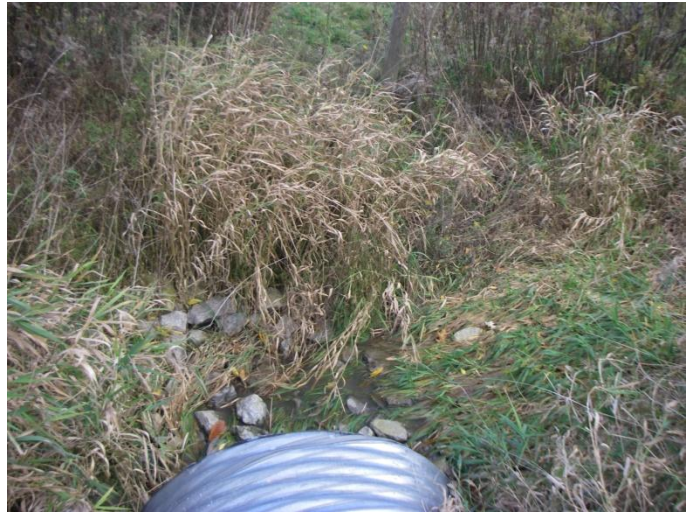
Photo 2: Evans-a (tile 9) - Looking at existing conditions at upstream end of CSP culvert. This site is located on Bains Road between Sutor Road and Haldimand Road 50.
