Client/Project	January 2011
SAMSUNG C&T	160960577
GRAND RENEWABLE ENERGY PARK

Title
HEMLOCK CREEK SUBWATERSHED PHOTOS

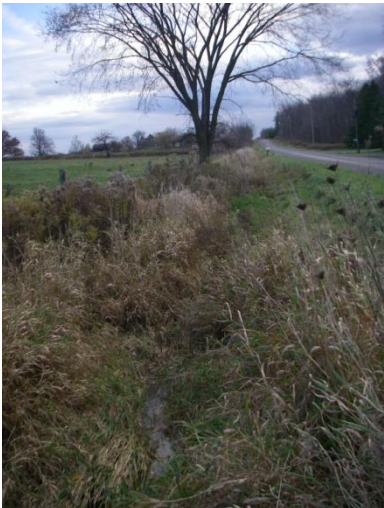
Photo 3: Evans-a (tile 9) - Looking east at roadside drain contributing to watercourse at upstream end of CSP culvert. This site is located on Bains Road between Sutor Road and Haldimand Road 50.

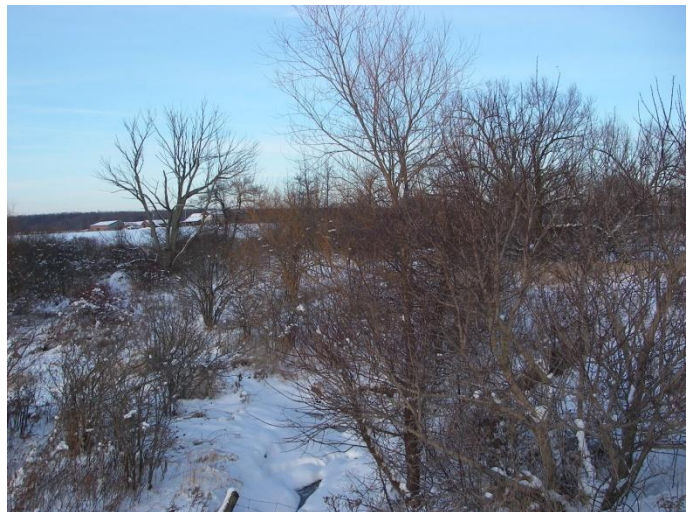
Photo 6: Evans- a (tile 9) - Looking upstream (north) from Rainham Road at channel location. Site is located on Sutor Road, between River Road and Meadows Road.

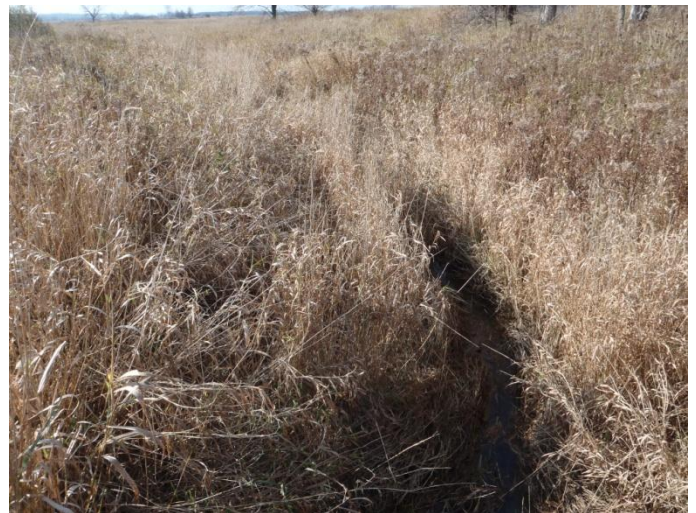
Photo 11: Evans-c (tile 12) - Looking downstream (east) at water feature on Haldimand Road 50, between Bains Road and Rainham Road.

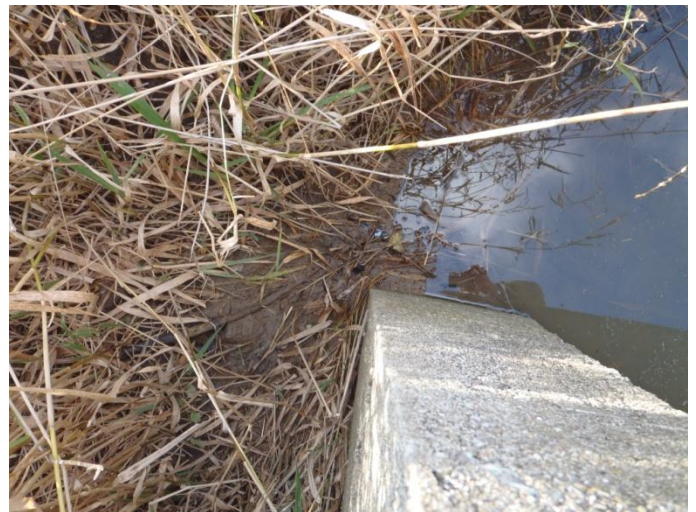
Photo 13: Evans-c (tile 12) - Looking at existing substrate in water feature on Haldimand Road 50, between Bains Road and Rainham Road.

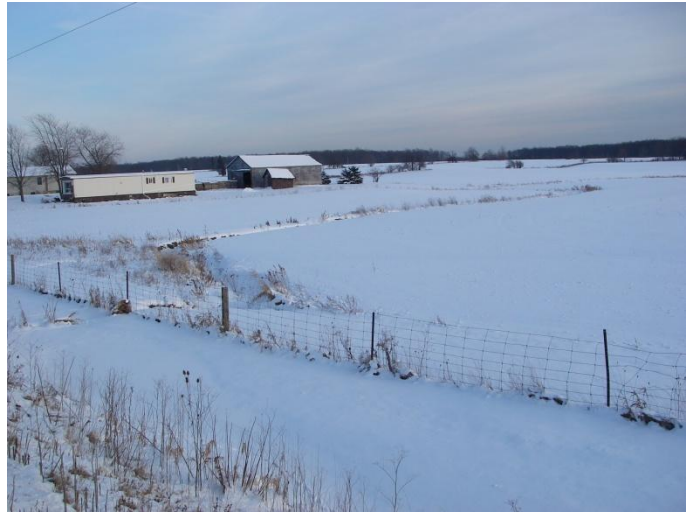
Photo17: Evans-e (tile 9) - Looking downstream (south) from Rainham Road at channel flowing though farm lands. Site is located on Rainham Road, between Brookers Road and Haldimand Road 50.

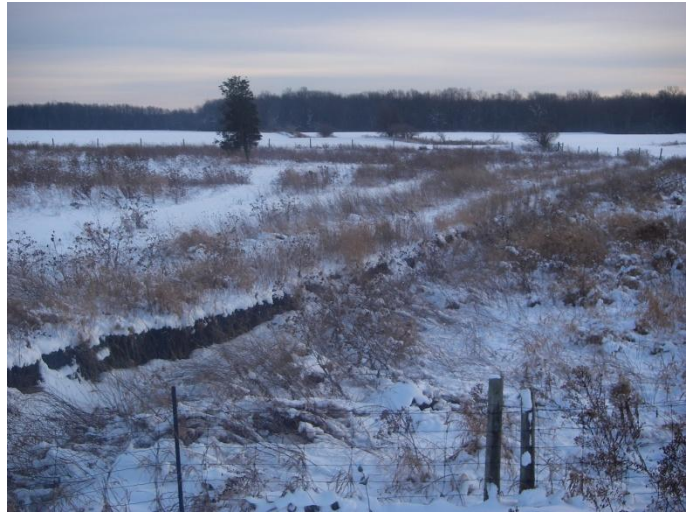
Photo 19: Evans-f (tile 9) - Looking downstream (south) from Rainham Road at channel flowing through farm lands. Site is located on Rainham Road, between Brookers Road and Haldimand Road 50.

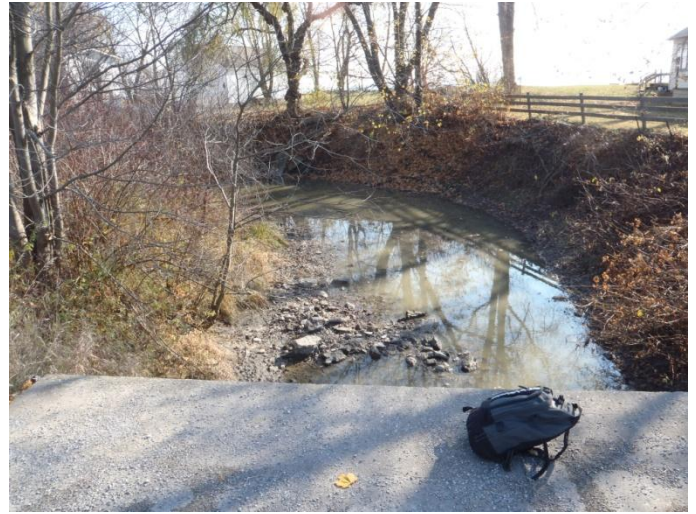
Photo 21: Evans-h (tile 10) - Looking downstream (south) from concrete culvert at Lakeshore Road. Site is located west of White Cap Lane and Haldimand Road 50, approximately 50 m north of the lake shore.

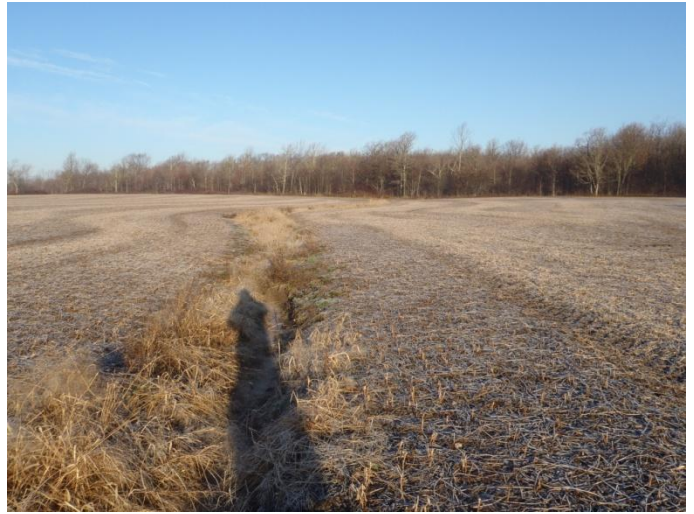
Photo 17: Evans-i (Tile 11) (field data sheet 33.0) - Looking upstream (north) at ill-defined channel flowing through an agricultural field. Site is located north of Bains Road between Haldimand Road 50 and South Cayuga Road.

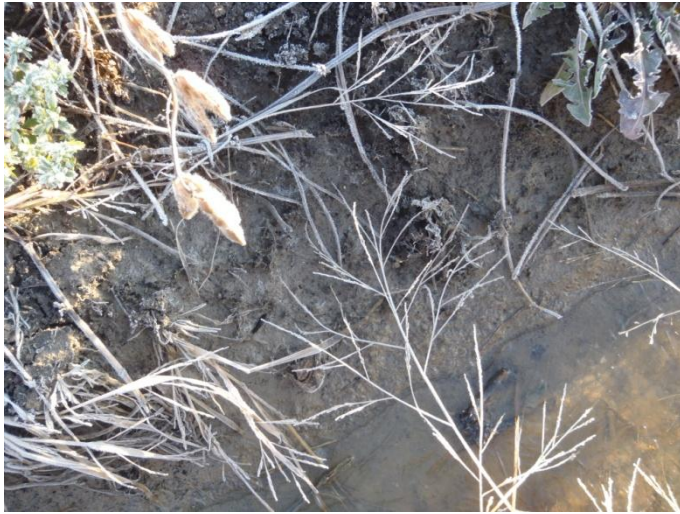
Photo 18: Evans-i (Tile 11) (field data sheet 33.0) - Existing substrate conditions in channel. Site is located north of Bains Road between Haldimand Road 50 and South Cayuga Road.

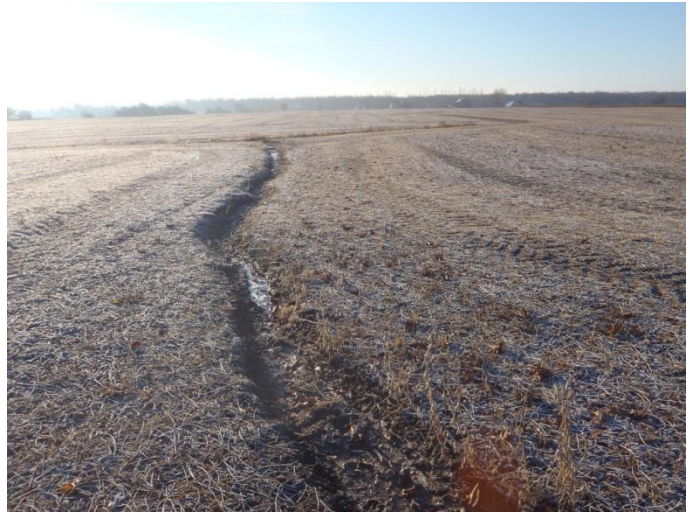
Photo 19: Evans-i (tile 11) (field data sheet 33.1) - Looking downstream (south) at plowed-through water feature flowing through an agricultural field. Site is located north of Bains Road between Haldimand Road 50 and South Cayuga Road.

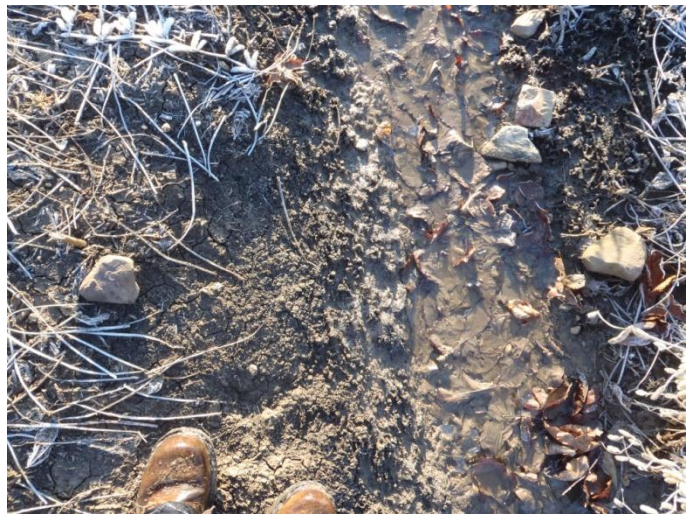
Photo 21: Evans-i (tile 11) (field data sheet 33.1) - Existing substrate conditions in channel. Site is located north of Bains Road between Haldimand Road 50 and South Cayuga Road.

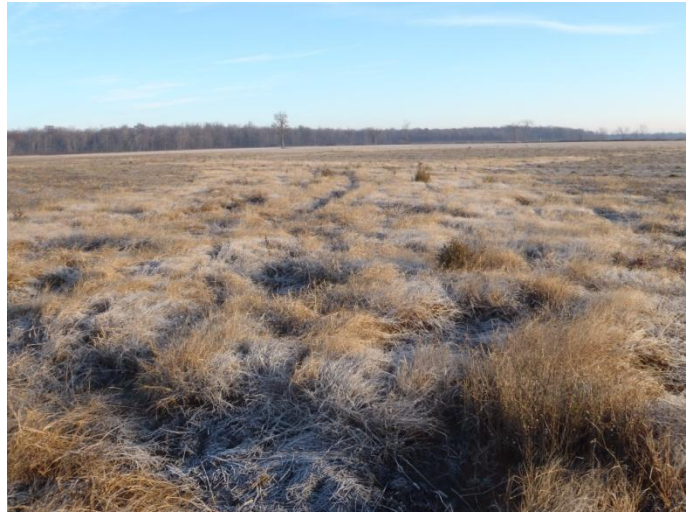
Photo 23: Evans-k (Tile 11) (field data sheet 33.2) - Looking upstream (east) at undefined channel flowing through an agricultural field. Site is located north of Bains Road between Haldimand Road 50 and South Cayuga Road.

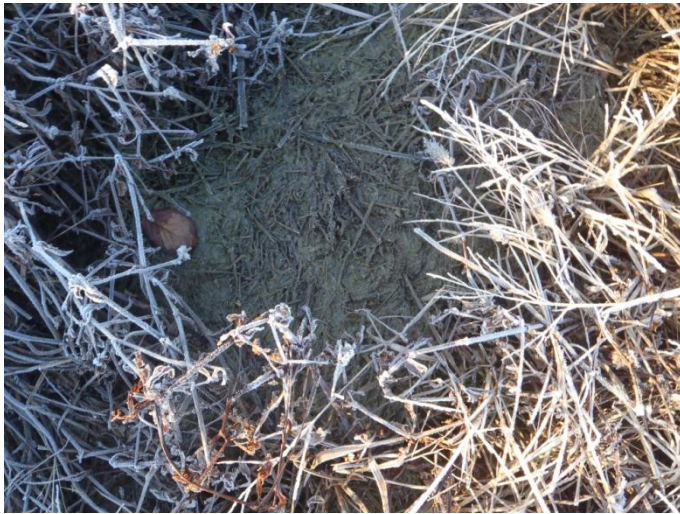
Photo 24: Evans-k (Tile 11) (field data sheet 33.2) - Existing substrate conditions in undefined channel. Site is located north of Bains Road between Haldimand Road 50 and South Cayuga Road.
