RAPID ASSESSMENT FORM FOR AQUATIC HABITAT

Project Samsung (GREP) Wind
 Station # 1
 Photos Taken D121, 0122, 0123
 GPS Coordinates 17T 0587854/4753842
 Descriptive Location crossing approximately 200 m South of Rt 3
@ house # 4260

Project # 161010646
 Field Staff E. Malindzak, M. Kozak
 Date 10-18-2010
 Time 12:22

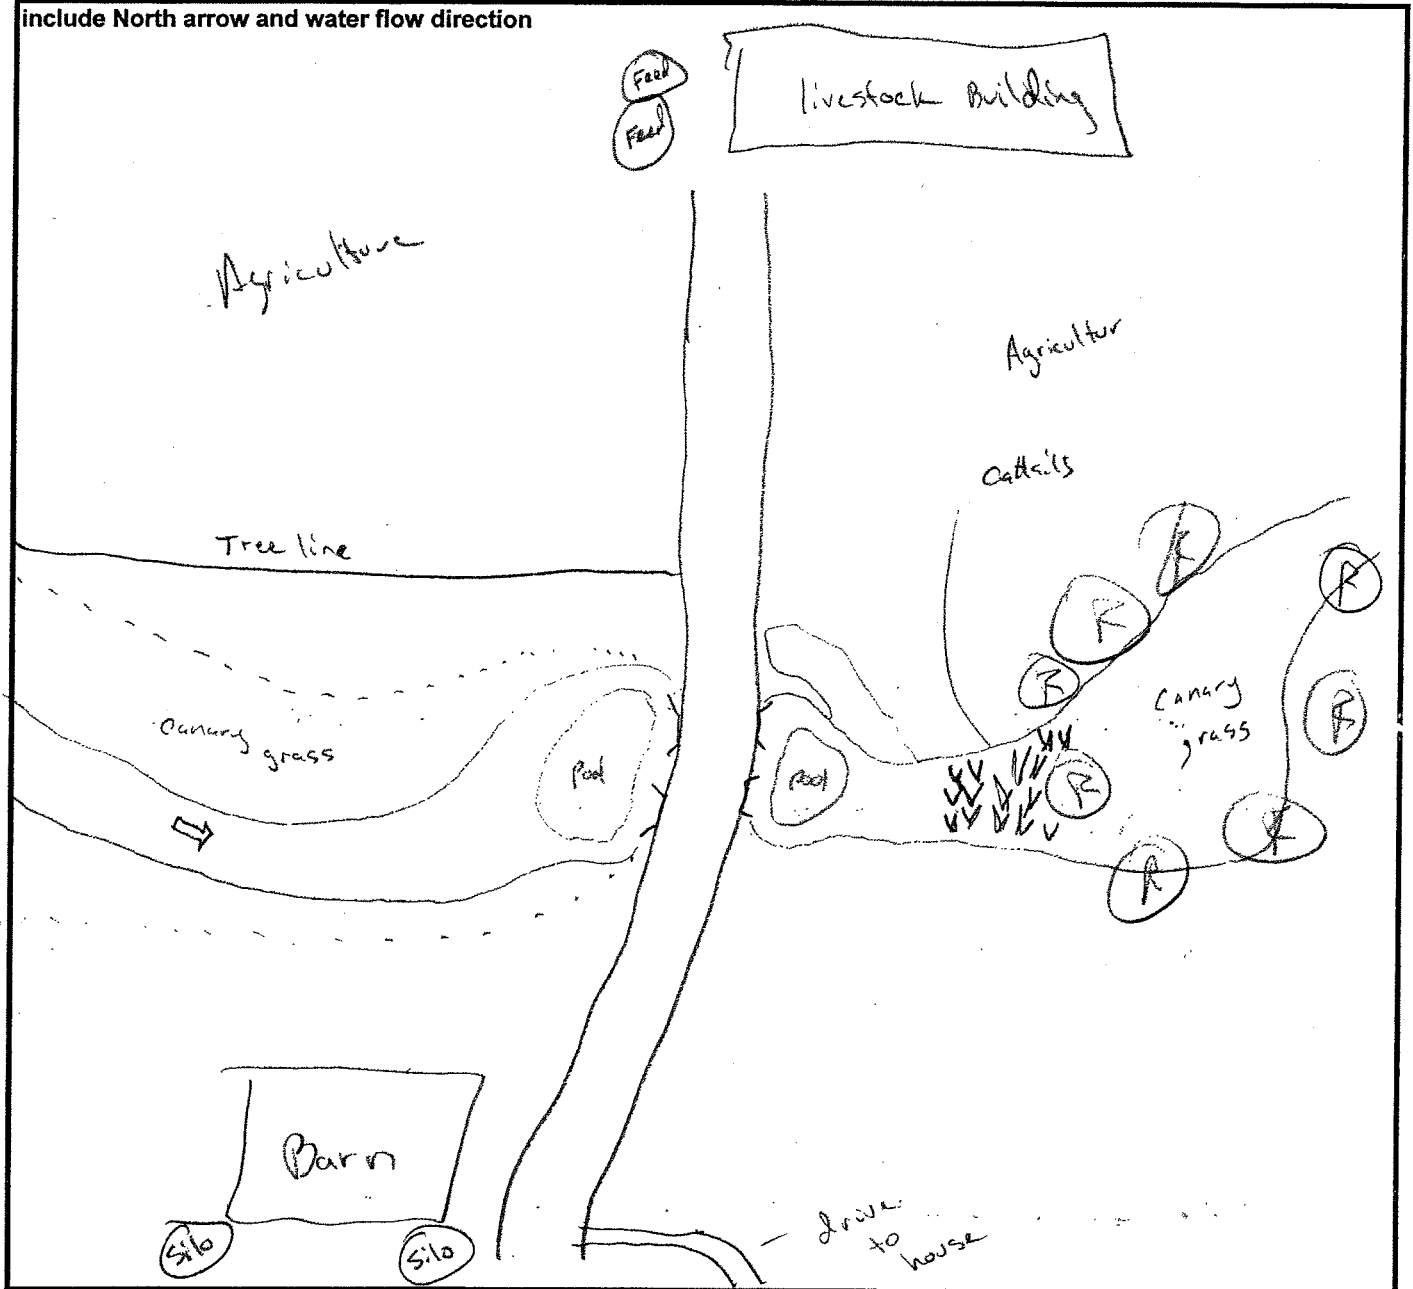
debris is very high on grass. Landowner states system is
flashy, especially in past few years

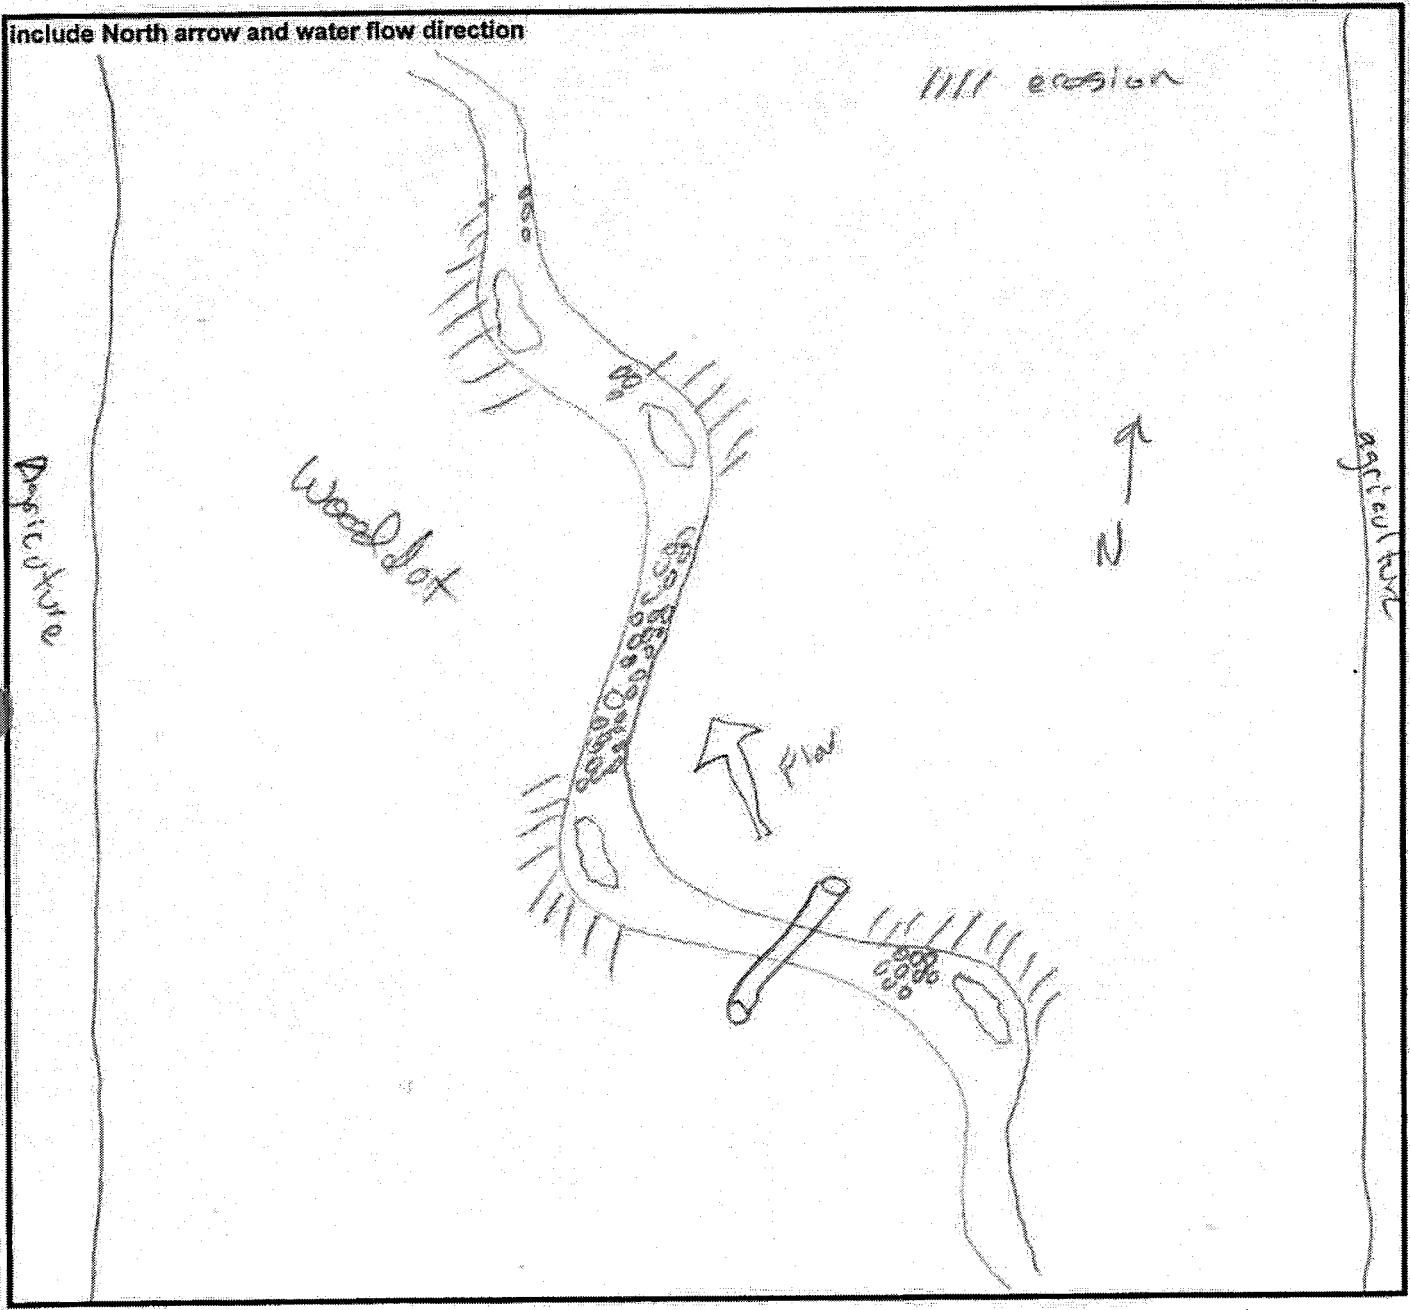
Station Number 17.0
Pass No. (if applicable) 1
Field Staff: E. Malachuk, M. Kozak

nice natural system w/meanders, too erosion is very
common Anecdotal info indicates historically helol pike
In water the visibility was complicated by layer of
recently fallen leaves
