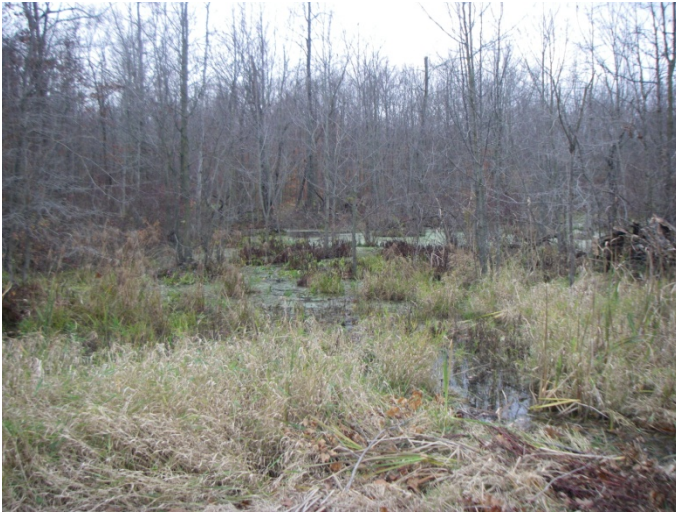
Photo 1: Lake-a (tile 12) - Looking west at flooded wooded area. Site is located on South Cayuga Road between Bains Road and Rainham Road.

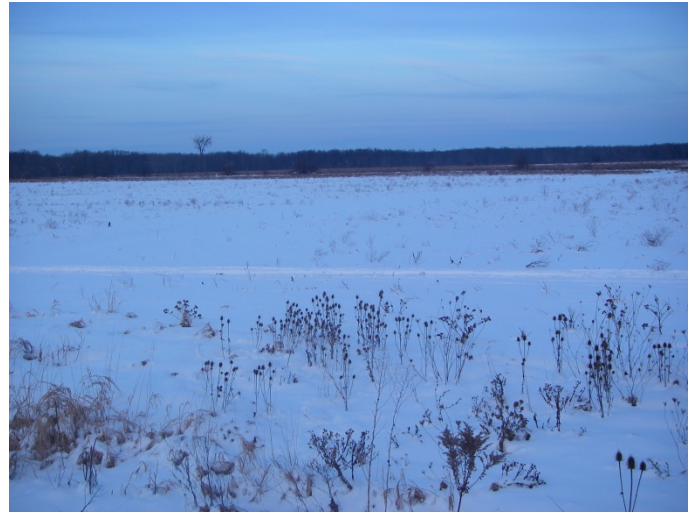
Photo 2: Lake-a (tile 12) Looking upstream (east) from South Cayuga Road at watercourse location and adjacent agricultural fields. Site is located on South Cayuga Road, between Bains Road and Rainham Road.

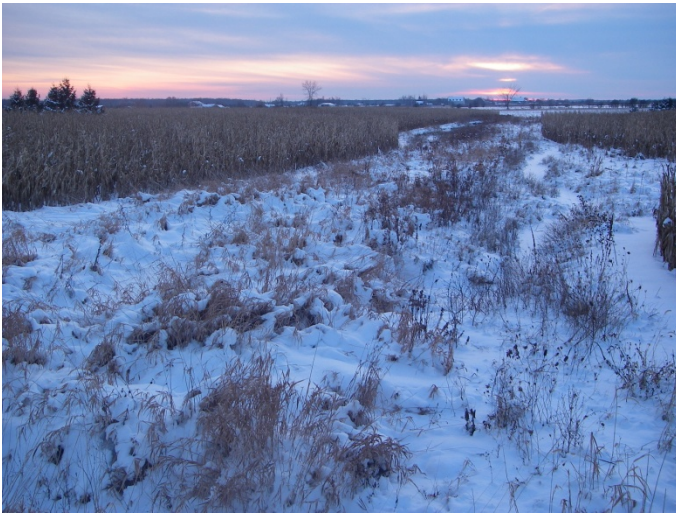
Photo 3: Lake-a (tile 12) - Looking downstream (west) from South Cayuga Road at watercourse location and adjacent agricultural fields. Site is located on South Cayuga Road, between Bains Road and Rainham Road.

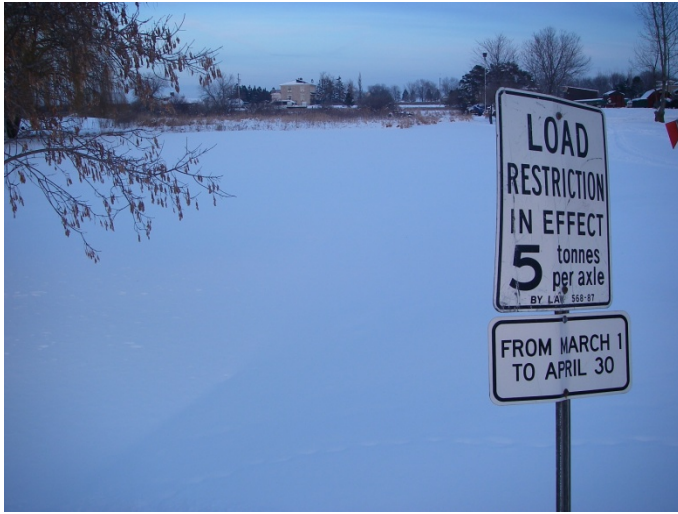
Photo 4: Lake-b (tile 12) - Looking upstream (east) from South Cayuga Road at location where channel is mapped. Site is located on South Cayuga Road, between Bains Road and Rainham Road.

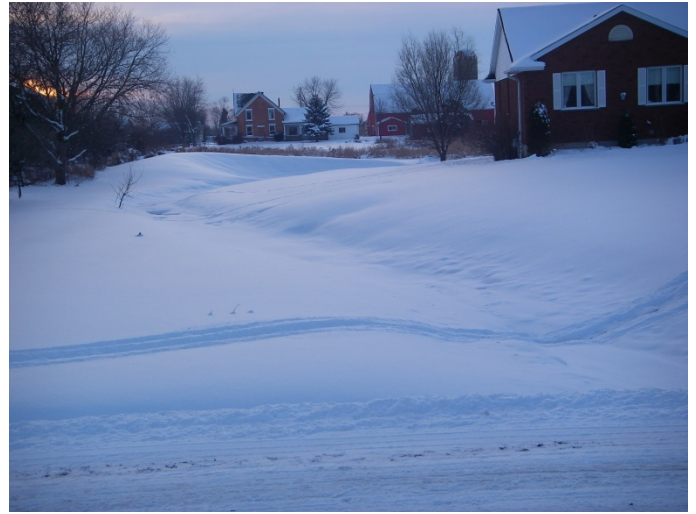
Photo 5: Lake-b (tile 12) - Looking downstream (west) from South Cayuga Road at adjacent residential location and location where channel is mapped and properties. Site is located on South Cayuga Road, between Bains Road and Rainham Road.

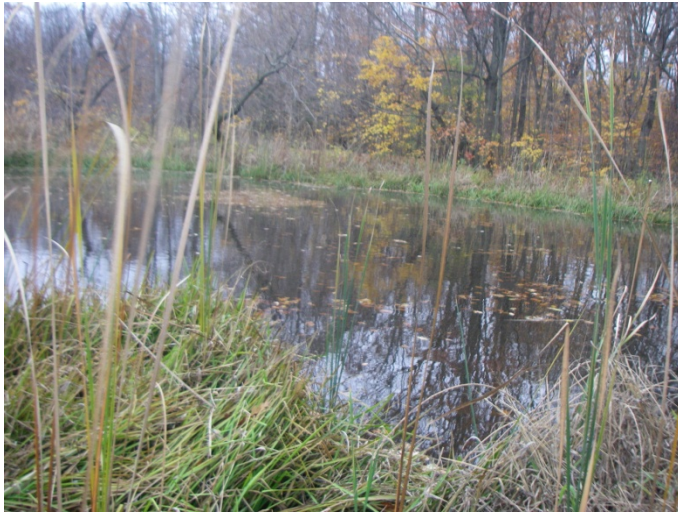
Photo 6: Lake-c (tile 12) - Looking south at man-made pond. Site is located south of Rainham Road between South Cayuga Road and Hald-Dunn Townline Road.

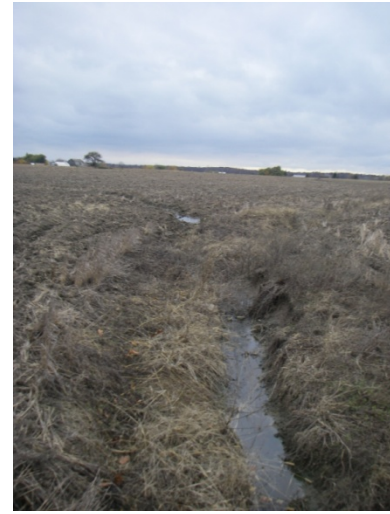
Photo 7: Lake-c (tile 12) - Looking upstream (northwest) at drain feature flowing through agricultural field. Site is located south of Rainham Road between South Cayuga Road and Hald-Dunn Townline Road.

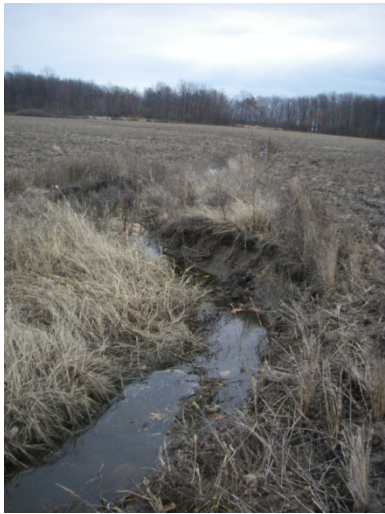
Photo 8: Lake-c (tile 12) - Looking downstream (southeast) at drain feature flowing through agricultural field and into wooded area. Site is located south of Rainham Road between South Cayuga Road and Hald-Dunn Townline Road.

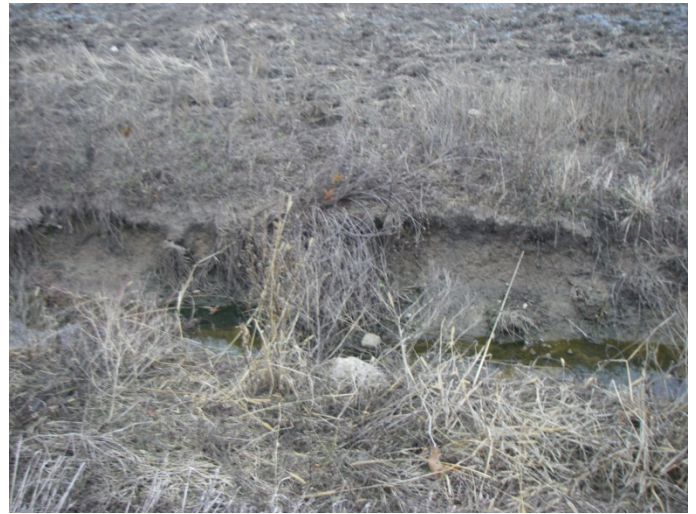
Photo 9: Lake-c (tile 12) - Looking at existing conditions within drain feature flowing through agricultural field. Site is located south of Rainham Road between South Cayuga Road and Hald-Dunn Townline Road.

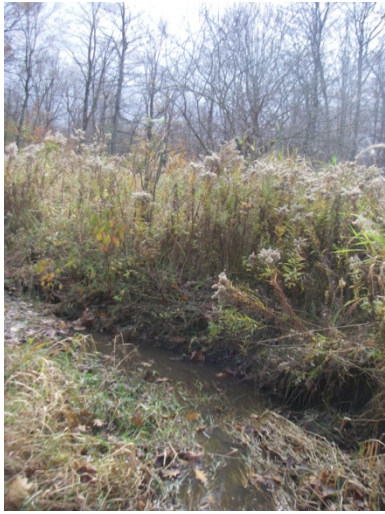
Photo 10: Lake-d (tile 15) - Looking downstream in low-lying area near interface with adjacent wooded area. Site is located east of Hald-Dunn Townline Road between Rainham Road and the lakeshore.

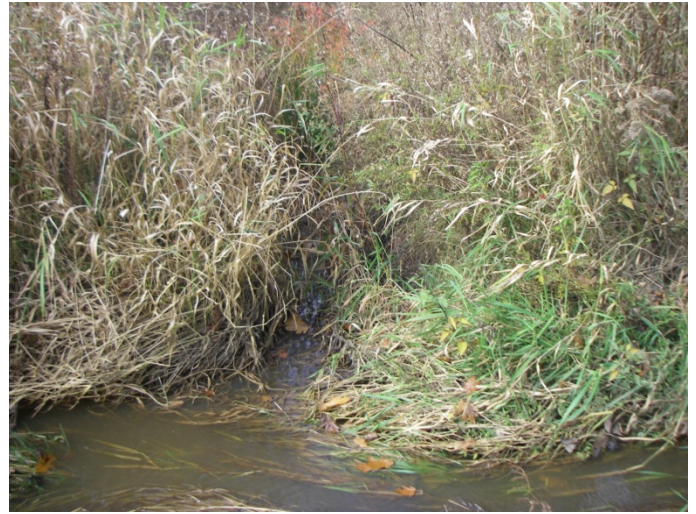
Photo 11: Lake-d (tile 15) - Looking at confluence of two channels in low-lying area near interface with adjacent wooded area. Site is located east of Hald-Dunn Townline Road between Rainham Road and the lakeshore.

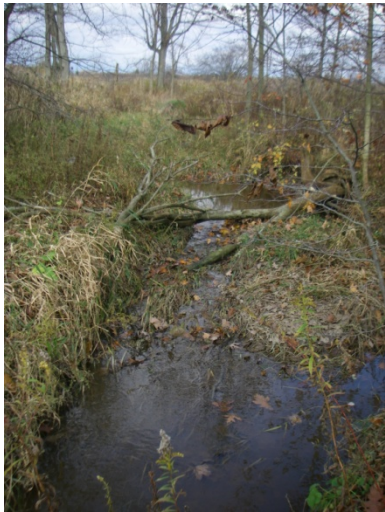
Photo 12: Lake-d (tile 15) - Looking upstream in low-lying area near border with adjacent wooded area. Site is located east of Hald-Dunn Townline Road between Rainham Road and the lakeshore.

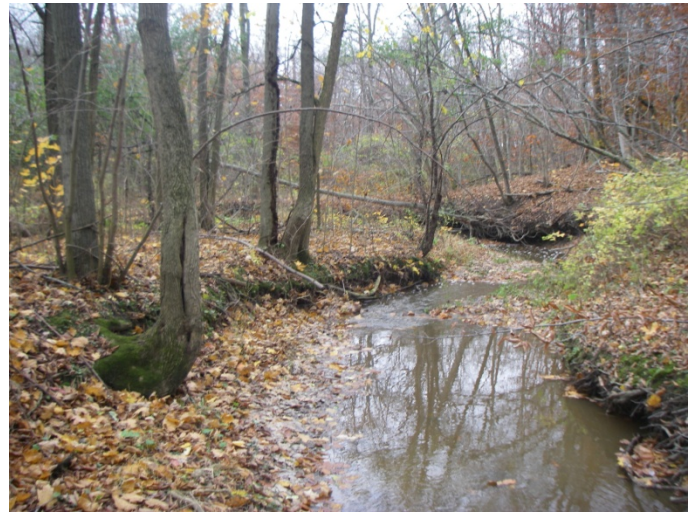
Photo 13: Lake-d (tile 15) - Looking downstream (northeast) at watercourse in wooded area. Site is located east of Hald-Dunn Townline Road between Rainham Road and the lakeshore.

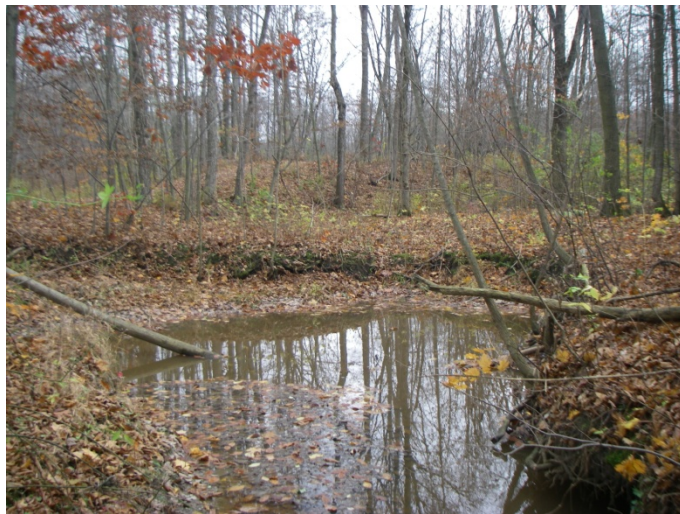
Photo 14: Lake-d (tile 15) - Looking upstream (southwest) at watercourse in wooded area. Site is located east of Hald-Dunn Townline Road between Rainham Road and the lakeshore.

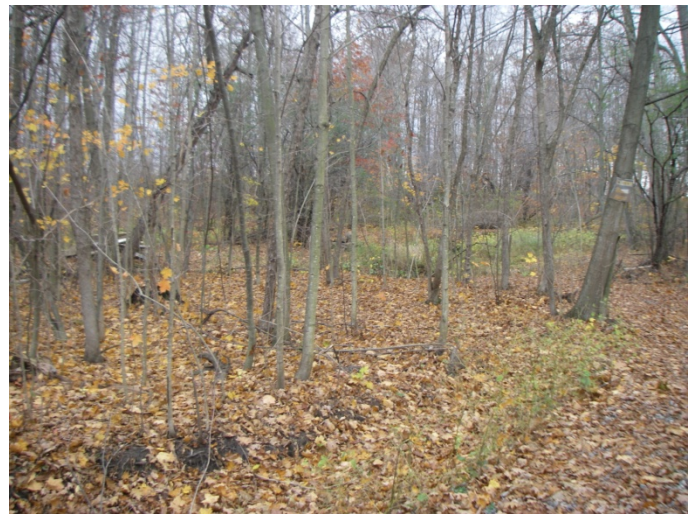
Photo 15: Lake-d (tile 15) - Looking at historic watercourse channel locations as evidenced by abandoned channel. Site is located east of Hald-Dunn Townline Road between Rainham Road and the lakeshore.

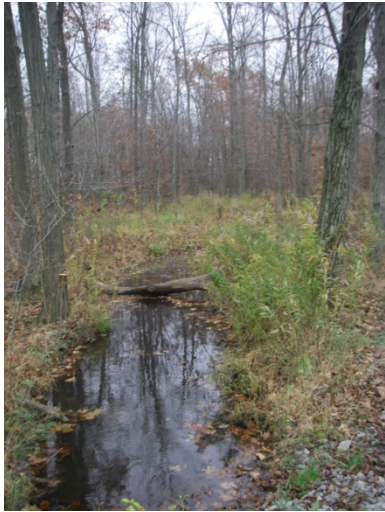
Photo 16: Lake-d (tile 15) - Looking at isolated linear pool with no upstream or downstream connection. Site is located east of Hald-Dunn Townline Road between Rainham Road and the lakeshore.

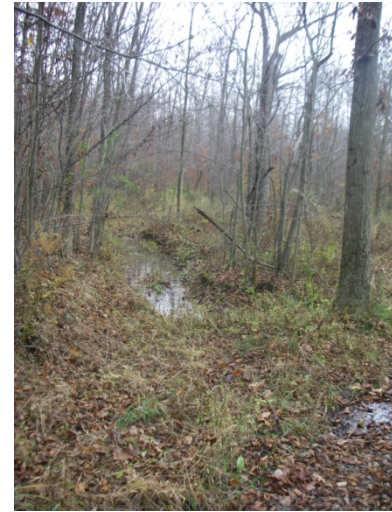
Photo 17: Lake-d (tile 15) - Looking at upstream channel from ATV trail in wooded area. Site is located east of Hald-Dunn Townline Road between Rainham Road and the lakeshore.

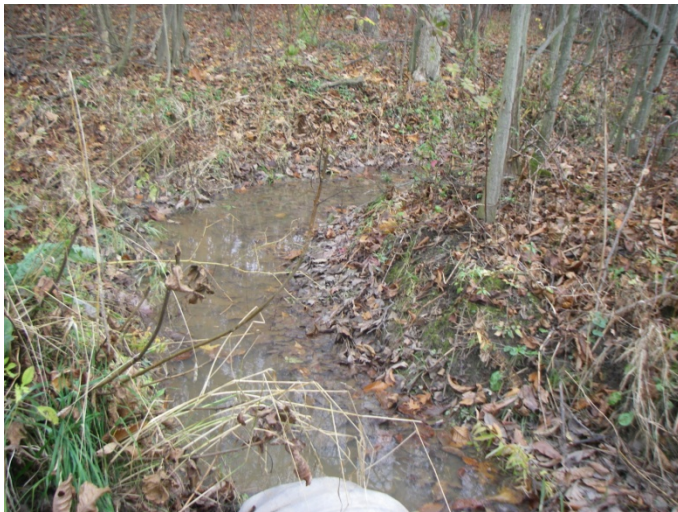
Photo 18: Lake-d (tile 15) - Looking upstream at CSP culvert and channel from ATV trail in wooded area. Site is located east of Hald-Dunn Townline Road between Rainham Road and the lakeshore.

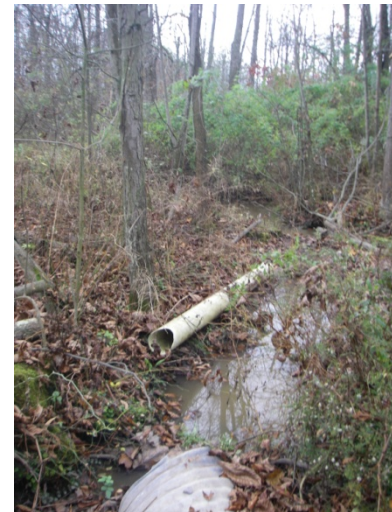
Photo 19: Lake-d (tile 15) - Looking downstream at CSP culvert and channel from ATV trail in wooded area. Site is located east of Hald-Dunn Townline Road between Rainham Road and the lakeshore.

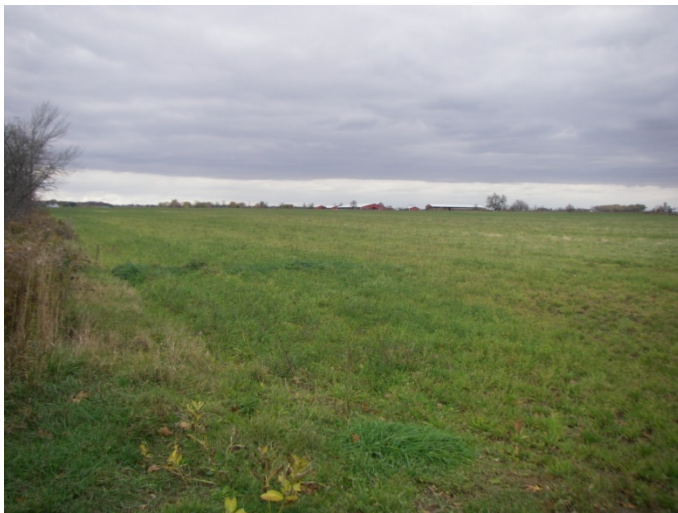
Photo 20: Lake-d (tile 15) - Looking at water feature identified from MNR mapping. Site is located east of Hald-Dunn Townline Road between Rainham Road and the lakeshore.

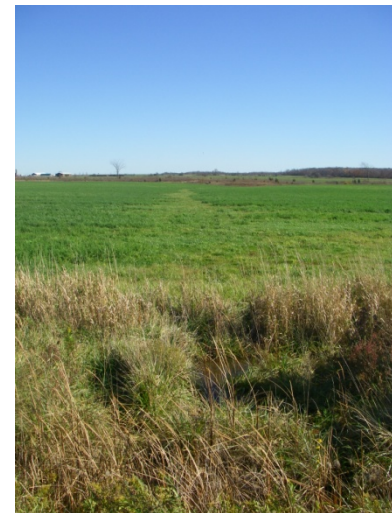
Photo 21: Lake-d (tile 15) - Looking downstream (west) from culvert on Hald-Dunn Townline Road, south of Rainham Road.

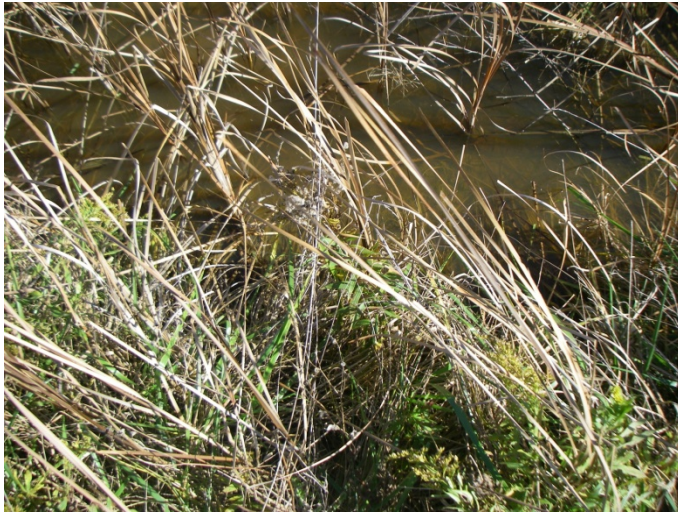
Photo 22: Lake-d (tile 15) - Looking at substrate at culvert on Hald-Dunn Townline Road, south of Rainham Road.

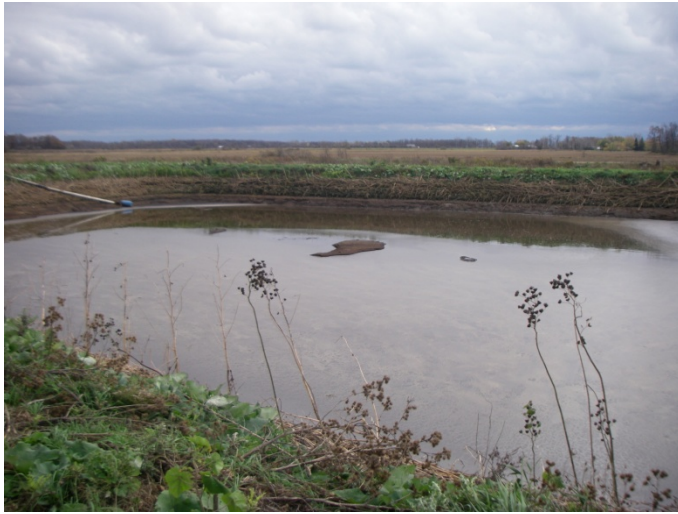
Photo 23: Lake-e (tile 15) - Looking at isolated man-made irrigation pond. Site is located east of Hald-Dunn Townline Road between Rainham Road and the lakeshore.

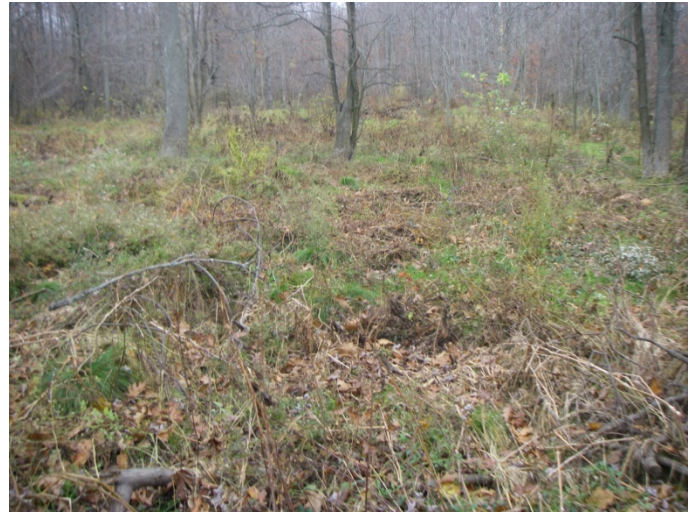
Photo 24: Lake-e (tile 15) - Looking at wooded area with wet soil and small amounts of standing water with no visible outflow. Site is located east of Hald-Dunn Townline Road between Rainham Road and the lakeshore.

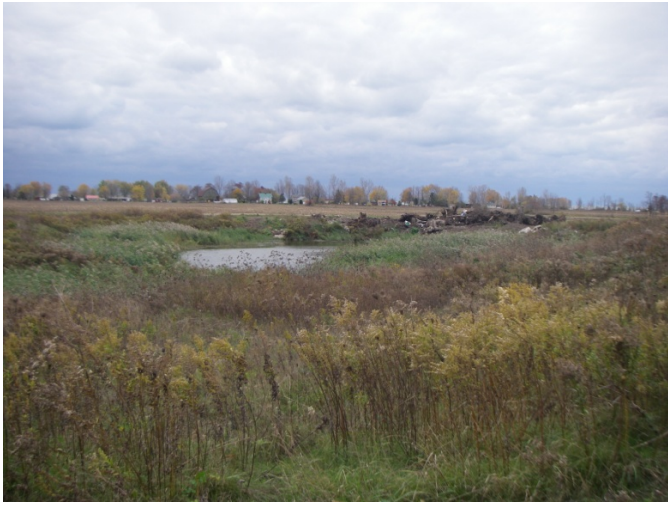
Photo 25: Lake-f (tile 15) - Looking at second isolated man-made irrigation pond. Pond area contains large amounts of debris. Site is located east of Hald-Dunn Townline Road between Rainham Road and the lakeshore.

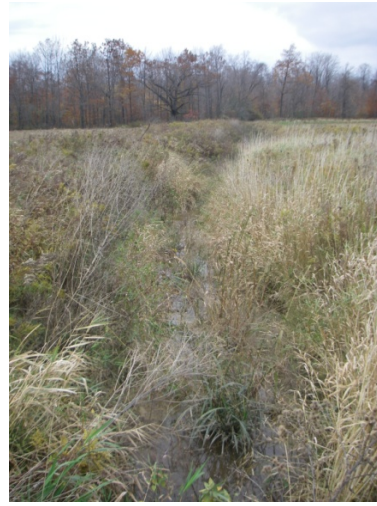
Photo 26: Lake-f (tile 15) - Looking upstream (east) at agricultural drain. Site is located east of Hald-Dunn Townline Road between Rainham Road and the lakeshore.

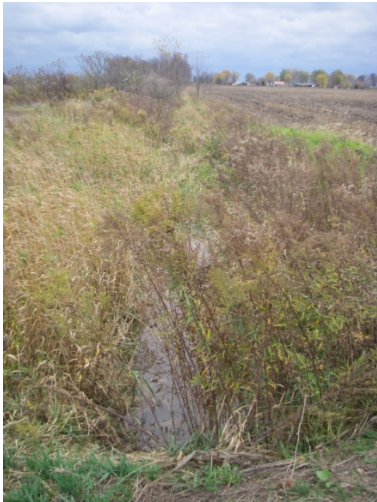
Photo 27: Lake-f (tile 15) - Looking downstream (south) from CSP culvert over an agricultural drain. Site is located east of Hald-Dunn Townline Road between Rainham Road and the lakeshore.

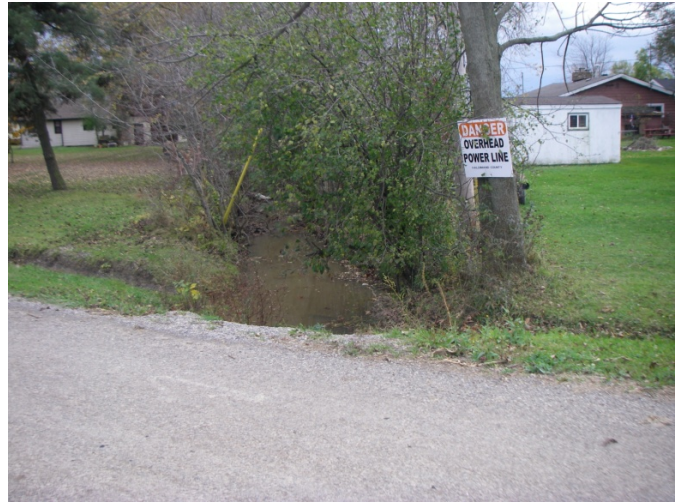
Photo 28: Lake-f (tile 15) - Watercourse likely associated with ponds at Lake-f. Looking downstream (south) from culvert on Lakeshore Road approximately 100 metres from the lake shore. Site is located east of Hald-Dunn Townline Road between Rainham Road and the lakeshore.

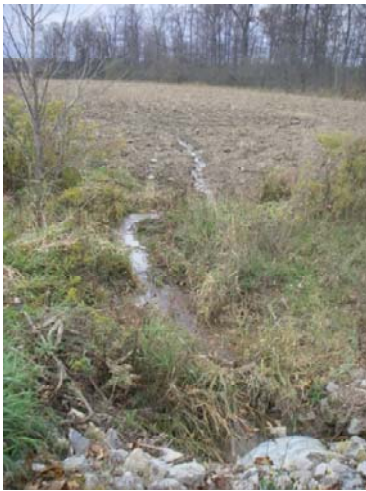
Photo 29: Lake-f (tile 15) - Looking upstream (north) from culvert on Lakeshore Road approximately 100 metres from the lake shore. Site is located east of Hald-Dunn Townline Road between Rainham Road and the lakeshore.

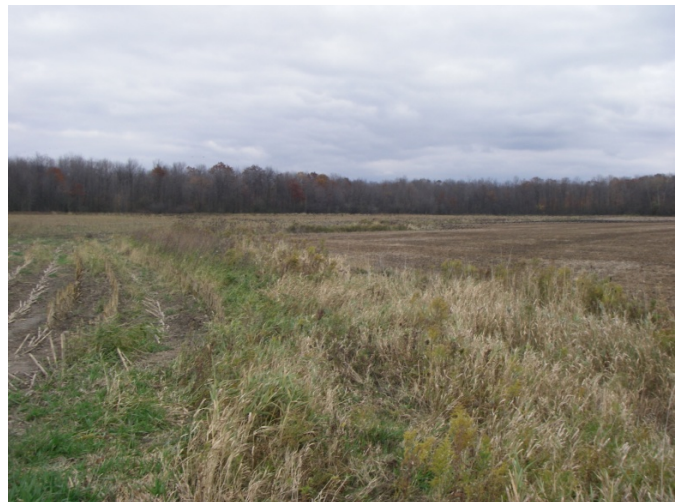
Photo 30: Lake-f (tile 15) - Looking upstream (northeast) at agricultural drain. Site is located east of Hald-Dunn Townline Road between Rainham Road and the lakeshore.

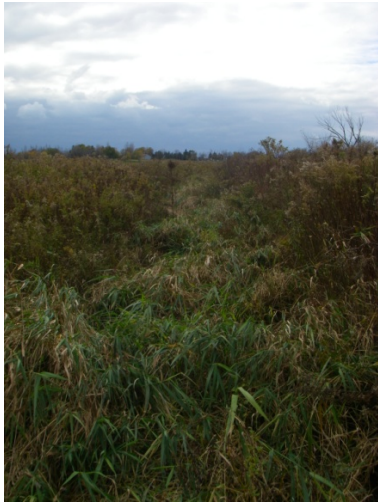
Photo 31: Lake-f (tile 15) - Looking downstream (southwest) at drain in the middle of an agricultural field. Site is located east of Hald-Dunn Townline Road between Rainham Road and the lakeshore.

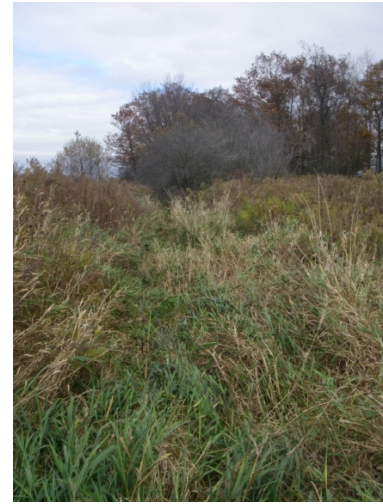
Photo 32: Lake-f (tile 15) - Looking upstream (northeast) at drain in the middle of an agricultural field. Site is located east of Hald-Dunn Townline Road between Rainham Road and the lakeshore.

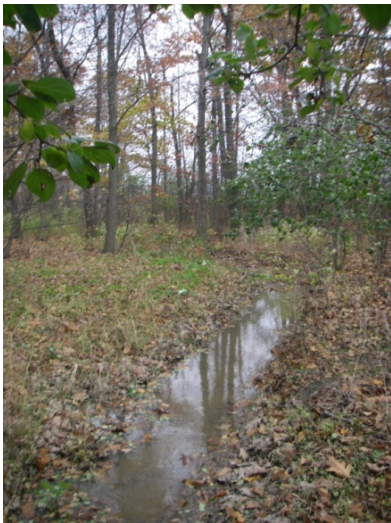
Photo 33: Lake-f (tile 15) - Looking upstream (east) at channel flowing through a wooded area on west side of site. Site is located east of Hald-Dunn Townline Road between Rainham Road and the lakeshore.

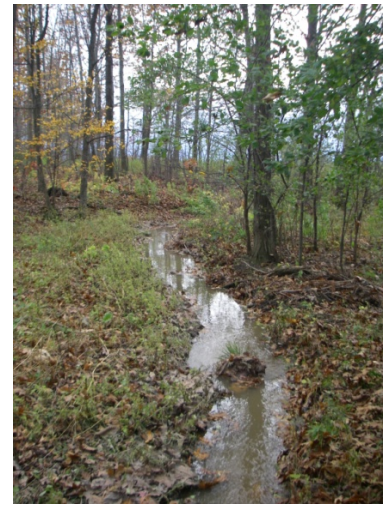
Photo 34: Lake-f (tile 15) - Looking downstream (west) at channel flowing through a wooded area on west side of site. Site is located east of Hald-Dunn Townline Road between Rainham Road and the lakeshore.

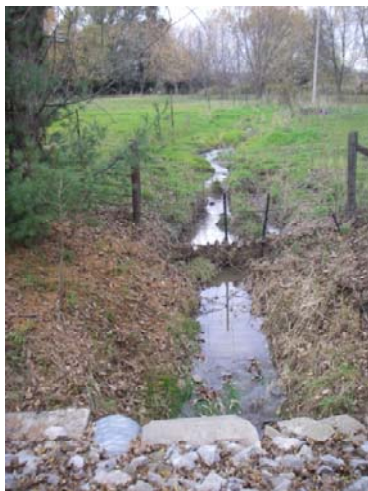
Photo 35: Lake-f (tile 15) - Looking upstream (north) from Lakeshore Road approximately 100 metres from the lake shore. Site is located east of Hald-Dunn Townline Road between Rainham Road and the lakeshore.

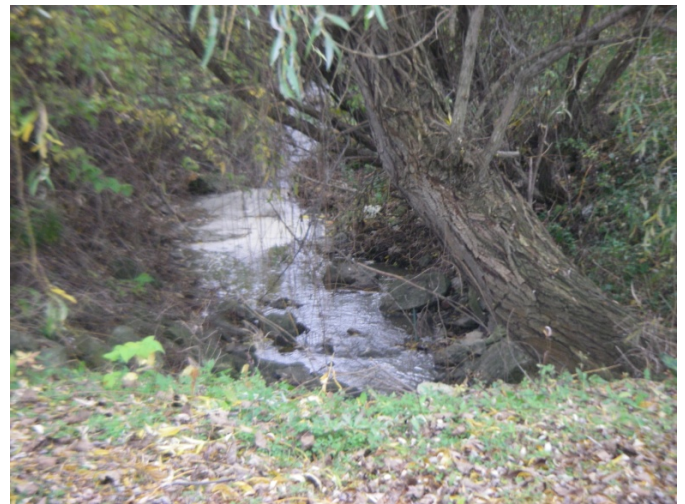
Photo 36: Lake-f (tile 15) - Looking downstream (south) from Lakeshore Road approximately 100 metres from the lake shore. Site is located east of Hald-Dunn Townline Road between Rainham Road and the lakeshore.

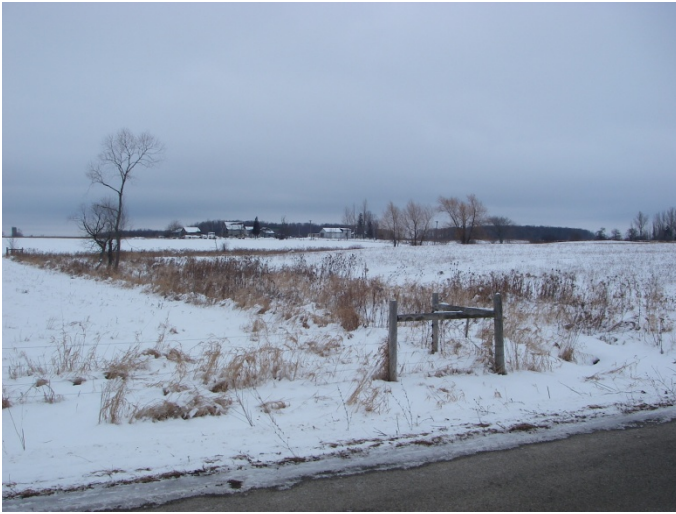
Photo 37: Lake-i (tile 15) - Looking upstream (northeast) from concrete culvert at channel flowing through field. Site is located on Kings Row, between Haldimand Road 49 and Myrnam Beach Road.

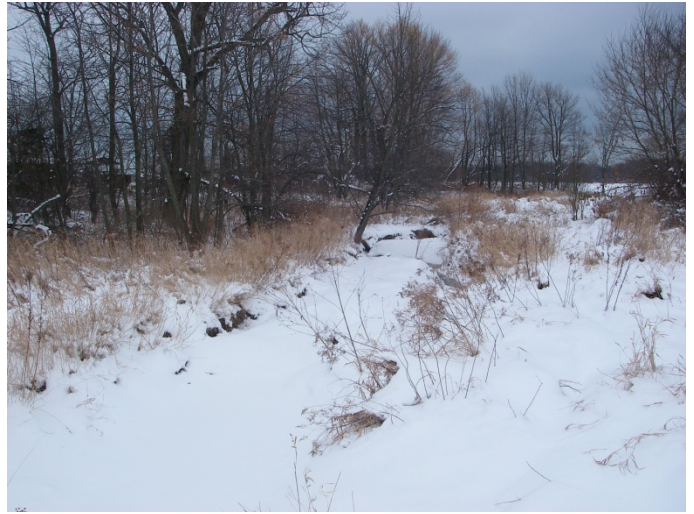
Photo 38: Lake-i (tile 15) - Looking at downstream (southwest) from concrete culvert at channel flowing through wooded area. Site is located on Kings Row, between Haldimand Road 49 and Myrnam Beach Road.

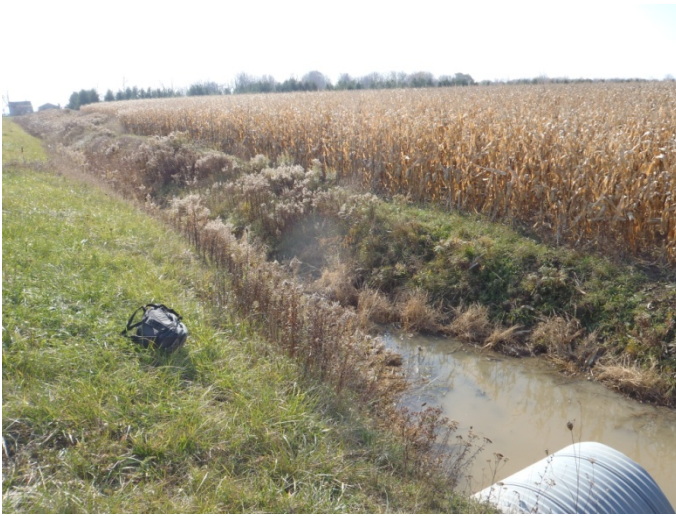
Photo 39: Lake-j (tile 10) - Looking upstream (west) at CSP culvert and water feature from Haldimand Road 50, approximately 300 m north of the lake shore.

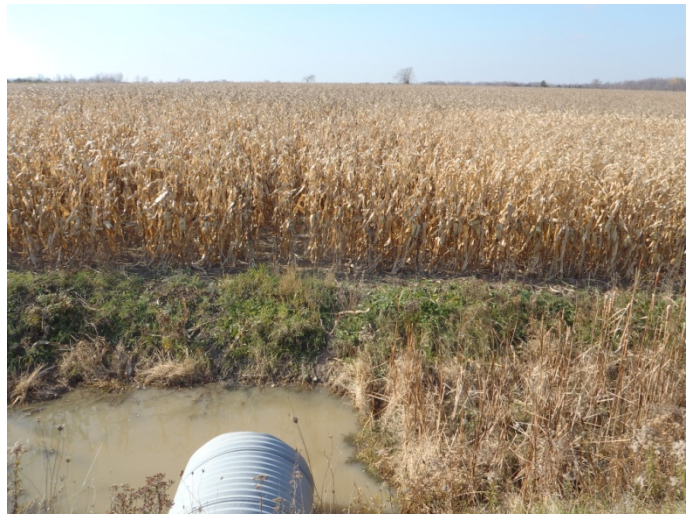
Photo 40: Lake-j (tile 10) - Looking upstream (south) at CSP culvert and water feature from Haldimand Road 50, approximately 300 m north of the lake shore.

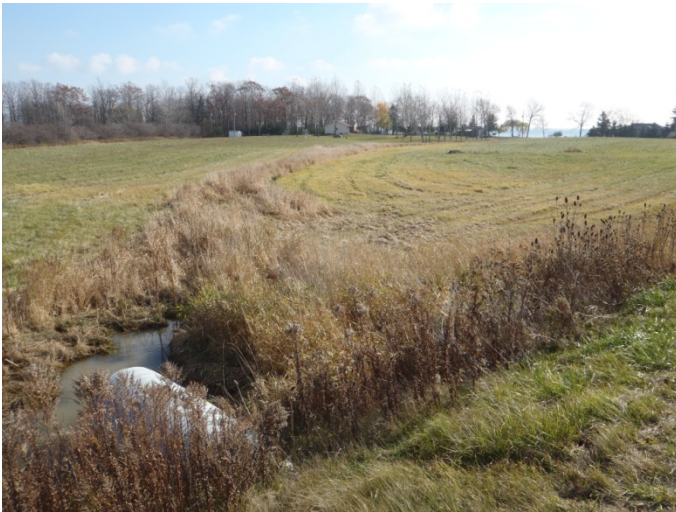
Photo 41: Lake-j (tile 10) - Looking downstream (southeast) at CSP culvert and water feature from Haldimand Road 50, approximately 300 m north of the lake shore.

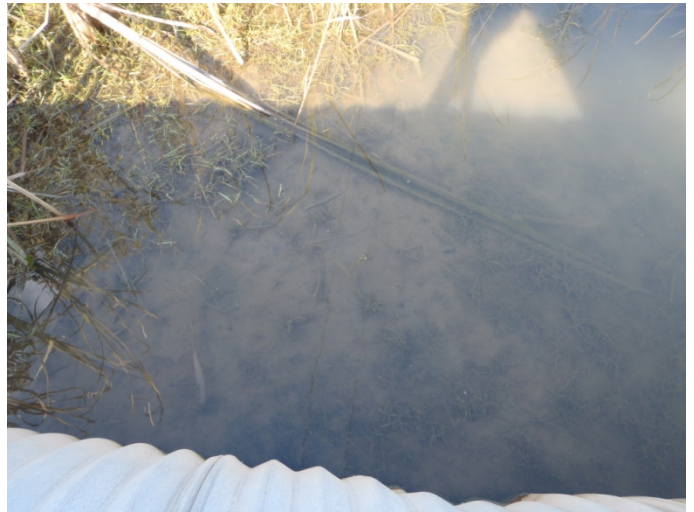
Photo 42: Lake-j (tile 10) - Looking at substrate at CSP culvert on Haldimand Road 50, approximately 300 m north of the lake shore.

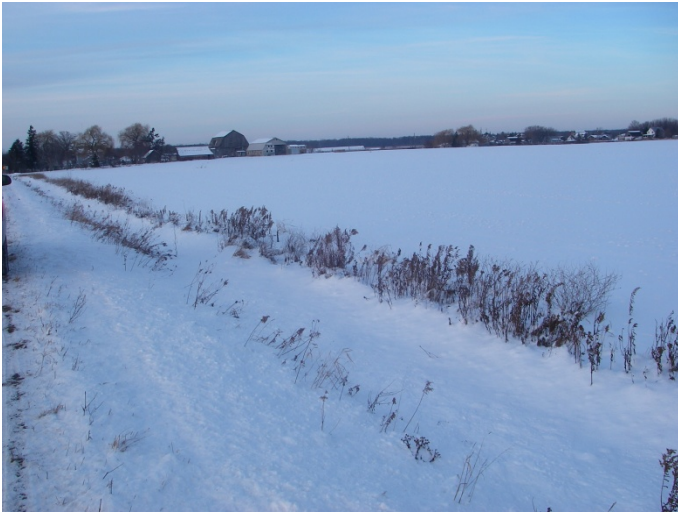
Photo 43: Lake-k (tile 12) - Looking at roadside drain and channel location. Site is located on South Cayuga Road, between Rainham Road and the lakeshore.

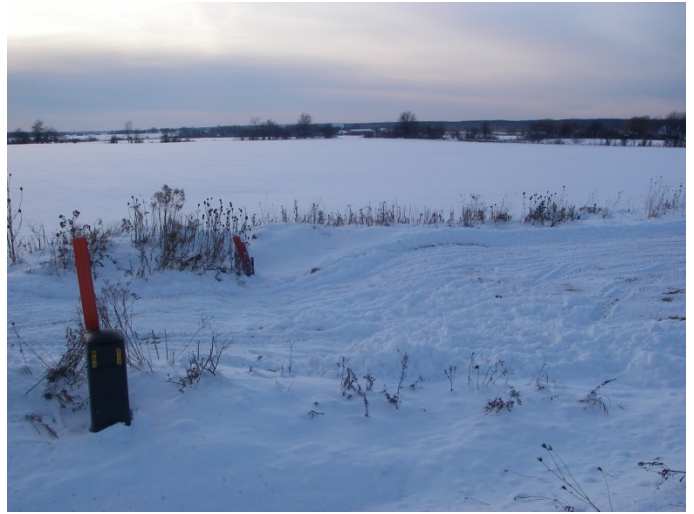
Photo 44: Lake-k (tile 12) - Looking downstream (west) at roadside drain and channel location in agricultural field. Site is located on South Cayuga Road, between Rainham Road and the lakeshore.

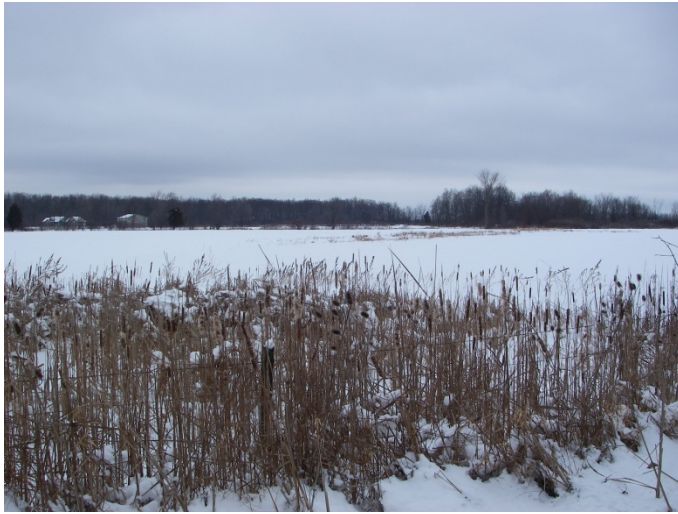
Photo 45: Lake-I (tile 16) - Looking north at swale on Haldimand Tract Road. Site is located on Haldimand Tract Road between Marshall Road and Haldimand Trail.

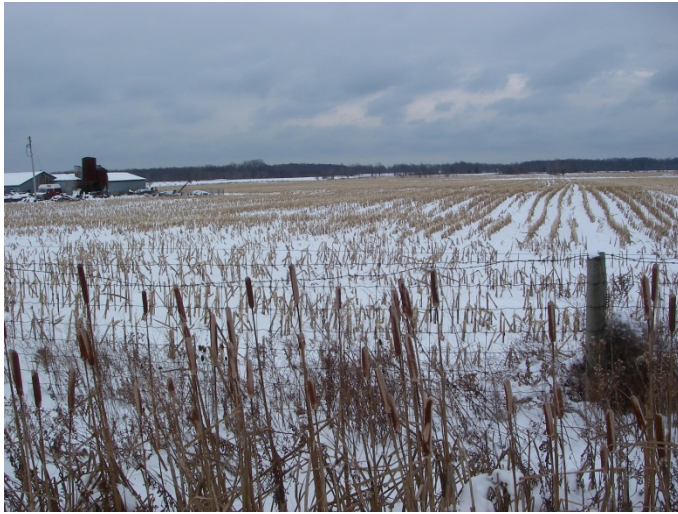
Photo 46: Lake-m (tile 16) - Looking south at feature location. Site is located on Kings Row between Marshall Road and Johnson Road.

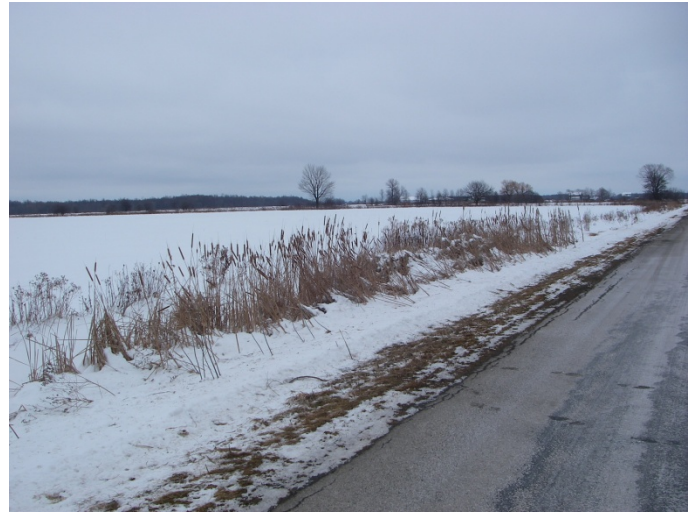
Photo 47: Lake-m (tile 16) - Looking northeast at feature location. Site is located on Kings Row between Marshall Road and Johnson Road.

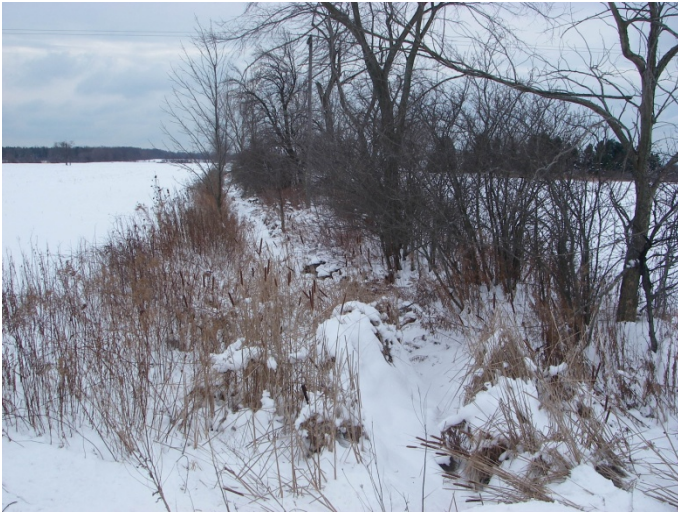
Photo 48: Lake-n (tile 16) - Looking south at channel flowing between two agricultural fields. Site is located on Kings Row between Marshall Road and Johnson Road.

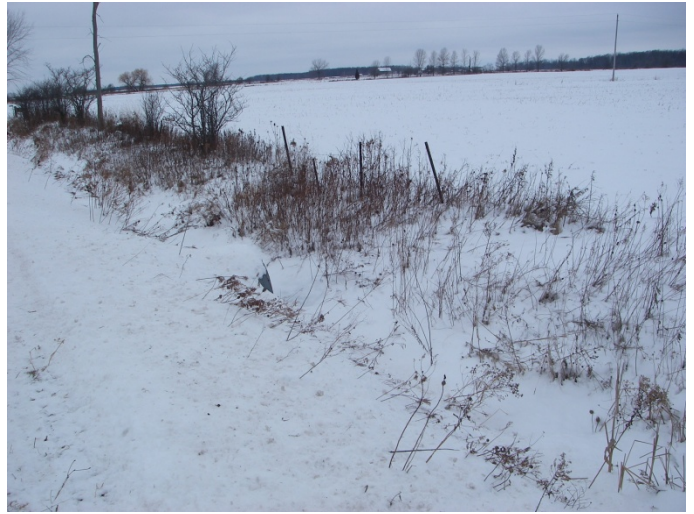
Photo 49: Lake-n (tile 16) - Looking northwest at feature location. Site is located on Kings Row between Marshall Road and Johnson Road.

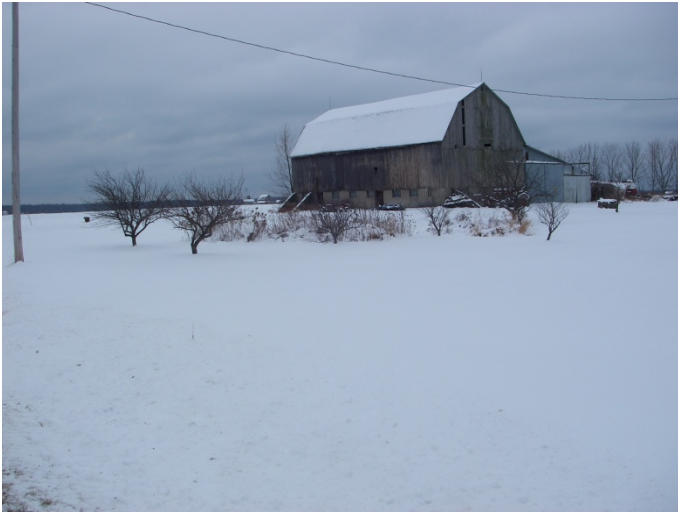
Photo 50: Lake-o (tile 16) - Looking east at mapped location of drainage feature. Site is located on Marshall Road between Haldimand Tract Road and Kings Row.

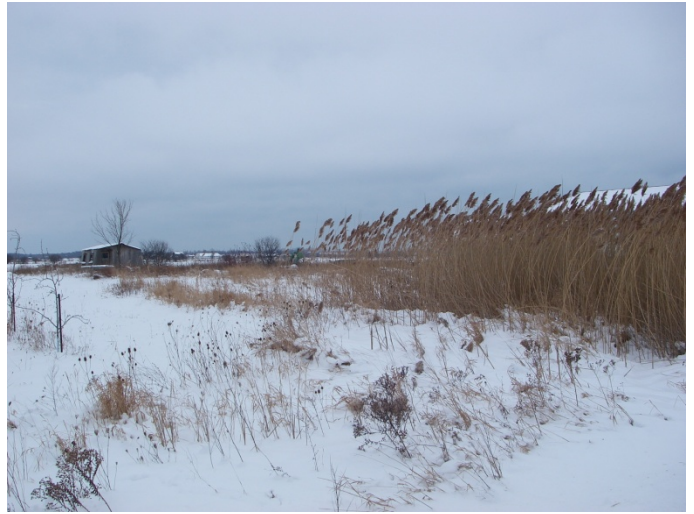
Photo 51: Lake-o (tile 16) - Looking west at mapped location of drainage feature. Site is located on Marshall Road between Haldimand Tract Road and Kings Row.

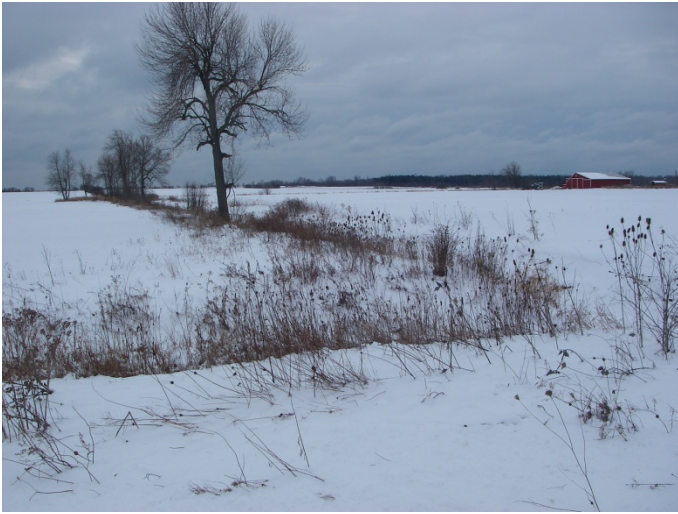
Photo 52: Lake-p (tile 16) - Looking downstream (southeast) at channel flowing between two agricultural fields. Site is located on Kings Row between Marshall Road and Johnson Road.

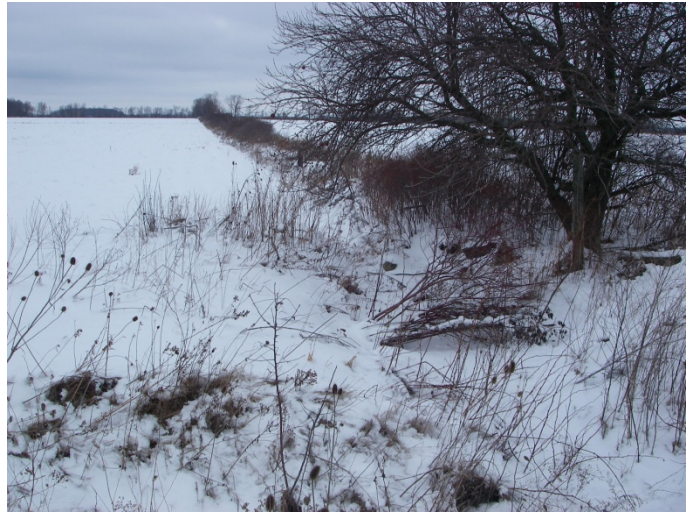
Photo 53: Lake-p (tile 16) - Looking upstream (north) at channel flowing between two agricultural fields. Site is located on Kings Row between Marshall Road and Johnson Road.

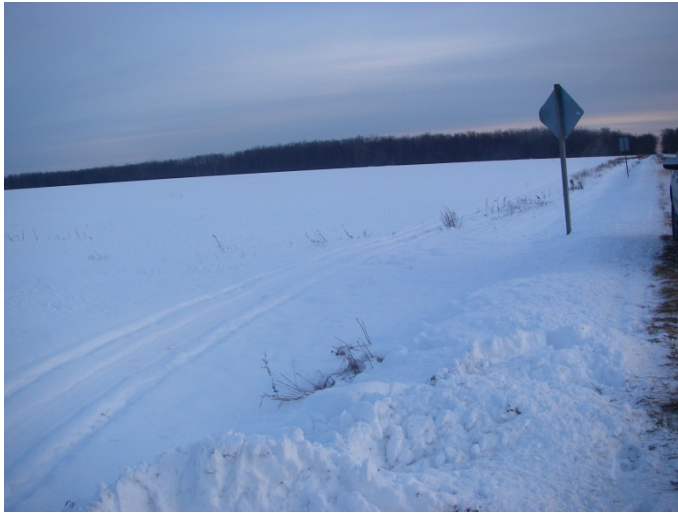
Photo 54: Lake-q (tile 12) - Looking at roadside ditch along South Cayuga Road at channel location. Site is located on South Cayuga Road, between Rainham Road and the lakeshore.

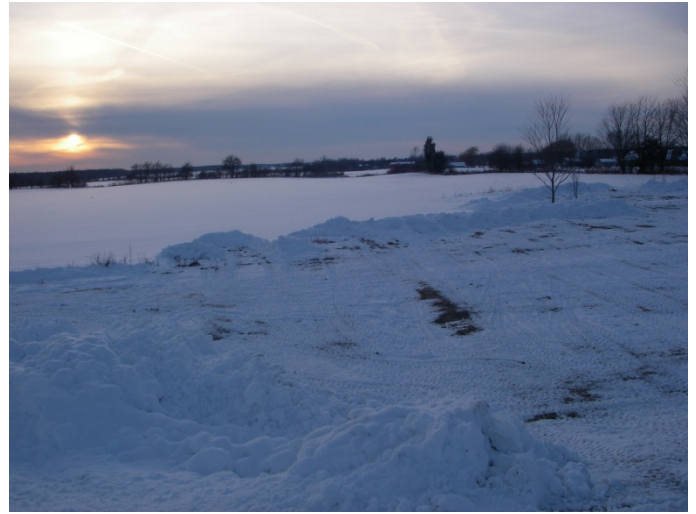
Photo 55: Lake-q (tile 12) - Looking downstream (west) at channel location on South Cayuga Road. Site is located on South Cayuga Road, between Rainham Road and the lakeshore.

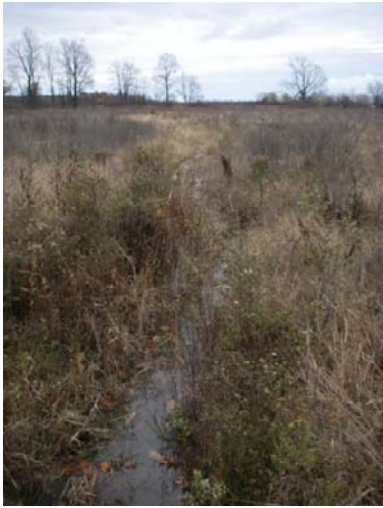
Photo 56: Lake-r (tile 10) - Looking downstream (southeast) from edge of wooded area at small drain feature flowing through an in-active agricultural field. Site is located east of Haldimand Road 50 between Rainham Road and the lake shore.

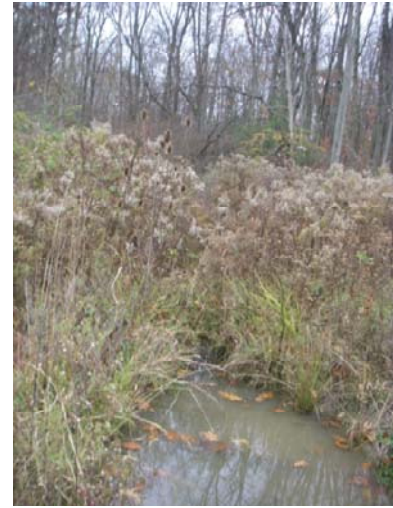
Photo 57: Lake-r (tile 10) - Looking upstream (northwest) from edge of in-active agricultural field at small drain feature flowing through wooded area. Site is located east of Haldimand Road 50 between Rainham Road and the lake shore.

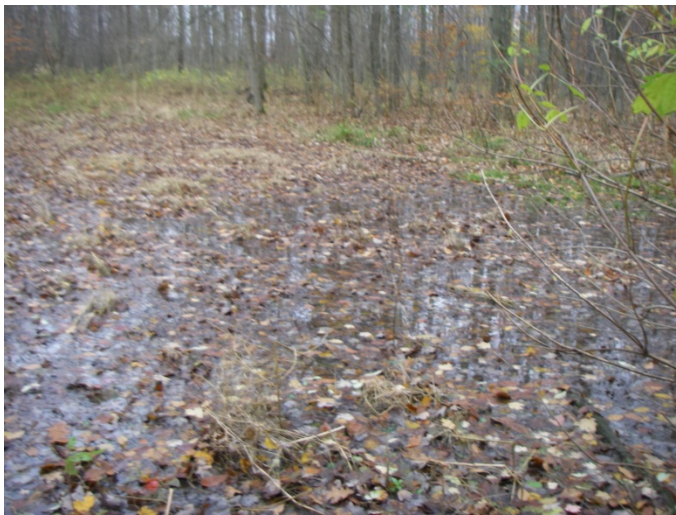
Photo 58: Lake-r (tile 10) - Looking at wetted area in centre of wooded area. Site is located east of Haldimand Road 50 between Rainham Road and the lake shore.

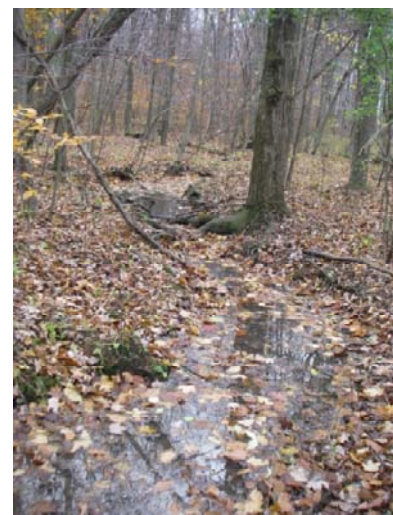
Photo 59: Lake-r (tile 10) - Looking downstream (southeast) from wetted area in centre of wooded area. Site is located east of Haldimand Road 50 between Rainham Road and the lake shore.

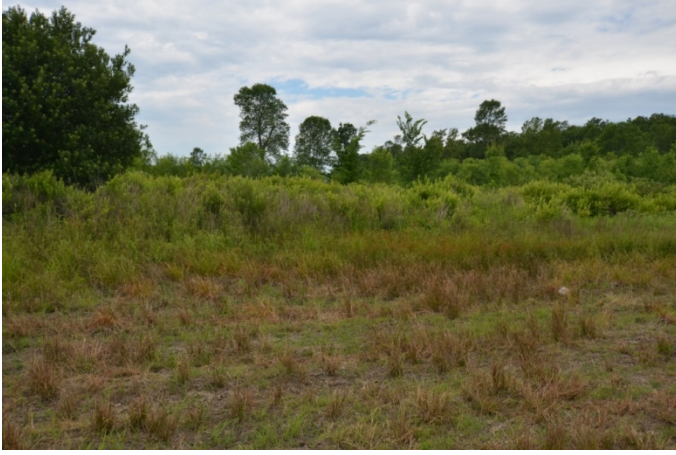
Photo 60: Lake-s (Tile 10) Looking west (upstream) showing absence of channel through edge of agricultural field.

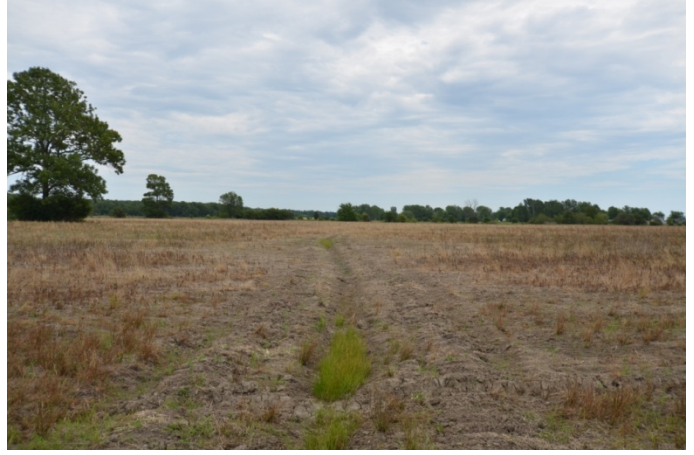
Photo 61: Lake s (Tile 10) Looking east (downstream) showing dry, low lying area through agricultural field.

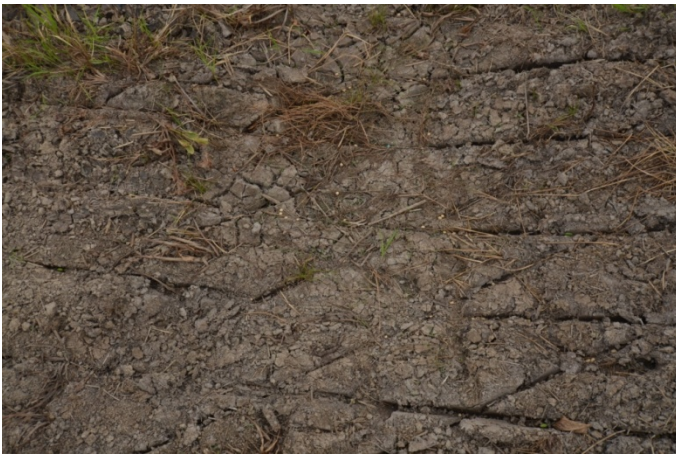
Photo 62: Lake-s (Tile 10) Showing substrate. Note that site is ploughed through and planted.

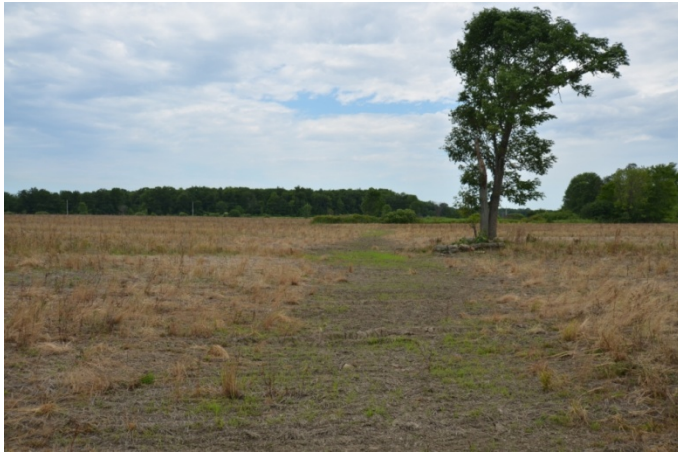
Photo 63: Lake-t (Tile 10) Looking west (upstream) showing dry, low lying area through agricultural field.

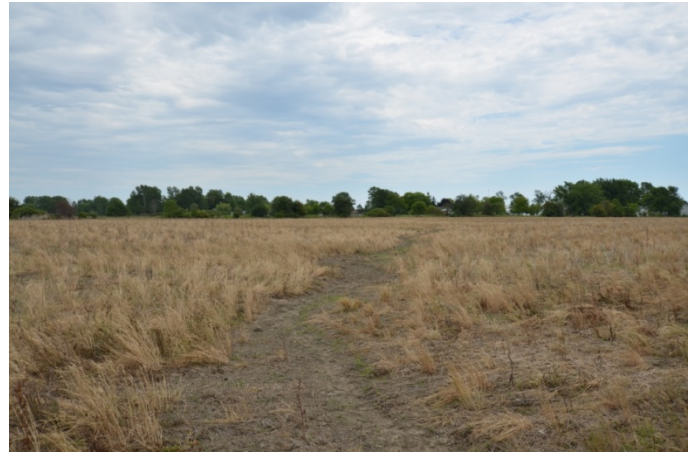
Photo 64: Lake-t (Tile 10) Looking east (downstream) showing dry, low lying area through agricultural field.

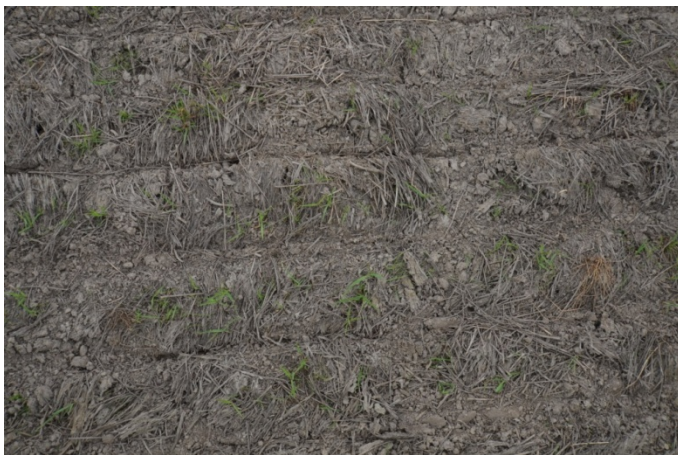
Photo 65: Lake-t (Tile 10) Showing substrate. Note that site is ploughed through and planted.
