**KINGSTON SOLAR LP
SOL-LUCE KINGSTON
SOLAR PV ENERGY PROJECT**

**WATER ASSESSMENT AND
WATER BODY REPORT**

**September 2012
TC111406
168335-0002-160-RPT-0016**

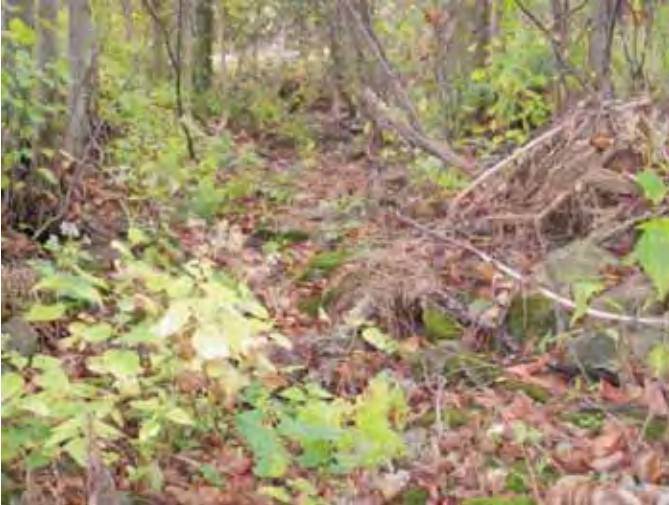
Photo 1: Looking south towards Rock Rd. culvert on Glenvale Cr. Trib.1. Intermittent drainage is diffuse upstream to downstream culvert. **Site ID# P1-A**

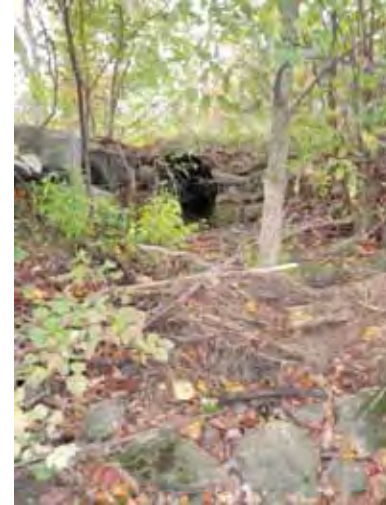
Photo 2: Looking south towards Rock Rd. culvert on Glenvale Cr. Trib.1. **Site ID# P1-A**

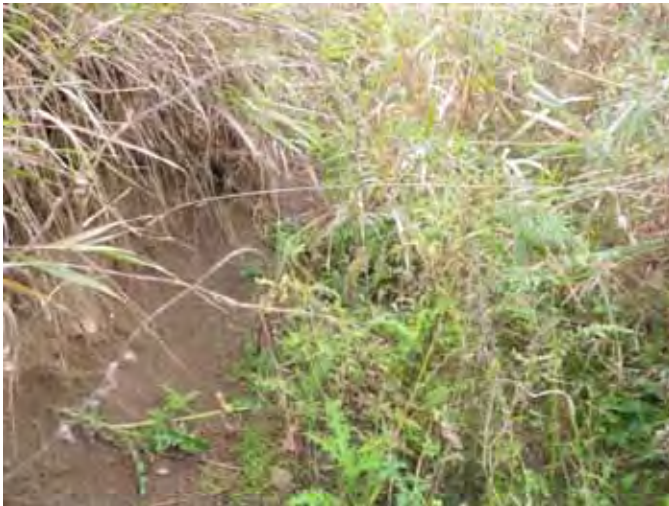
Photo 3: Erosion upstream from Rock Rd. culvert. **Site ID# P1-A**

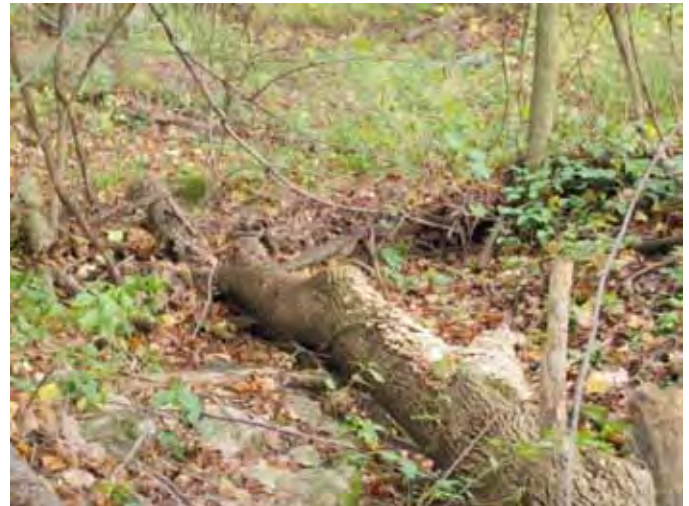
Photo 4: Upstream from Rock Rd. Channel is dry with lots in-grown terrestrial vegetation and leaf litter. **Site ID# P1-A**

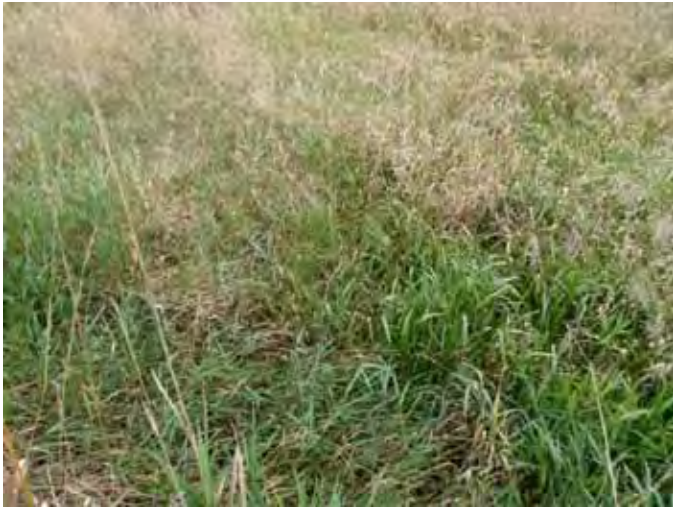
Photo 5: 20-25 year old dug out pond, dry for some time. Historically was used as wading area for cattle. **Site ID# P3-Pond-A**

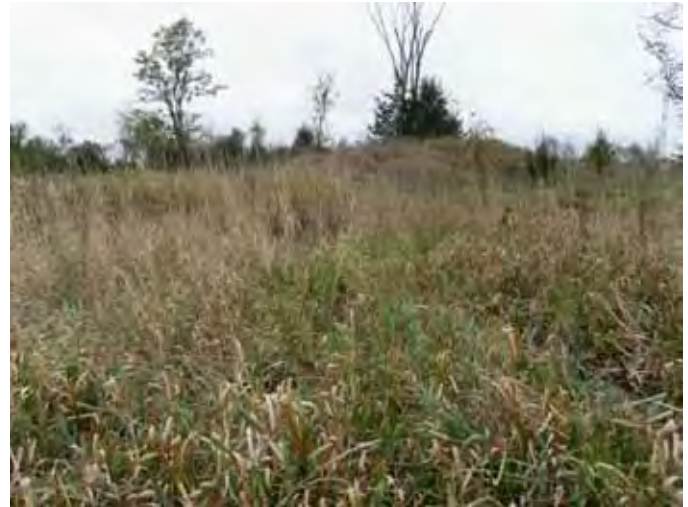
Photo 6: Looking west from pond where ground is elevated. **Site ID# P3-Pond-A**

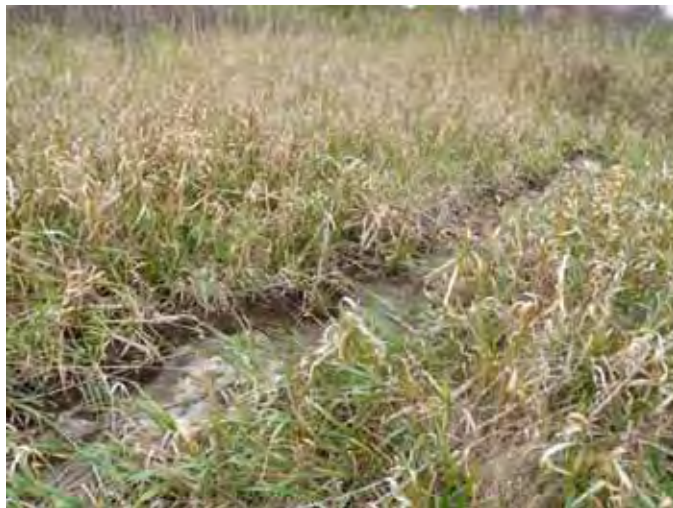
Photo 7: Exposed limestone inside pond. Max depth is $\sim 0.20\text{m}$ when wet. **Site ID# P3-Pond-A**

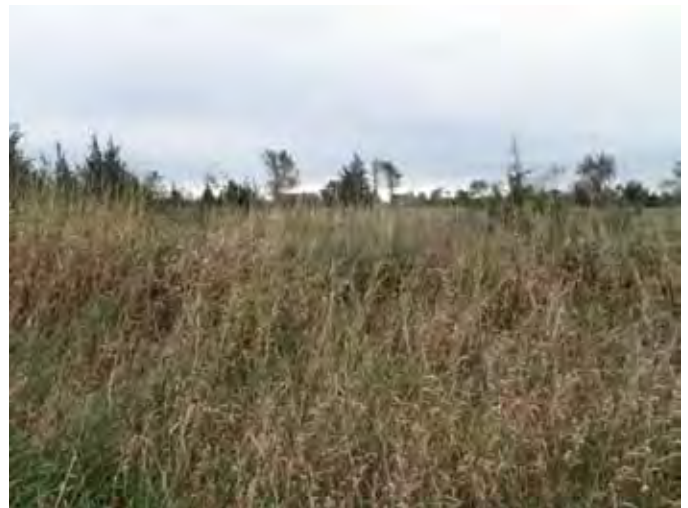
Photo 8: Looking south towards Unity Rd. from southern edge of pond. **Site ID# P3-Pond-A**

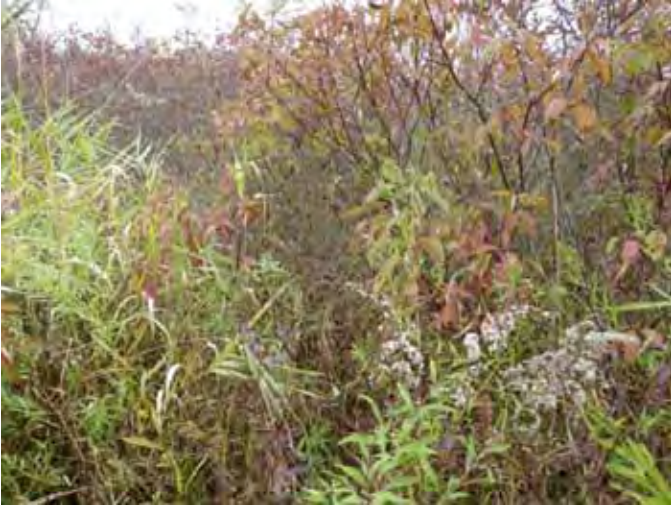
Photo 9: Wet area of intermittent drainage thick with terrestrial vegetation. **Site ID# P3-B**

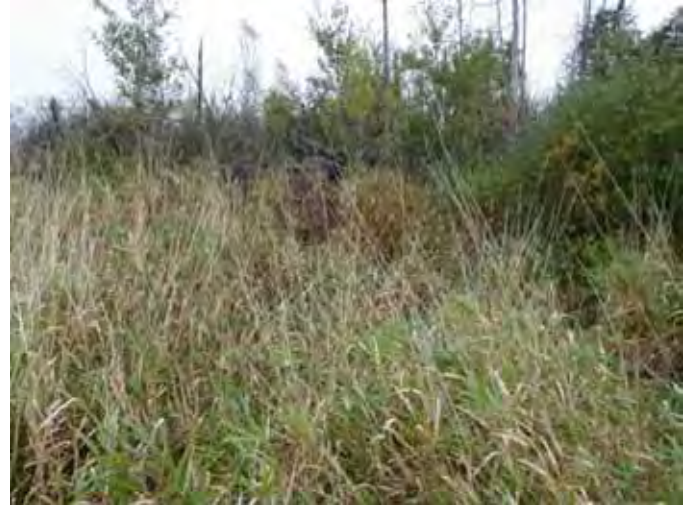
Photo 10: Looking West from lower lying area showing some die-off, woody trees and shrubs. **Site ID# P3-B**

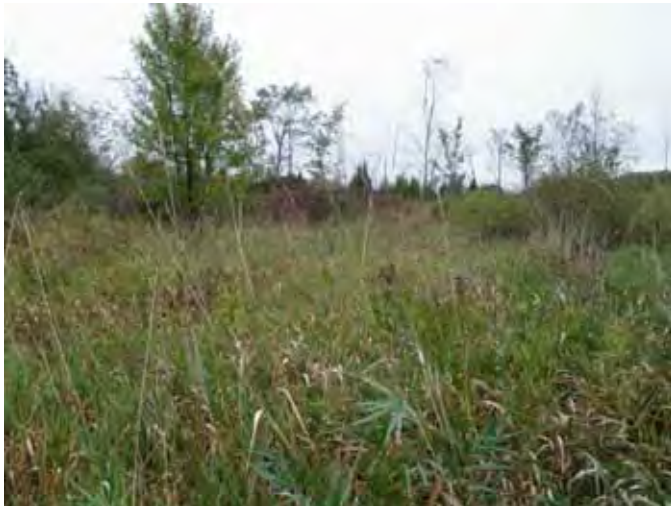
Photo 11: Looking north from intermittently wetted low lying area, currently dry. **Site ID# P3-B**

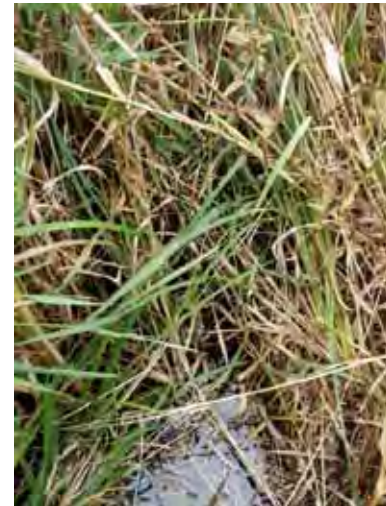
Photo 12: Shallow drainage to neighboring property channel/pond. (Pond is man-made) Vegetation transitions to wetland species. **Site ID# P3-B**

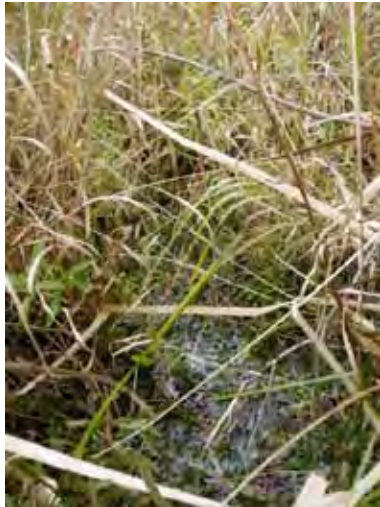
Photo 13: Willow/dogwood/cattail marsh. Site ID# P2-B

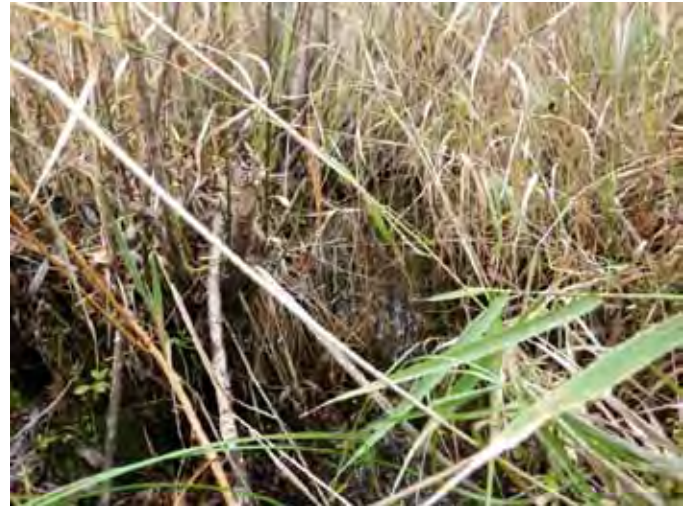
Photo 14: Small intermittent and diffuse channels. Site ID# P2-B

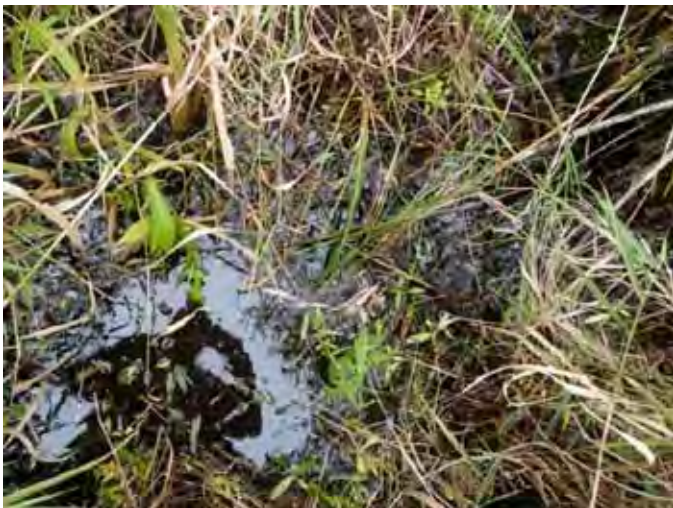
Photo 15: Wetted channel choked with vegetation. Site ID# P2-B

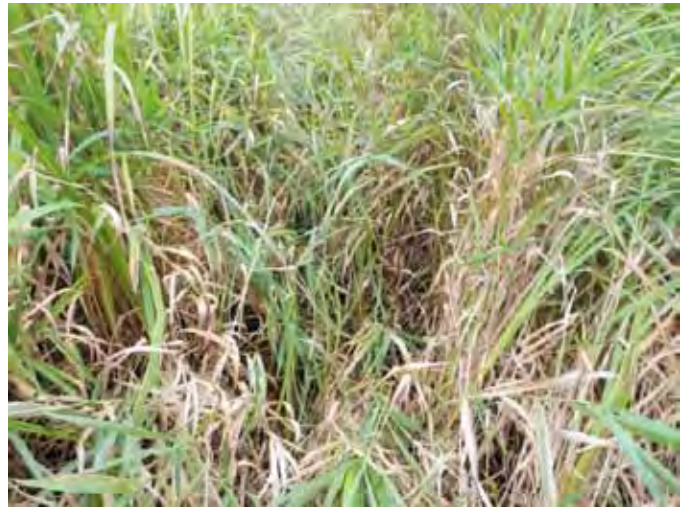
Photo 16: Wetted "channel" along property line with graminoid and sedge vegetation. Site ID# P2-A

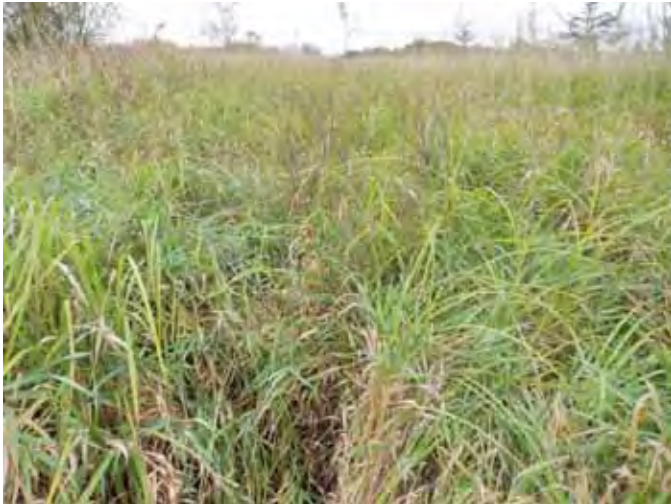
Photo 17: Narrow channel, looking south along property line towards Unity Rd. **Site ID# P2-A**

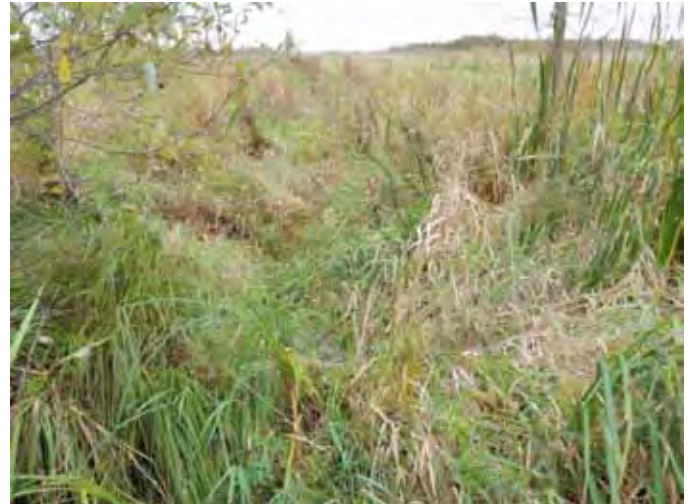
Photo 18: Narrow channel, looking north, <0.05 m wetted depth with a bankfull width of ~1m and a bankfull height of ~0.45m. **Site ID# P2-A**

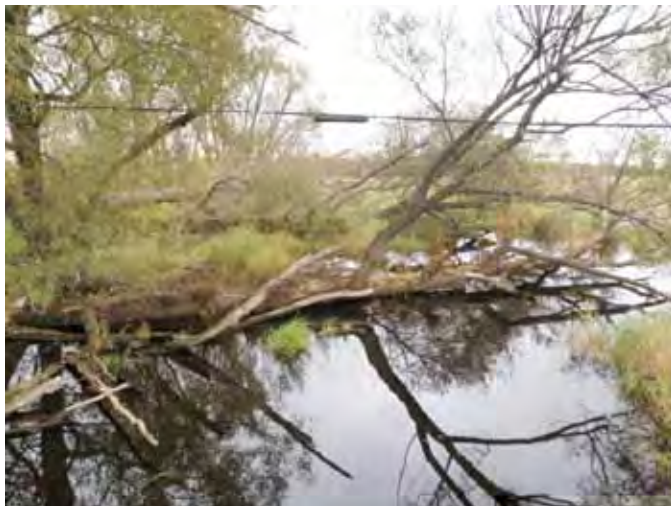
Photo 19: North east end of property at Unity Rd. bridge looking south on Glenvale Cr. **Site ID# P12-A**

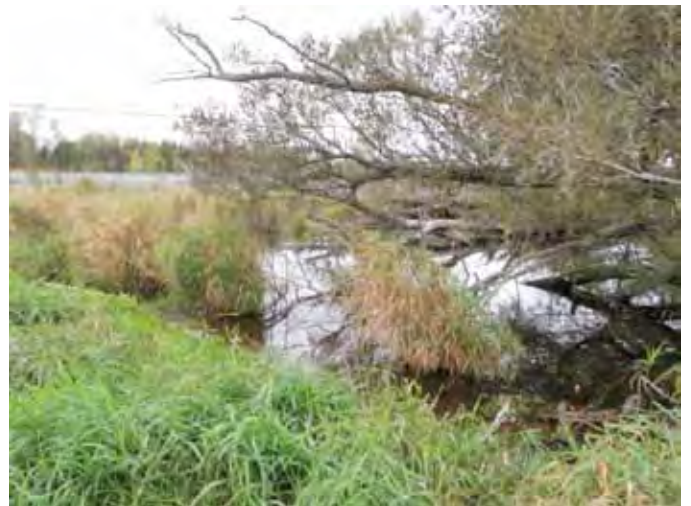
Photo 20: Looking north towards Unity Rd. bridge on Glenvale Cr. Large woody debris present. **Site ID# P12-A**

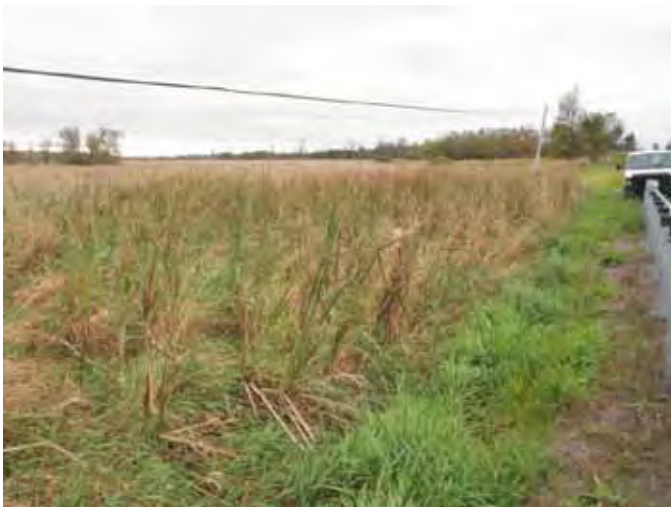
Photo 21: Looking west from Unity Rd. bridge at roadside ditch with heavy cattails. **Site ID# P12-A**

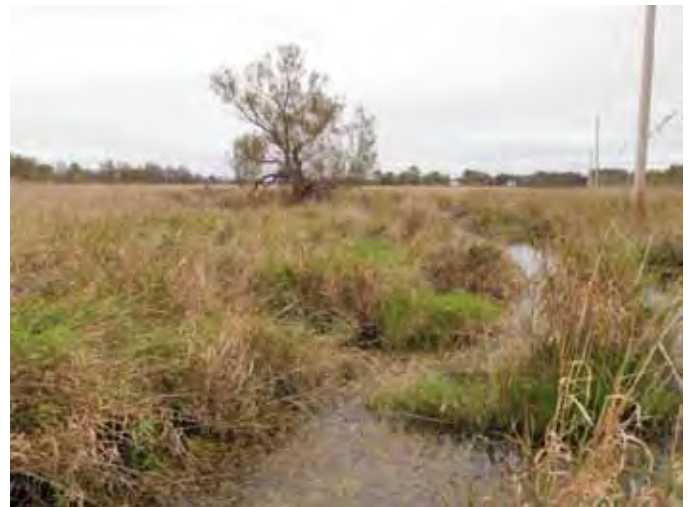
Photo 22: Channel going south-west from Unity Rd. **Site ID# P12-A**

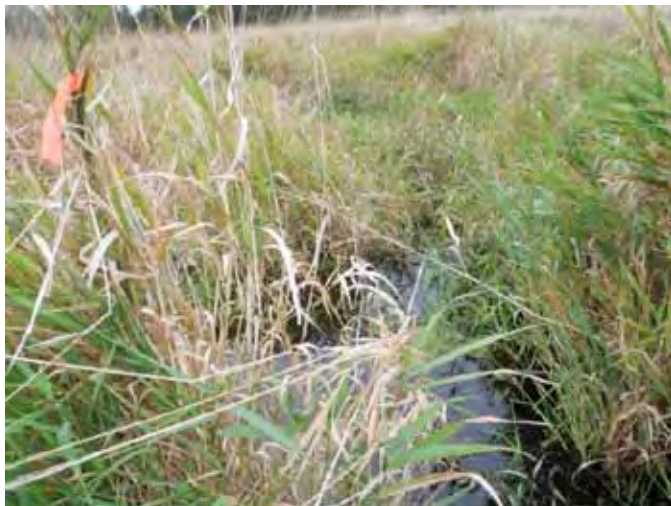
Photo 23: Minnow trap set in channel south of Unity Rd. **Site ID# P12-B**

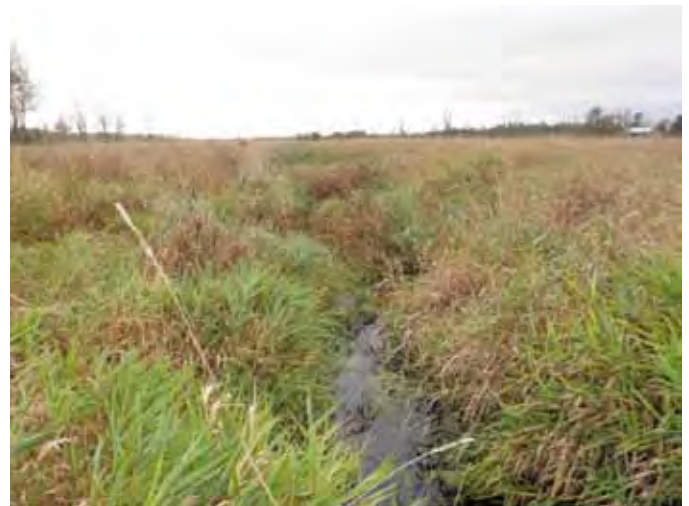
Photo 24: Looking west and downstream on Glenvale Cr. Riparian vegetation is dominated by sedge and grasses. **Site ID# P12-B**

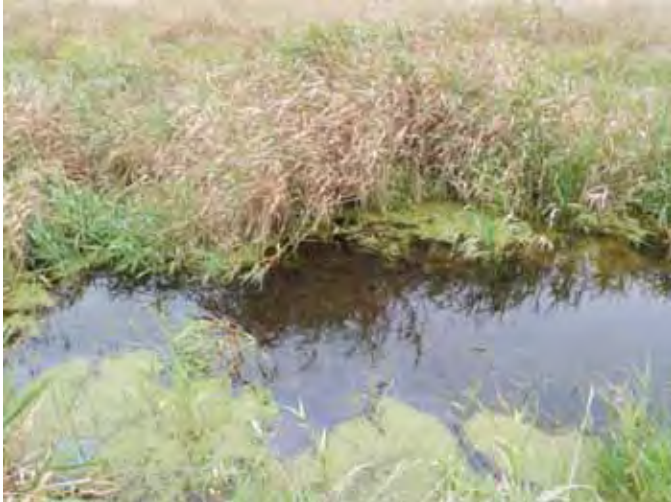
Photo 25: Channelized section of Glenvale Cr. with in stream aquatic vegetation and riparian sedges and grasses. **Site ID# P12-B**

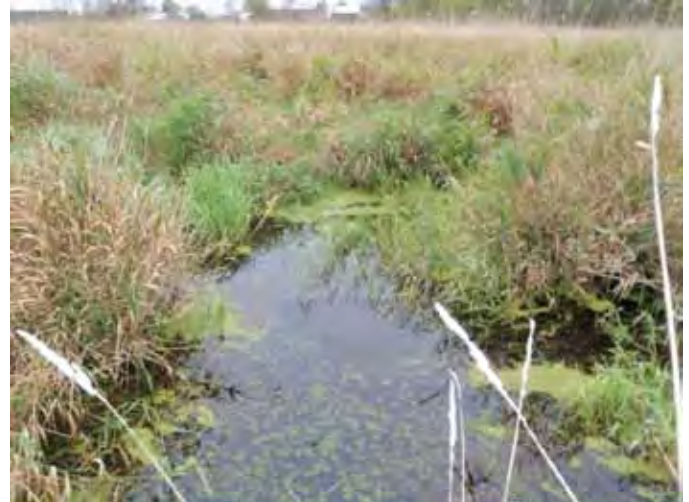
Photo 26: Looking downstream on Glenvale Cr. creek, location shown here is channelized but generally diffuse with connecting channels throughout large sedge and grass dominated riparian zone. **Site ID# P12-B**

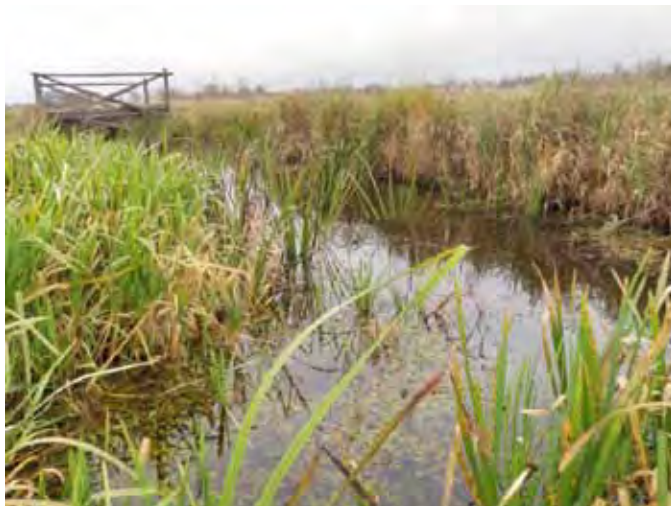
Photo 27: Two minnow traps set at the cattle bridge on Glenvale Cr. View is looking north towards Unity Rd. **Site ID# P12-C-MT1**

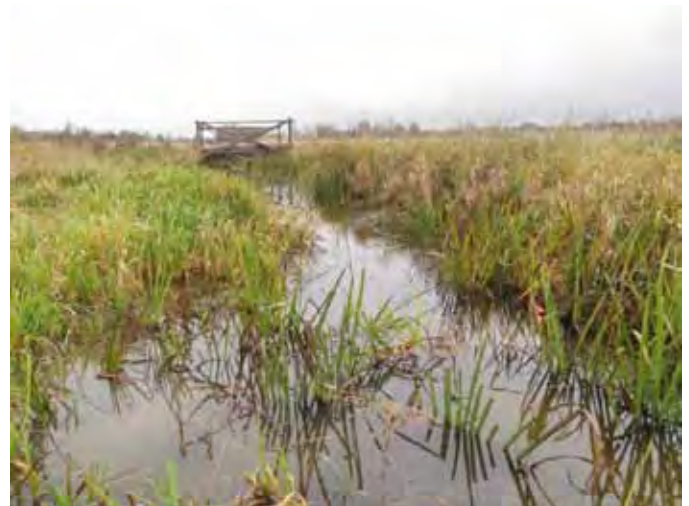
Photo 28: Glenvale Cr. channel has little to no meander pattern through this reach and shows signs of riparian inundation at wetter periods **Site ID# P12-C**

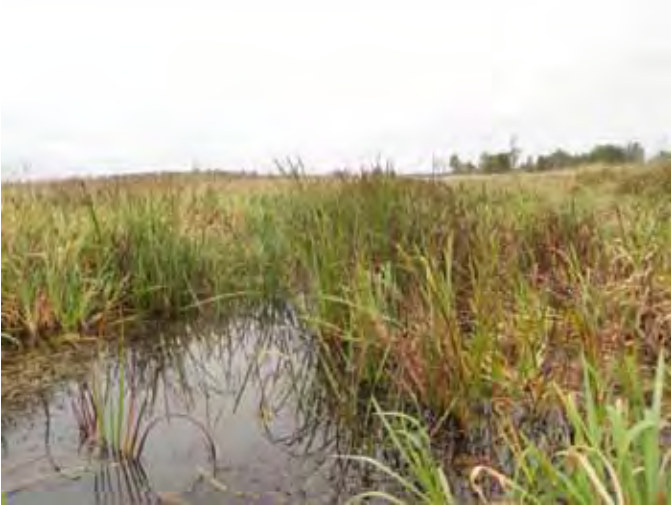
Photo 29: Looking south-west on Glenvale Cr. in Property 12 riparian vegetation is more inundated. Site ID# P12-C

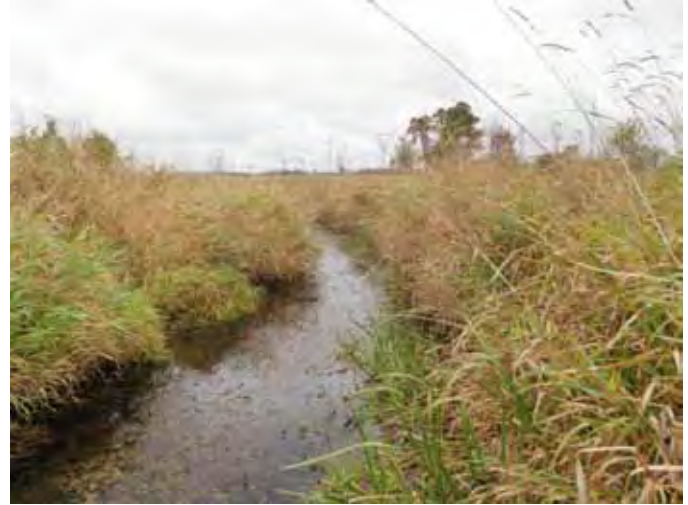
Photo 30: Looking south-west towards hydro line. Location is just west of fenced property boundary between P12 and P13. Site ID# P13-A

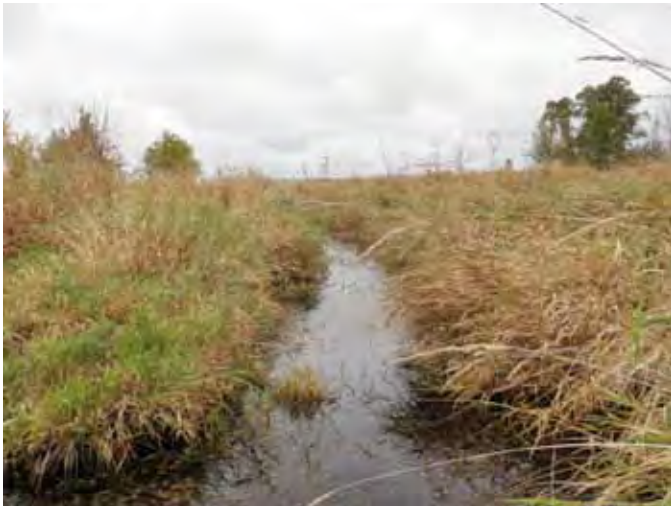
Photo 31: Higher mounds of vegetation in comparison the adjacent property. Channel morphology 100% flats. Site ID# P13-A

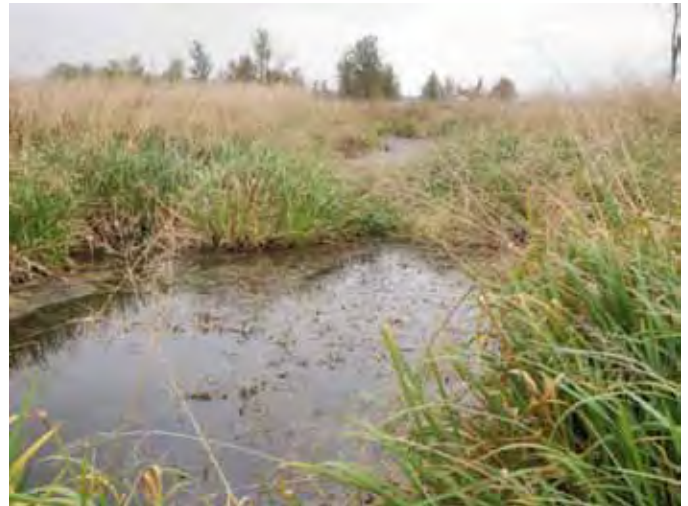
Photo 32: Suspected historic area of cattle crossing appears to be creating damming effect on creek. Site ID# P13-A

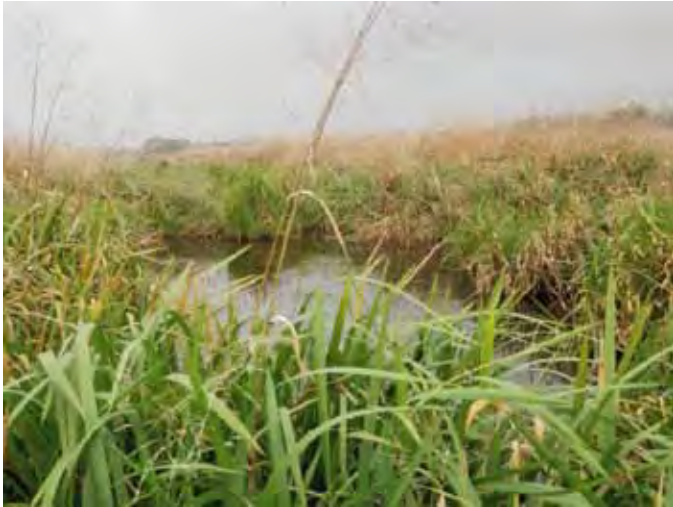
Photo 33: Looking north towards Unity Rd. on Glenvale Cr. Area of thick wetland vegetation. **Site ID# P13-A**

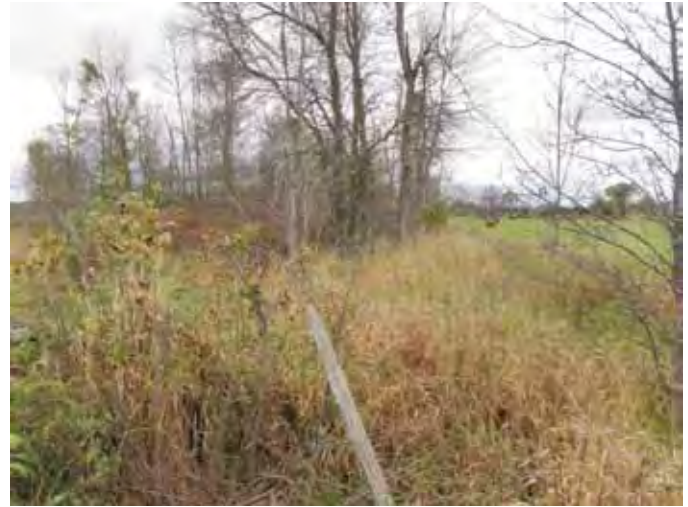
Photo 34: Glenvale Cr. Trib.2c, looking west from roadway. No water or distinct channel visible as suspected from mapping. Suspect to be a seasonal swale. **Site ID# P6A-1**

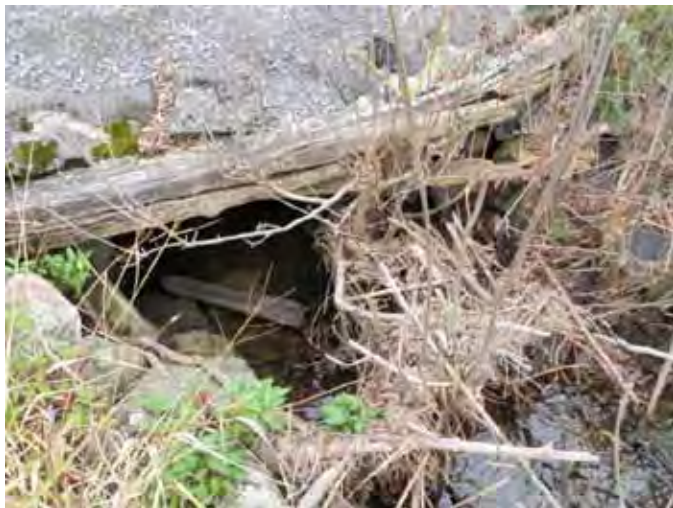
Photo 35: Glenvale Cr. Trib.2c culvert has pooled water present but no water upstream or downstream in suspected seasonal swale between fields. **Site ID# P6A-1**

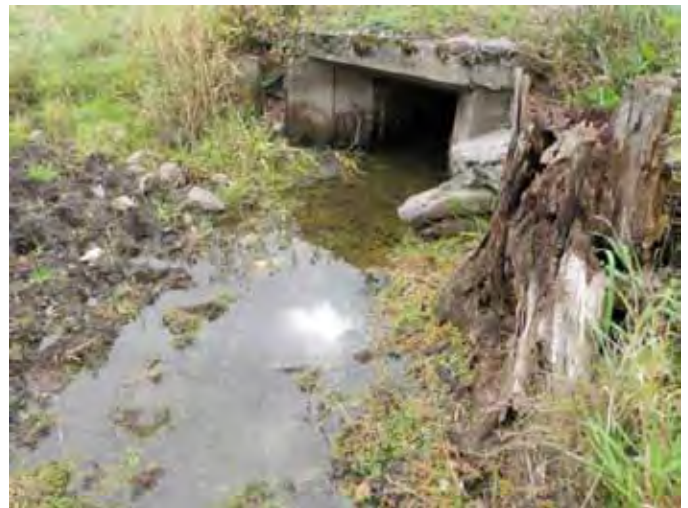
Photo 36: Pool on the north side of Unity Rd. box culvert. **Site ID# P6A-A**

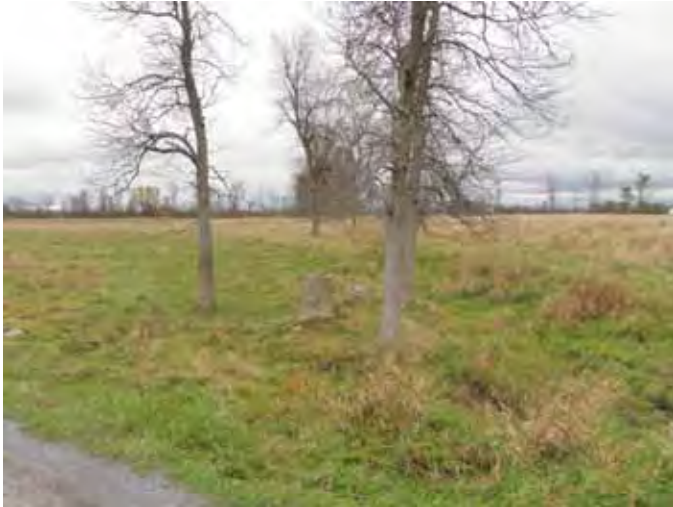
Photo 37: Looking east towards P5 from culvert with no signs of water conveyance, only terrestrial vegetation present. Suspect to be seasonal swale between fields. **Site ID# P6A-2**

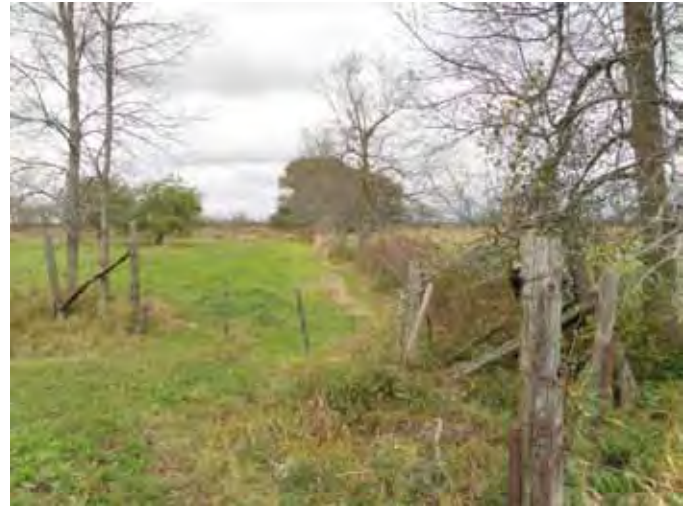
Photo 38: Looking west from laneway at GC-Trib 2b seasonal swale. **Site ID# P6A-2**

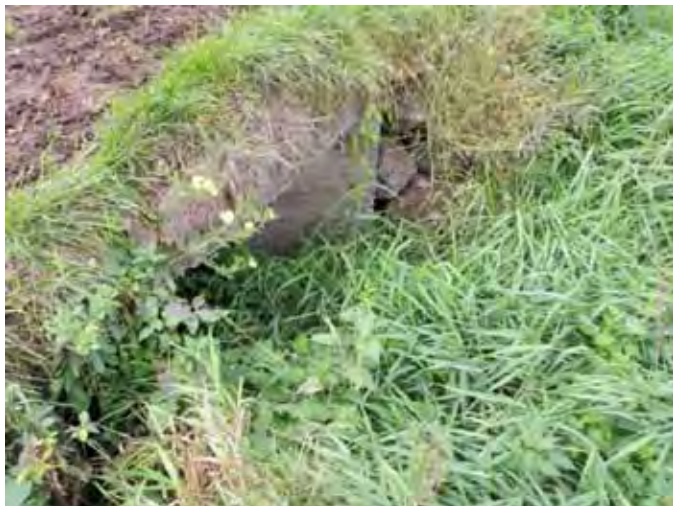
Photo 39: Glenvale Cr. Trib.2c culvert has standing water in depression and is choked with vegetation. It's suspected to be an intermittent swale. **Site ID# P6A-2**

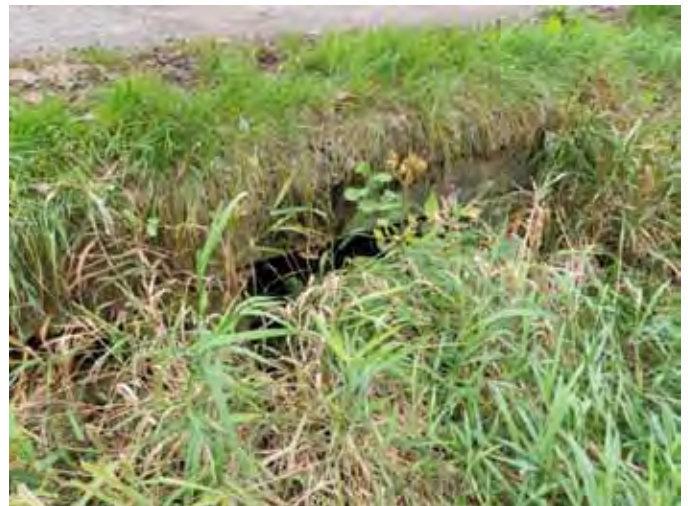
Photo 40: Pool from culvert on east side of roadway choked with vegetation. No channel or swale observed. **Site ID# P6A-2**

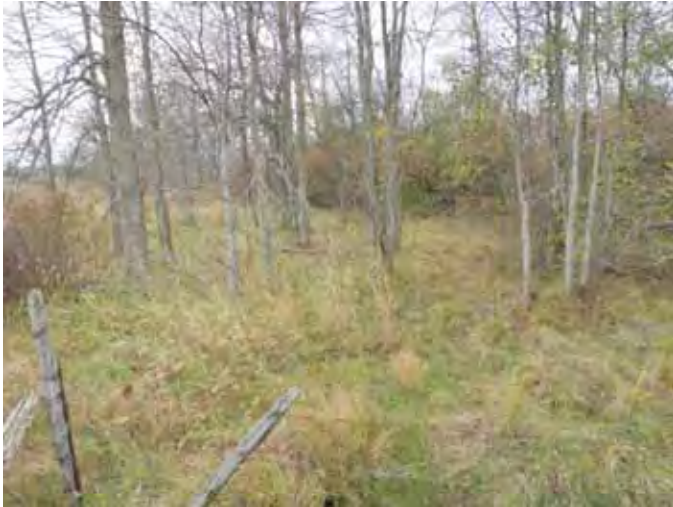
Photo 41: Glenvale Cr. Trib.2b looking west from culvert with no signs of water conveyance, only terrestrial vegetation present. Suspect to be seasonal swale along tree line. **Site ID# P6A-3**

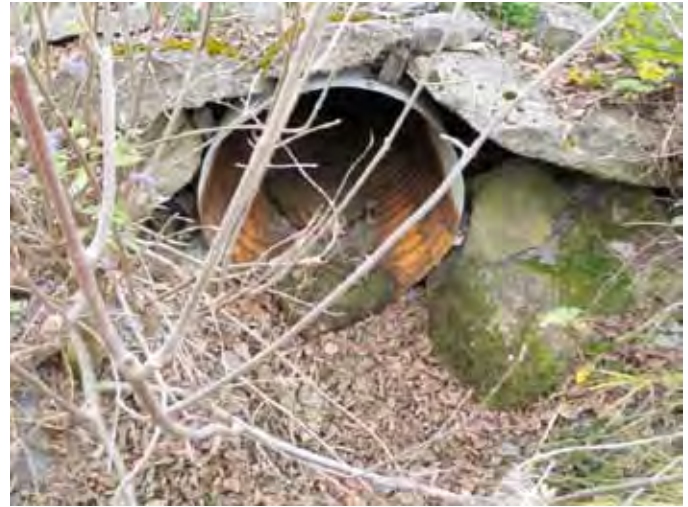
Photo 42: Glenvale Cr. Trib.2b, west of laneway is completely dry appears to be a seasonal swale. **Site ID# P6A-3**

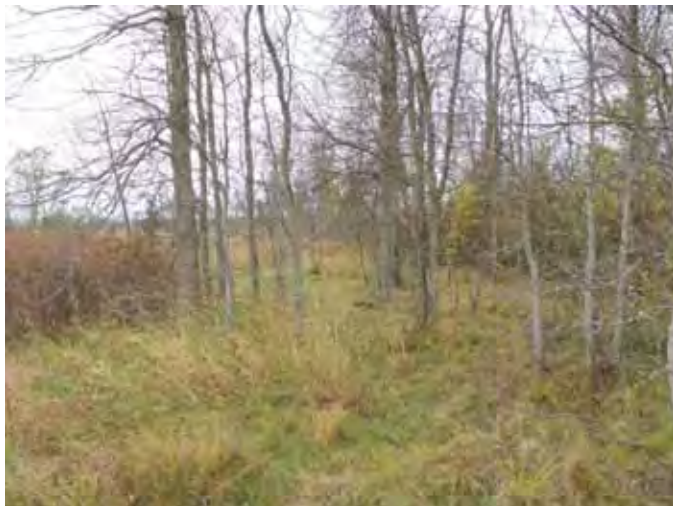
Photo 43: Seasonal swale looking west on property 6A. **Site ID# P6A-3**

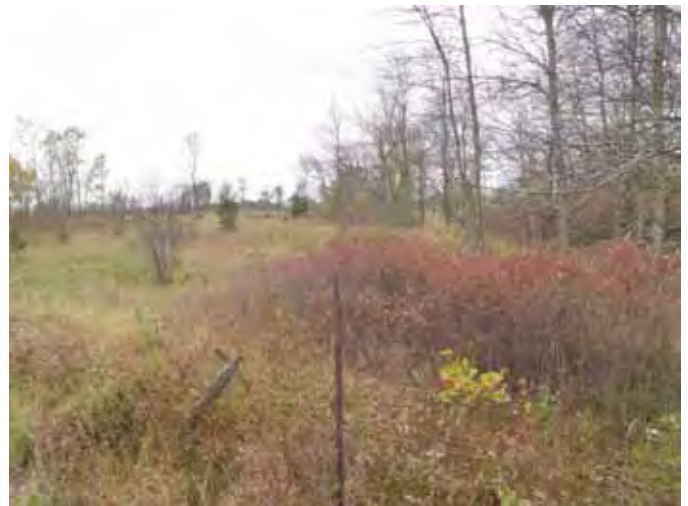
Photo 44: Tree line looking west from drainage culvert. **Site ID# P6A-3**

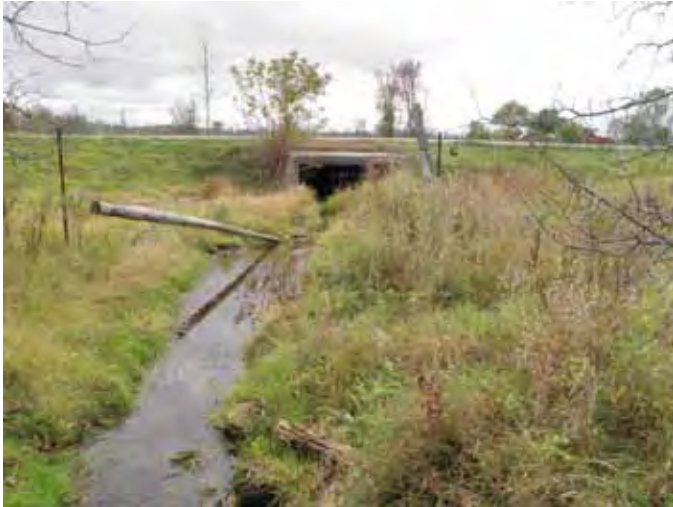
Photo 45: Looking south at box culvert at Unity Rd. crossing. Flow is downstream into P14B pond. **Site ID# P6A-A**

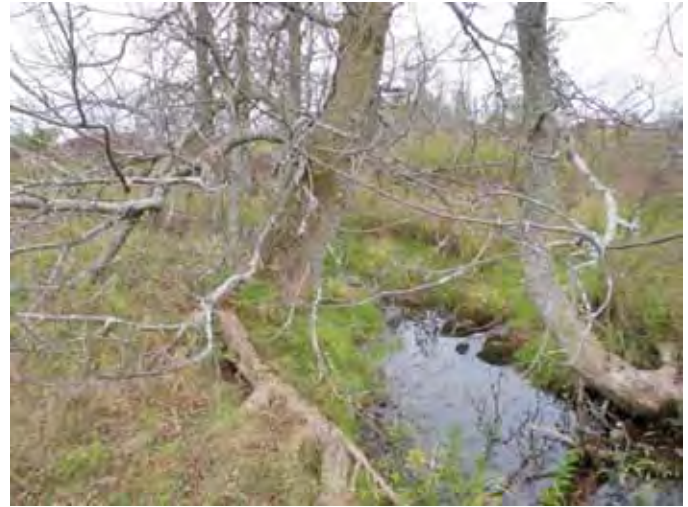
Photo 46: Looking north just upstream from box culvert. Wetted depth is ~0.18m. **Site ID# P6A-A**

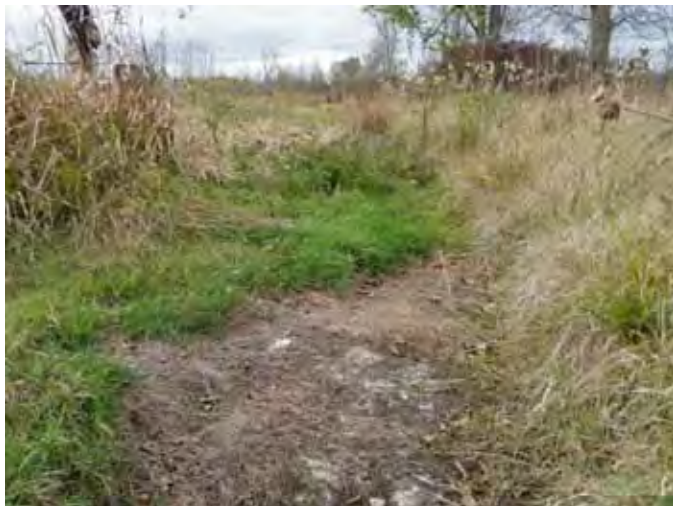
Photo 47: Looking west where swale branches into channel. Dry swale with no aquatic vegetation present is an intermittent drainage from upper fields' and drains into box culvert. **Site ID# P6A-A**

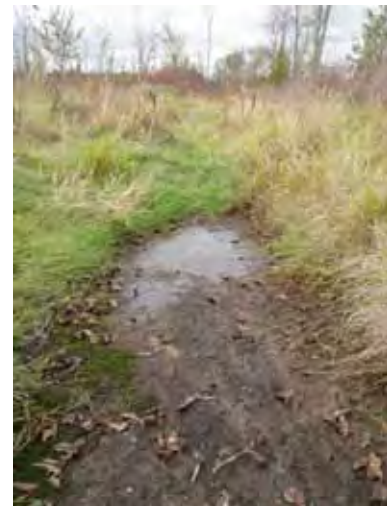
Photo 48: Looking north from fork where field water is conveyed over exposed limestone toward Unity Rd. **Site ID# P6A-A**

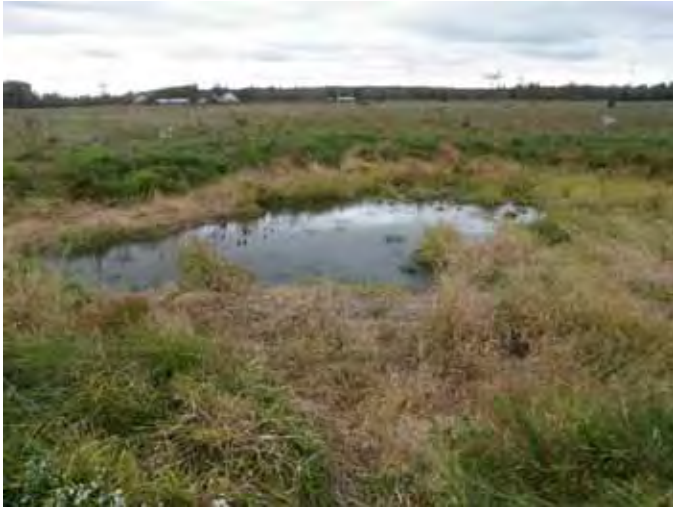
Photo 49: Looking west at small ephemeral pond on northern end of property boundary, ~7mx14m.
Site ID# P5-A

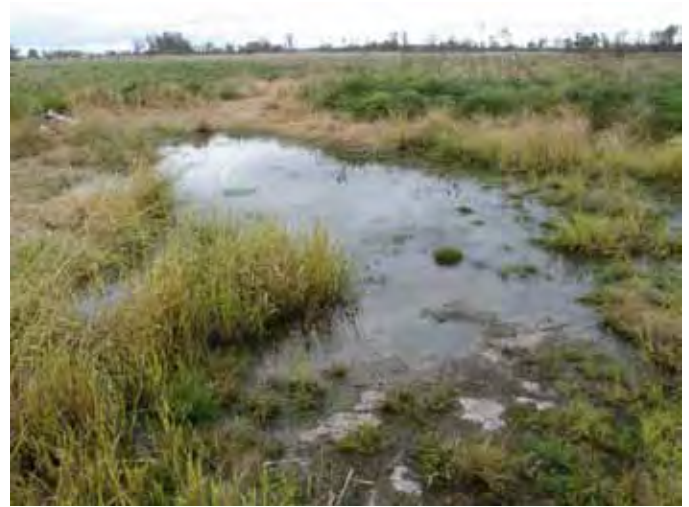
Photo 50: Looking south at pond where ground is low lying and limestone outcropping is observed.
Site ID# P5-A

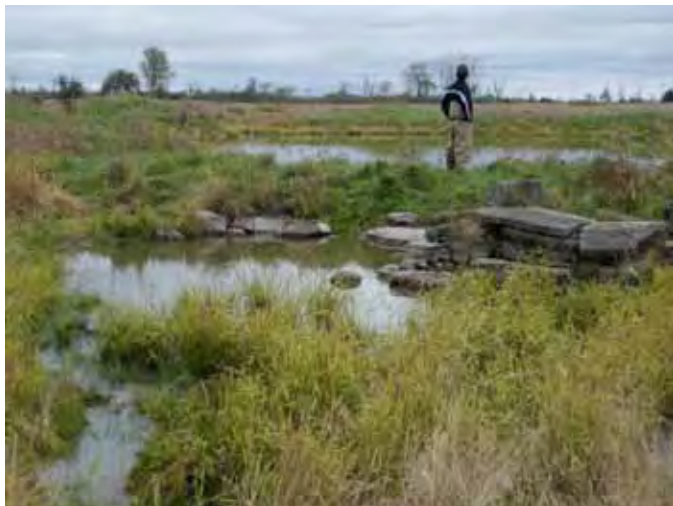
Photo 51: Looking east at larger pond on adjacent property. Possible old well located here, likely ground water fed and drainage from the Glenvale Cr. Trib.2b. Site ID# P5-A

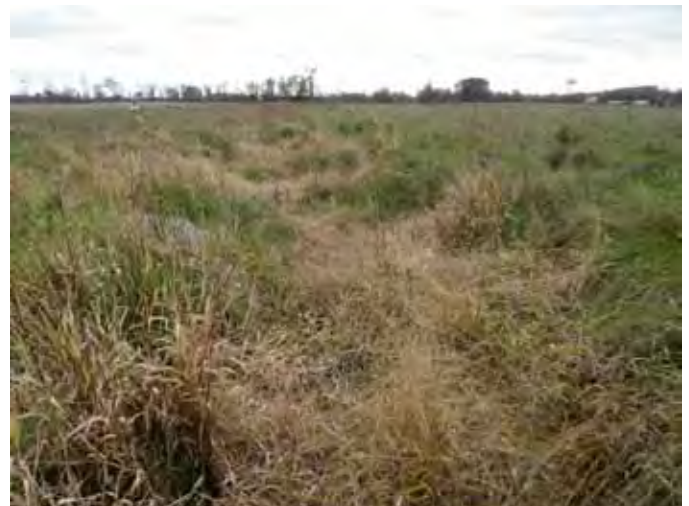
Photo 52: Looking east from large pond ground is low lying and is a grassed waterway with little defined depression with <0.05m of water.
Site ID# P5-A

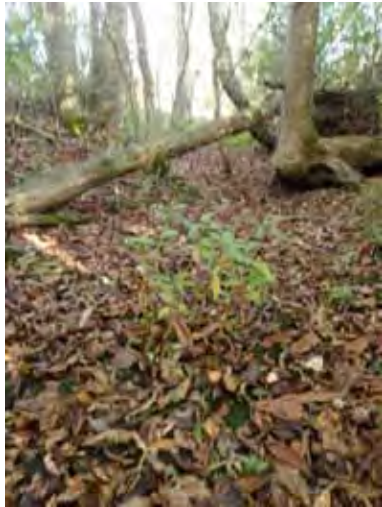
Photo 53: Looking north from Howes Rd. CSP, looks to be typically wet and intermittent but currently dry. Site ID# P16-Pond

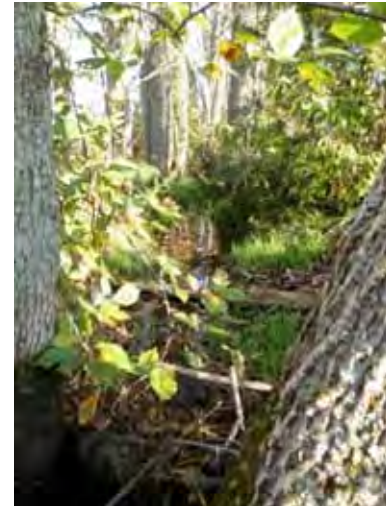
Photo 54: Looking north at standing water where leaf litter is choking flow in lower lying ground along tree line. ID# P16-Pond

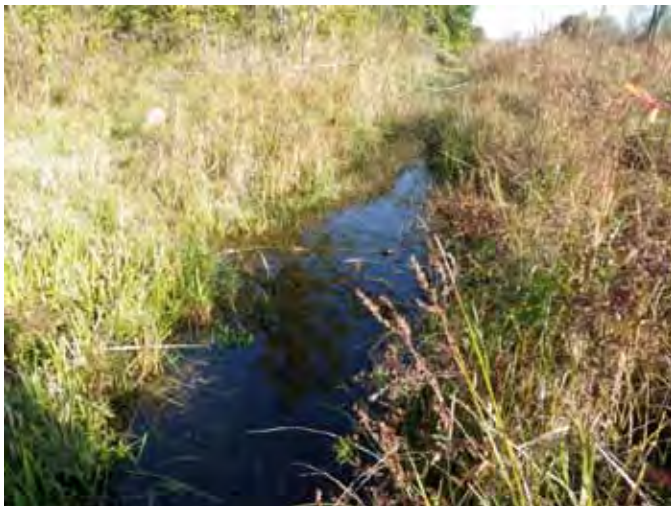
Photo 55: Looking upstream where channel is more defined and has aquatic vegetation and leaf litter. Site ID# P16-Pond

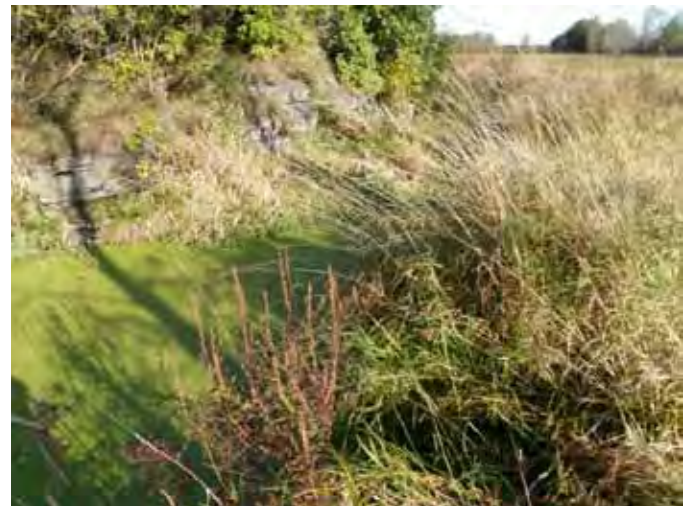
Photo 56: Small pond at top of drainage holding water in low lying area, possibly area of water drainage from upper field. Site ID# P16-Pond

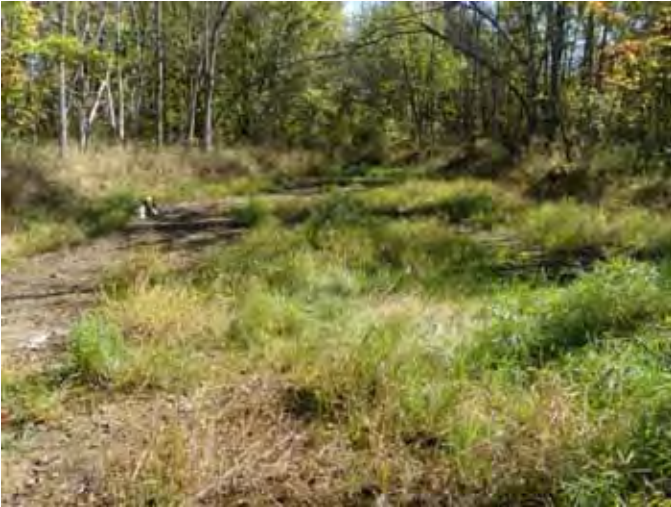
Photo 57: From the western bank looking north east across length of the pond. Currently dry and looks to have been for some time. **Site ID# P20-A**

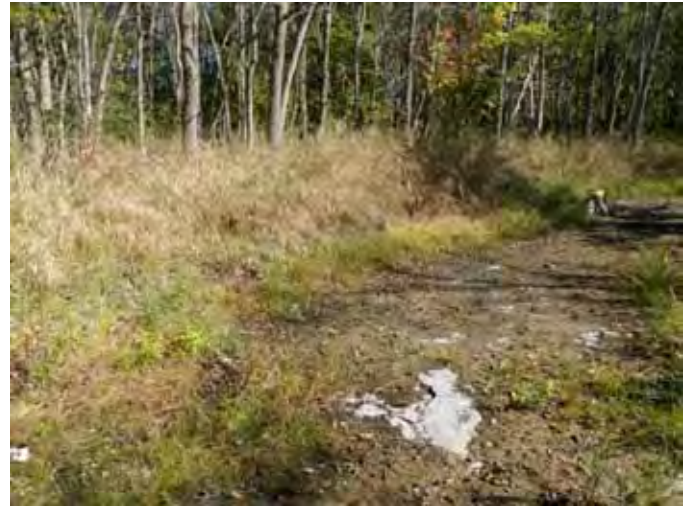
Photo 58: Exposed limestone and terrestrial vegetation growing in basin. Damp soil and mosses may indicate some groundwater influence. **Site ID# P20-A**

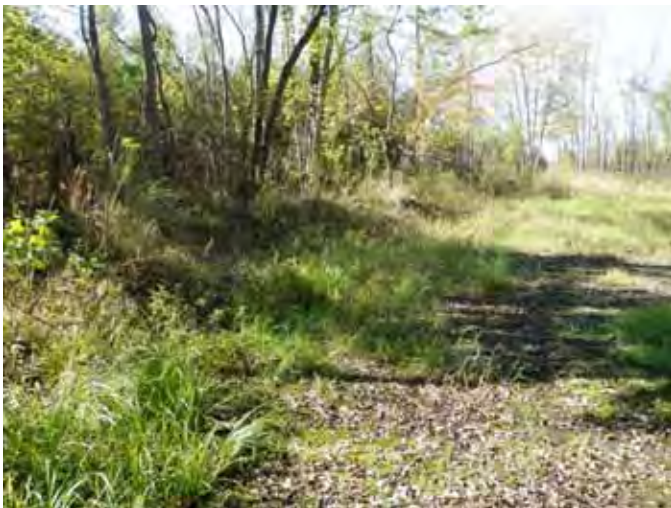
Photo 59: Looking west along south bank of low pond basin, no drainage but possible ground water effect observed. **Site ID# P20-A**

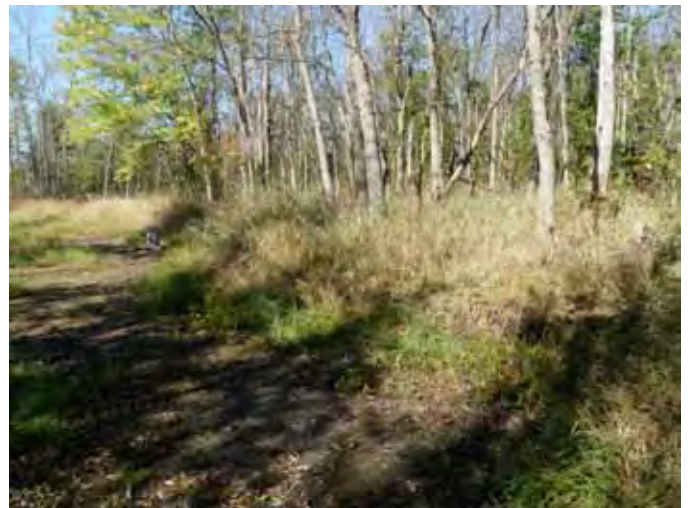
Photo 60: Looking west along northern bank of low lying dry pond. **Site ID# P20-A**

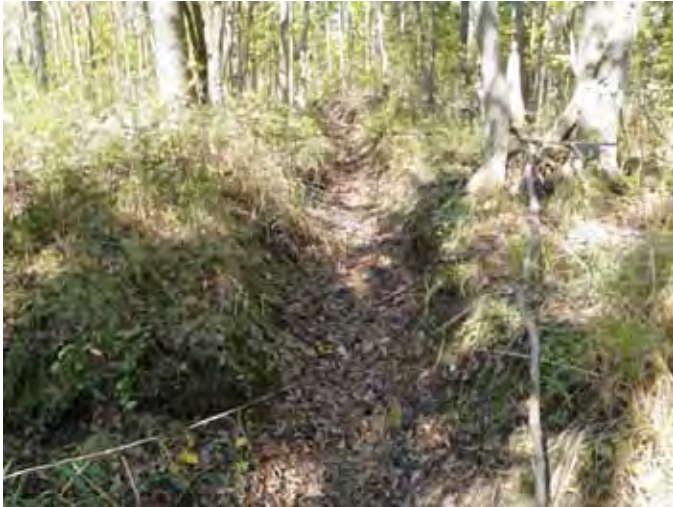
Photo 61: Walking north from pond, relatively encised channel with noticeable gradient is found. Site ID# P20-B

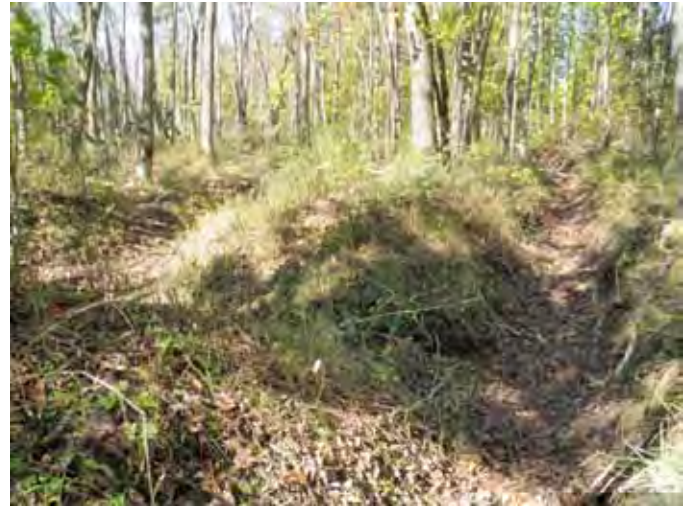
Photo 62: Branching of encised channel. Channel with leaf litter, exposed roots, mosses. ID# P20-B

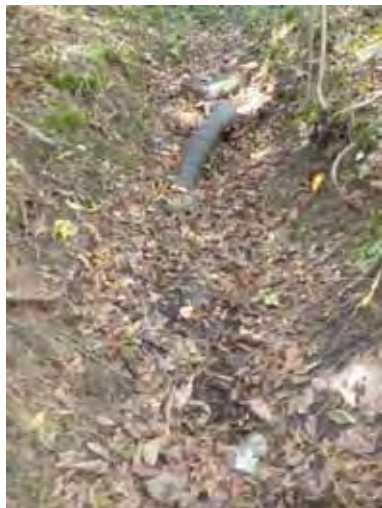
Photo 63: Upstream of P20-B2 a corrugated plastic pipe was found exposed in the channel. Channel leads to base of cleared field that likely drains to this feature. Site ID# P20-B2

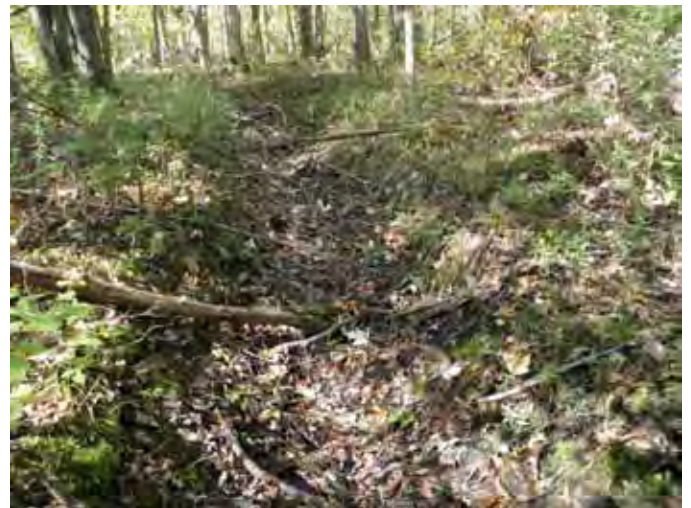
Photo 64: Channel north of P20-pond with lots of organic debris. Area relatively forested. Site ID# P20-B2
