**KINGSTON SOLAR LP
SOL-LUCE KINGSTON
SOLAR PV ENERGY PROJECT**

**WATER ASSESSMENT AND
WATER BODY REPORT**

**September 2012
TC111406
168335-0002-160-RPT-0016**

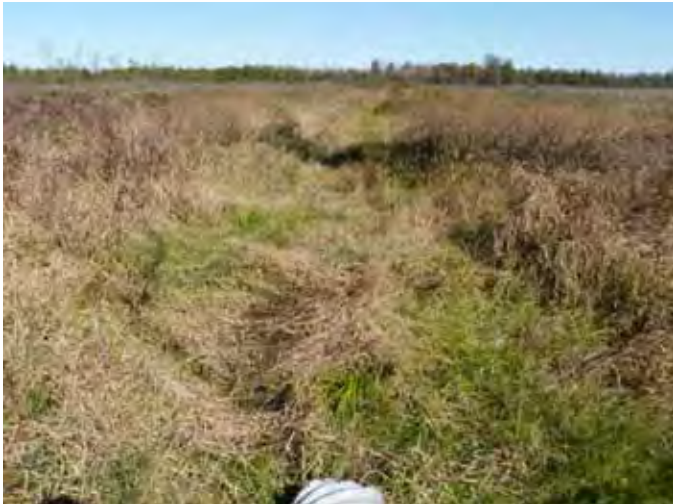
Photo 65: Looking east into field from CSP at the end of Hegadorn Rd. laneway near the 401. (Unnamed Drainage) Area wetted but with little channelization. **Site ID# P24-D**

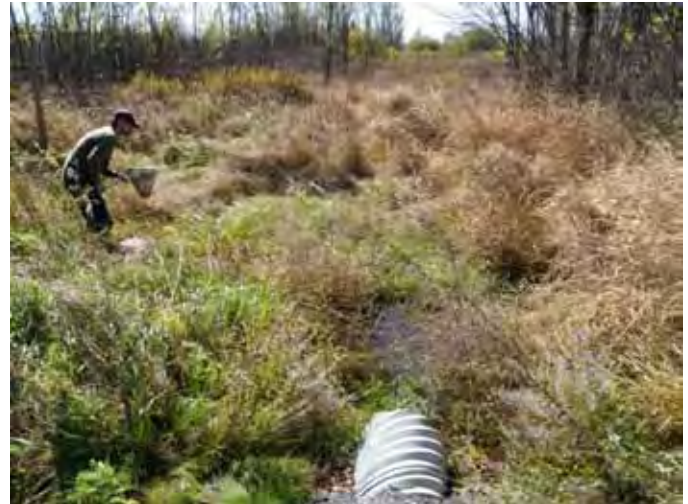
Photo 66: Looking west from Hegadorn Rd. laneway CSP with diffuse pooled pockets of water ~0.10m deep with no defined channel. **ID# P24-D**

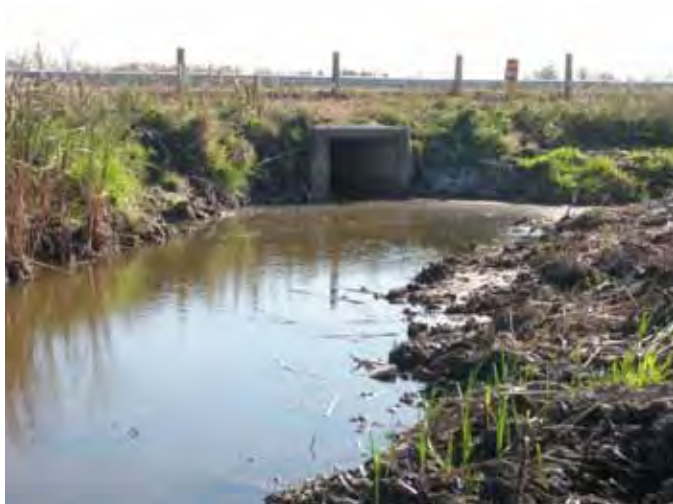
Photo 67: Highway 401 box culvert crossing at ROW, 6mx8.5m pond. (Millhaven Cr. Trib.1) **Site ID# P24-A**

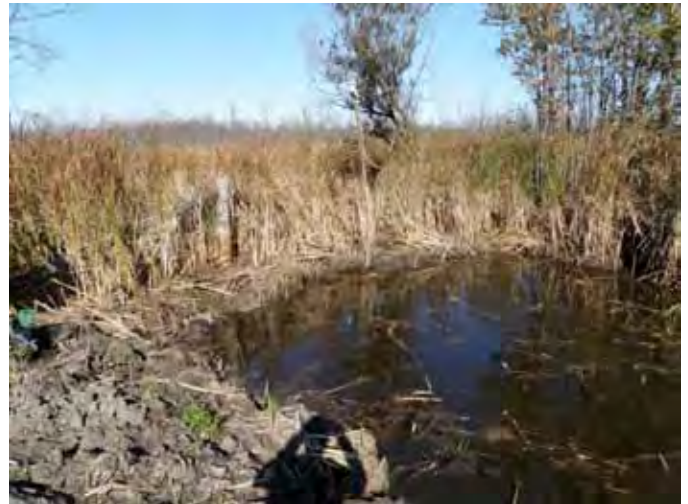
Photo 68: Looking north from highway 401, area is dominated by cattails. Nearby beaver activity observed. **Site ID# P24-A**

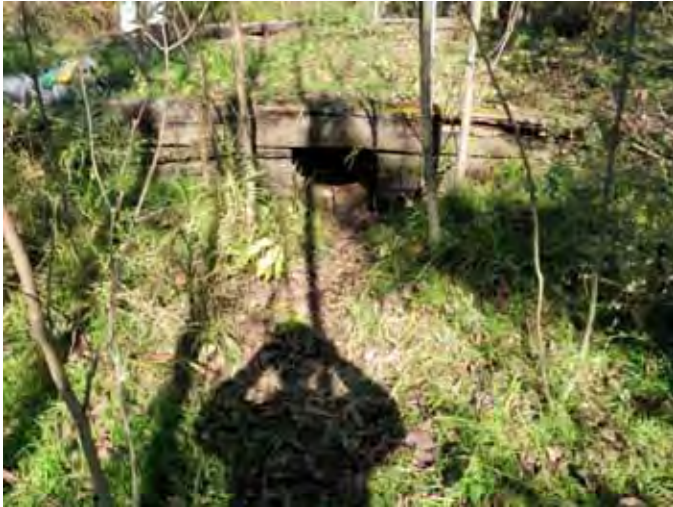
Photo 69: Looking north, CSP and cradle structure at the end of an access laneway near the Flying J billboard. **Site ID# P24-B**

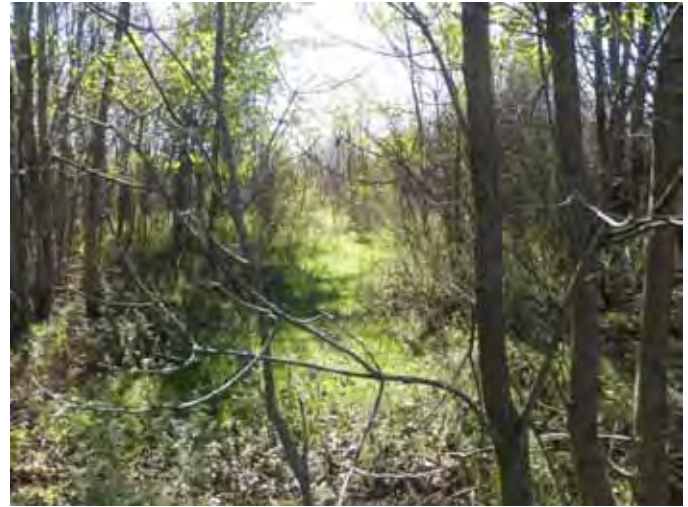
Photo 70: Looking south from CSP, currently dry seasonal intermittent drainage with poorly defined channel. **ID# P24-B**

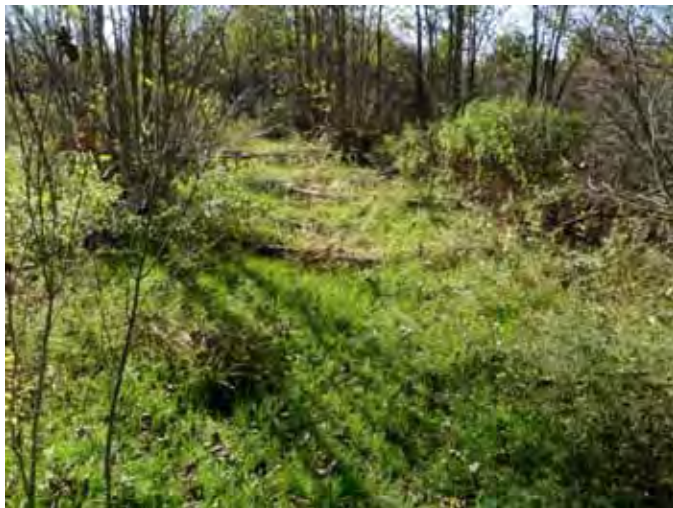
Photo 71: Looking south from crossing there is no defined channel or signs of aquatic vegetation. **Site ID# P24-B**

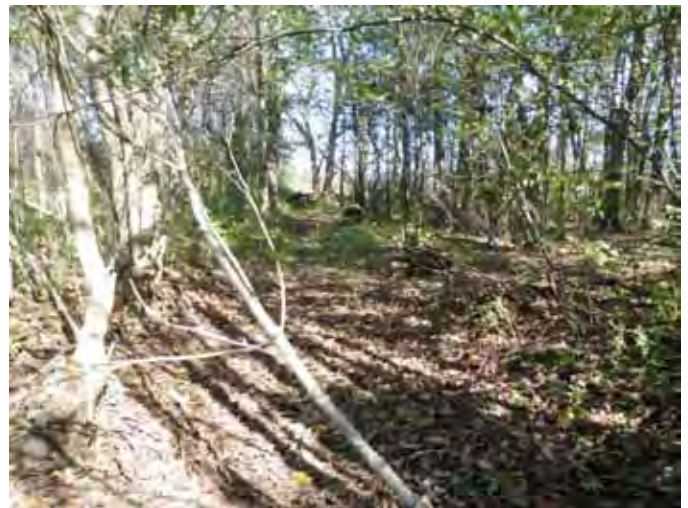
Photo 72: Looking north from crossing towards pond terrestrial vegetation is more dominant with lots of leaf litter. **Site ID# P24-B**

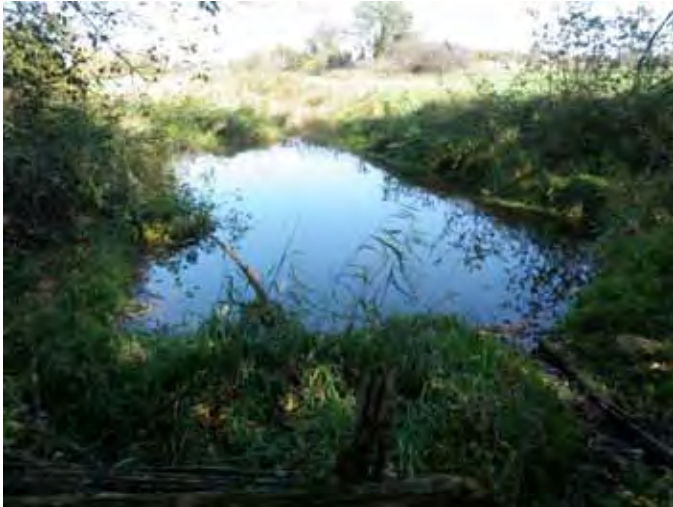
Photo 73: Looking north, pond is 6mx15m. Possible groundwater input to pond and drainage receiver from sod fields. **Site ID# P24-B-Pond**

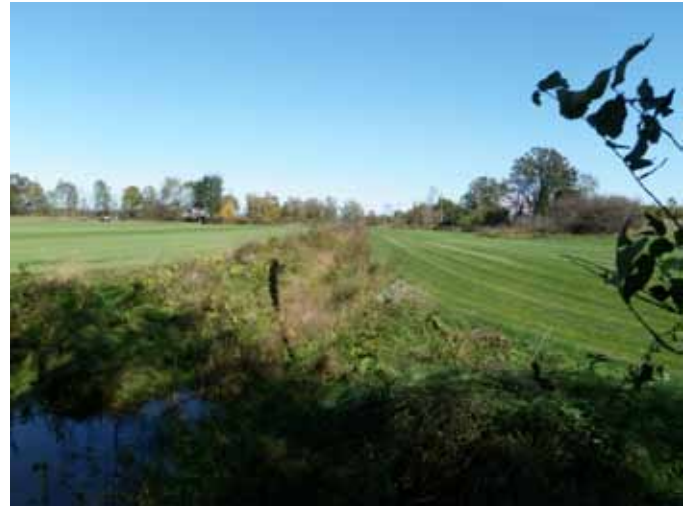
Photo 74: Intermittent drainage upstream between two sod fields. **ID# P24-B-Pond**

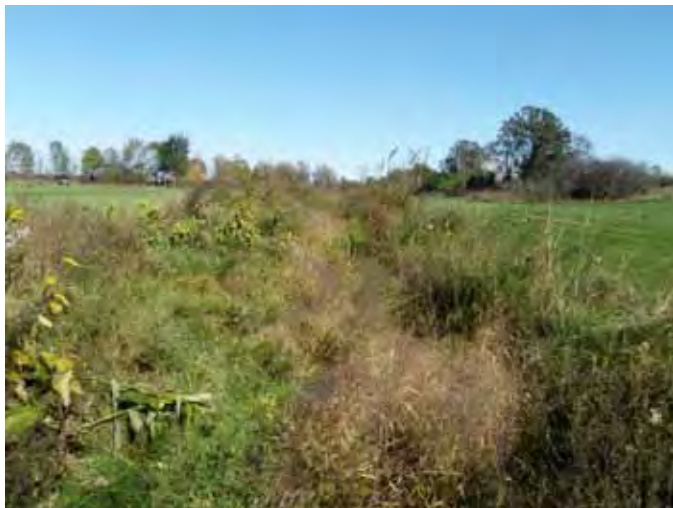
Photo 75: Drainage swale to the north on restricted property. **Site ID# P24-B-Pond**

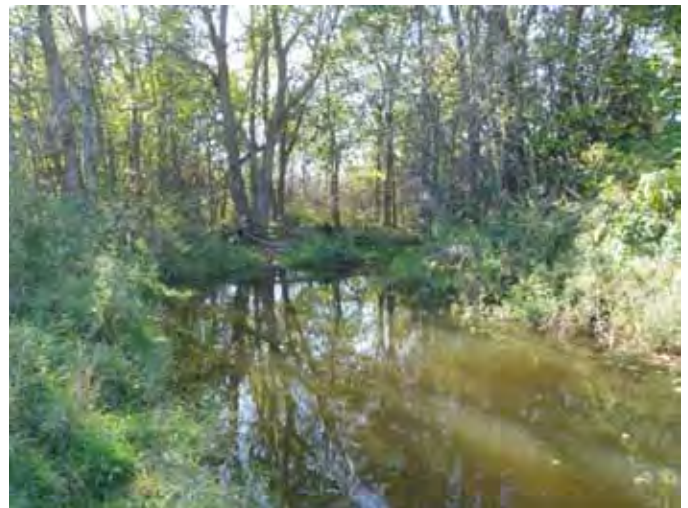
Photo 76: Looking south from north end of limestone pond. **Site ID# P24-B-Pond**

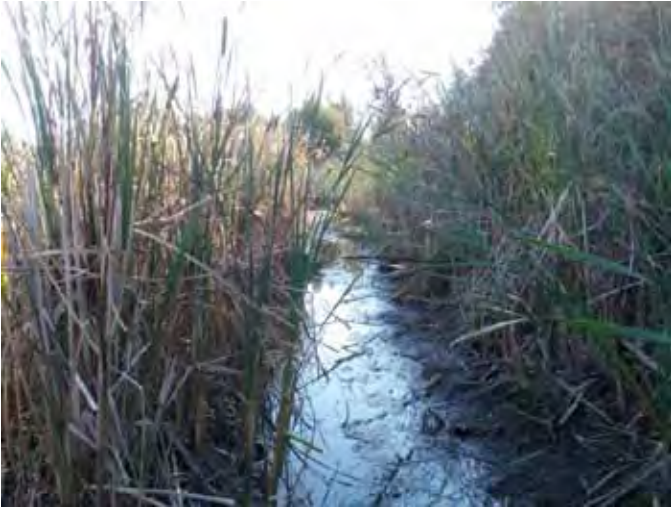
Photo 77: Looking south towards highway 401, area is a wetland complex with braids flowing at higher water levels. **Site ID# P23-A**

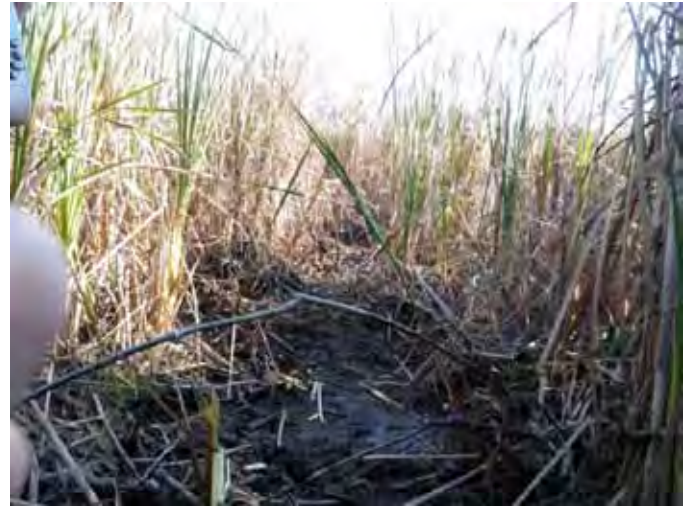
Photo 78: Surrounding vegetation is 100% cattails with high amounts of muck and detritus. **Site ID# P23-A**

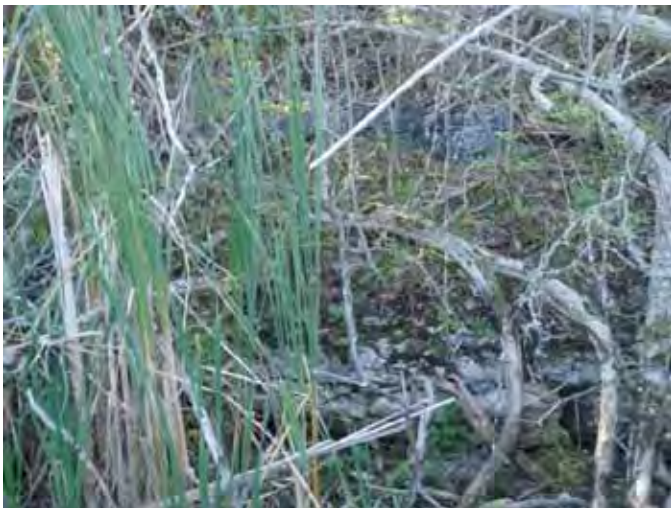
Photo 79: Looking west the upstream bank has large limestone embankments with a mixed tree line. **Site ID# P23-A**

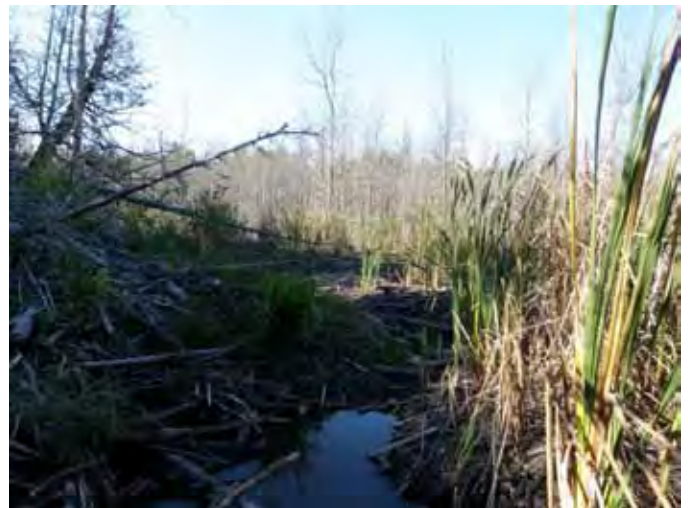
Photo 80: Looking north a beaver dam is observed on the left bank. **Site ID# P23-A**

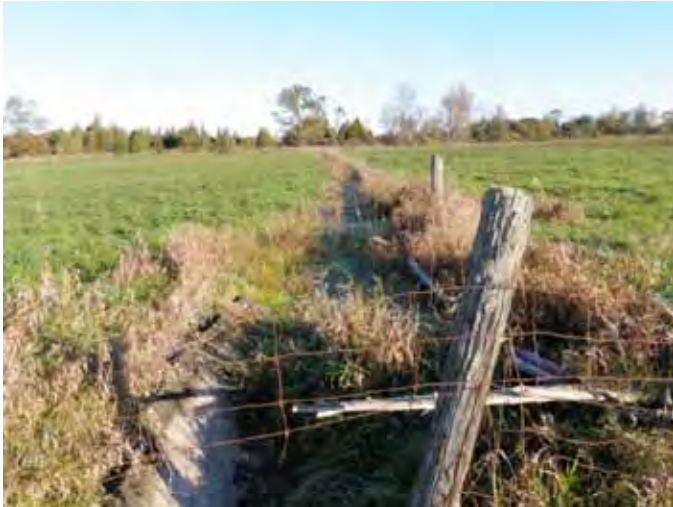
Photo 81: Looking north towards Millhaven Cr / Odessa Lake. from CSP on Mud Lake Rd. area is 100% terrestrial. Swale is intermittent, currently dry. Site ID# OL-A

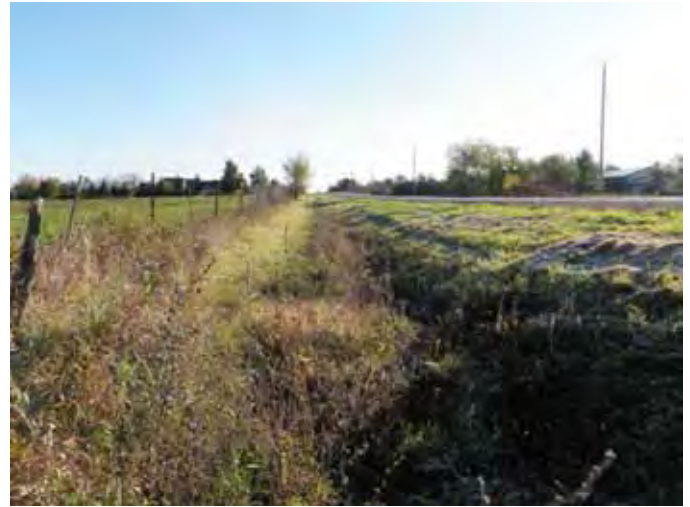
Photo 82: Roadside ditch on the north side of Mud Lake Rd. looking north, currently dry. Site ID# OL-A

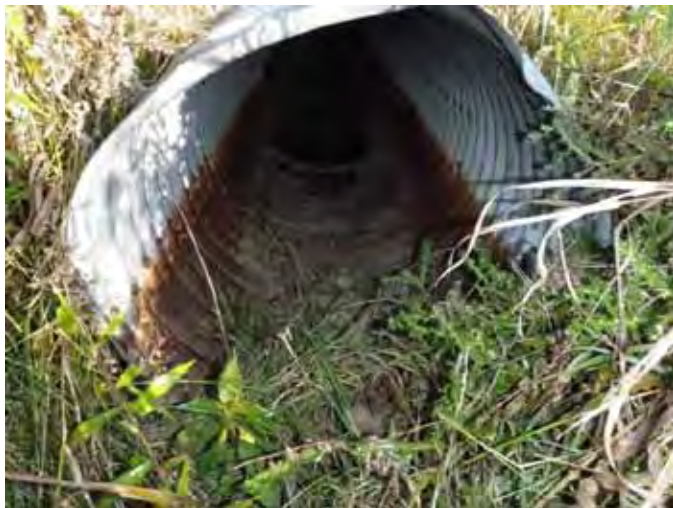
Photo 83: Looking into dry CSP on south side of Mud Lake Rd. Scour at mouth indicates water conveyance with roadside ditch during wet periods. Site ID# OL-A

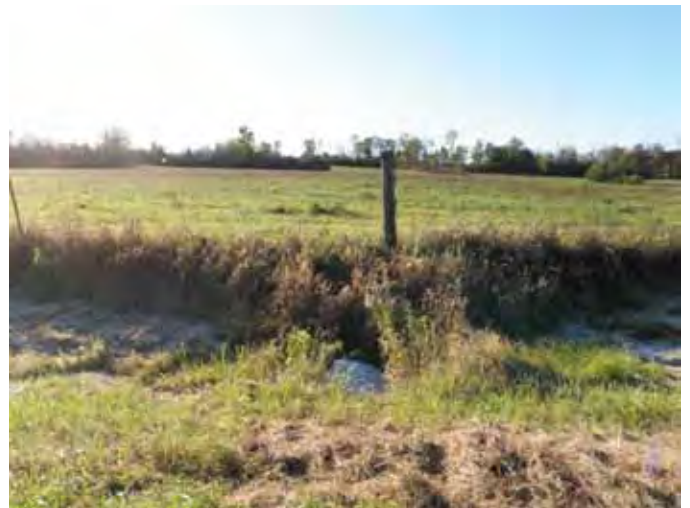
Photo 84: Looking south at opposite side of Mud Lake Rd. drain does not extend into farmer's field but is contained by roadside ditching. Site ID# OL-A

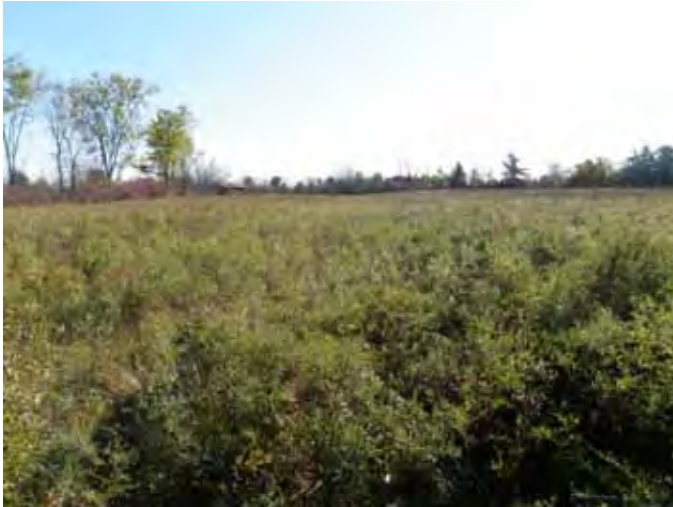
Photo 85: Looking east across field at intermittent drainage with no signs of wetting, possibly for multiple years. Site ID# P23-B2

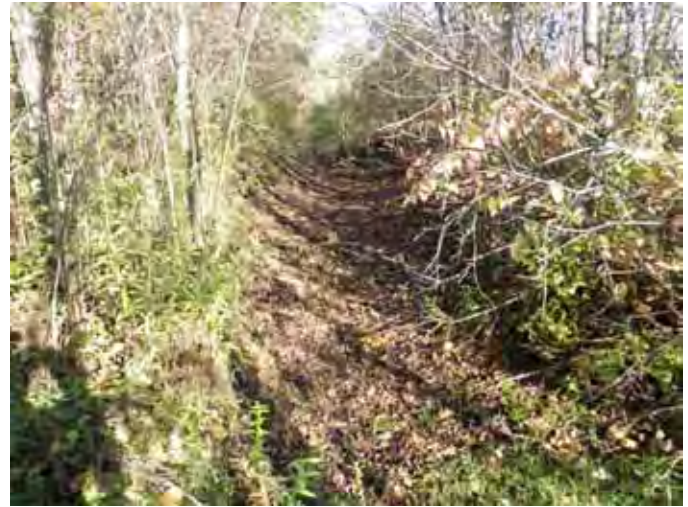
Photo 86: Looking west at intermittent drainage swale/lane from west boundary of property. Site ID# P23-B1

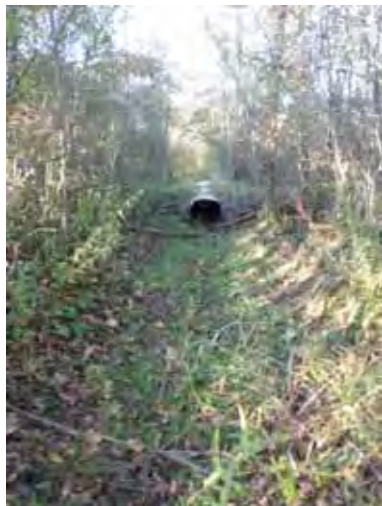
Photo 87: Continuing to look west at drainage swale/lane where culvert has been placed to maintain lane crossing. Site ID# P23-Northern-1

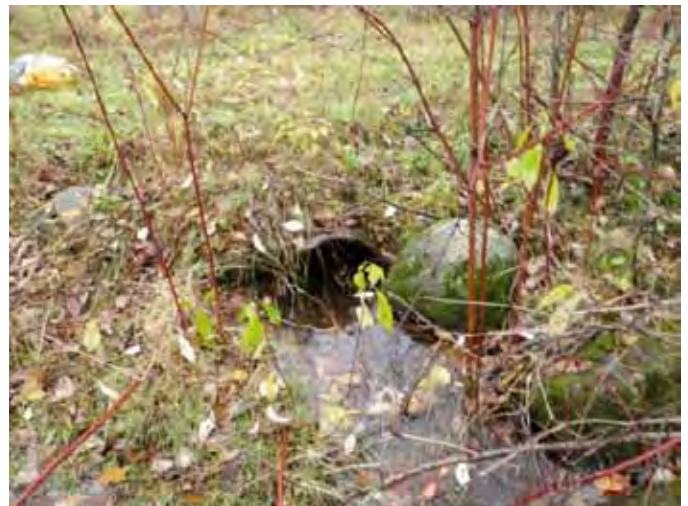
Photo 88: Culvert crossing on second visit. Wet from rainfall and draining fields. Water is flowing from east to west. Site ID# P23-Northern-2

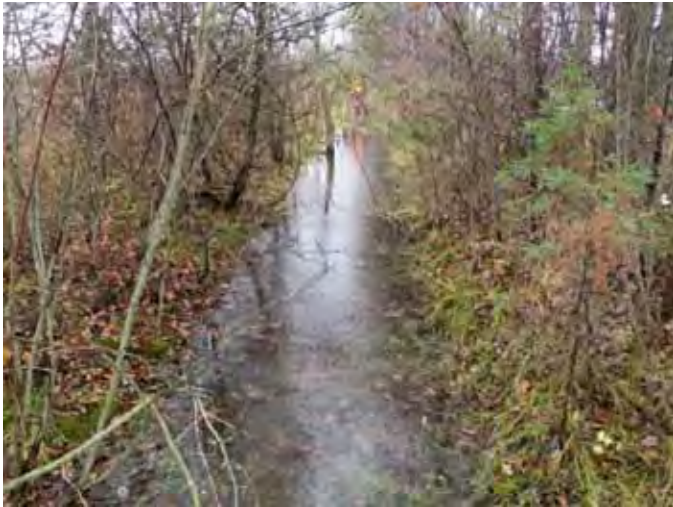
Photo 89: Intermittent drainage west boundary of property that was previously visited and was dry. Wet on second visit
Site ID# P23-Northern-1

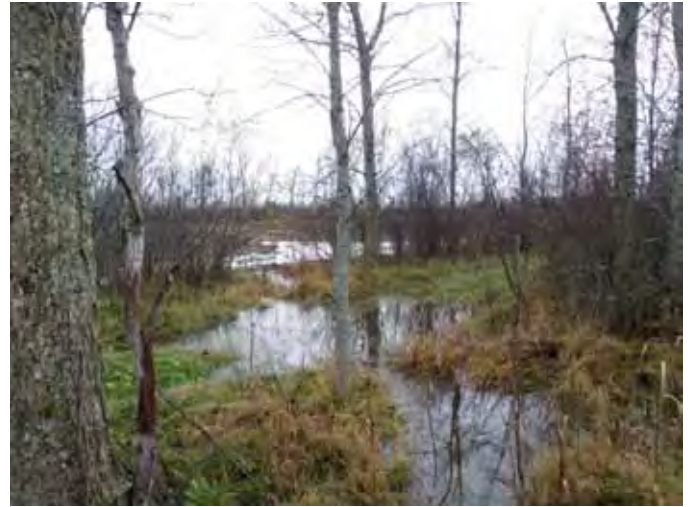
Photo 90: Small culvert conveying field run-off under laneway with a large depression here from farming equipment collecting water.
Site ID# P23-Northern-1

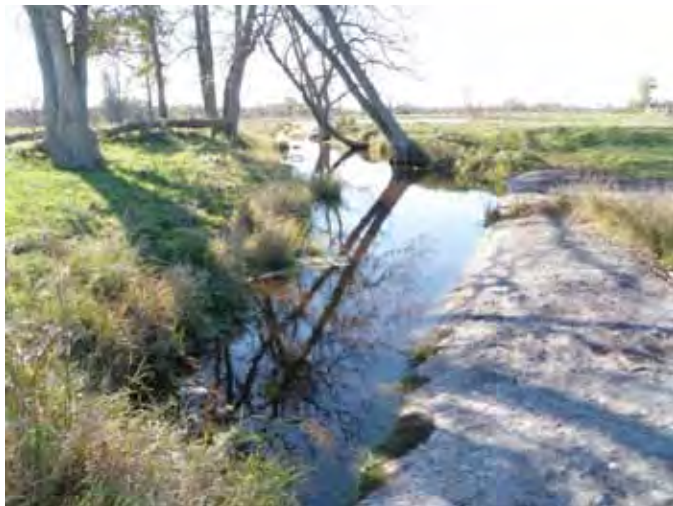
Photo 91: Looking south at dug out permanent drainage feature from fields on north side (Property 6A) of Unity Rd. **Site ID# P14-B1**

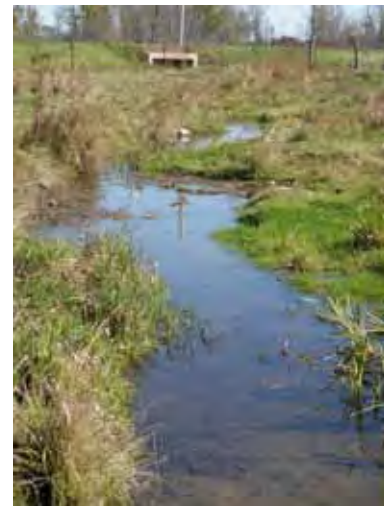
Photo 92: Looking north at box culvert crossing at Unity Rd in cow pasture area upstream of man-made Property 14B Pond. **Site ID# P14-B2**

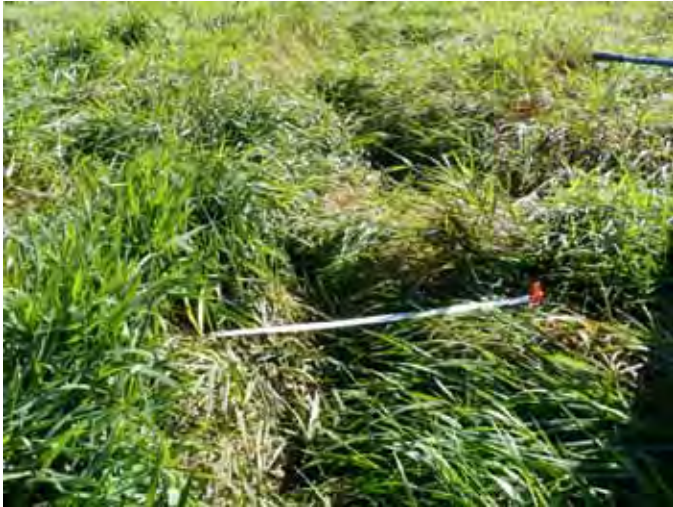
Photo 93: Looking south at small intermittent drainage swale ~0.3m wide and <0.1m deep when inundated. Location is just south of fence line for cattle. **Site ID# P14-B3**

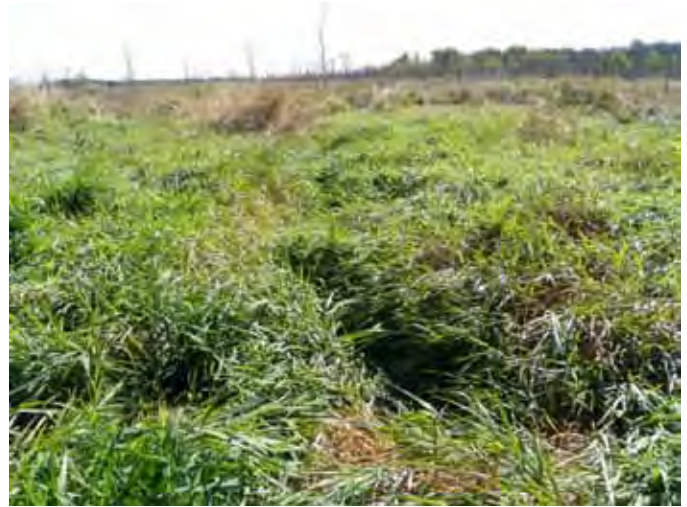
Photo 94: Same drainage swale as previous photo looking south. **ID# P14-B3**

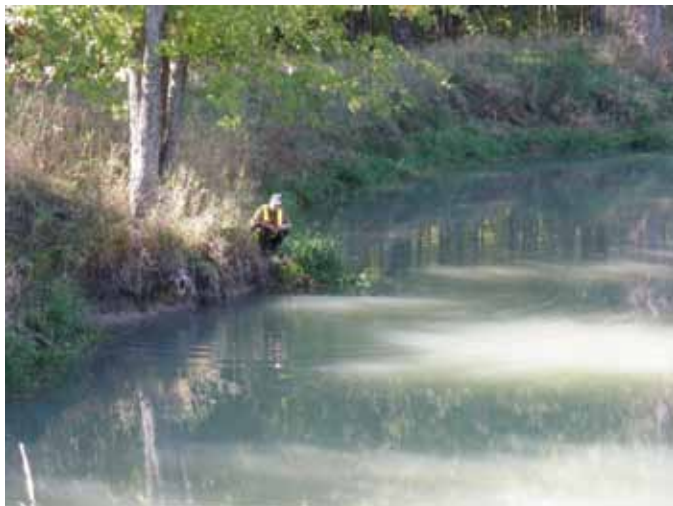
Photo 95: Large man-made pond situated in lower lying mixed forest at the south end of property 14B. **Site ID# P14-B-South-Pond**

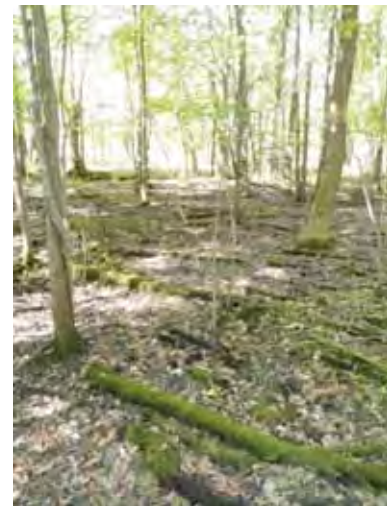
Photo 96: Mixed forest at the base of large berm around the circumference of the pond. **Site ID# P14-B-South-Pond**

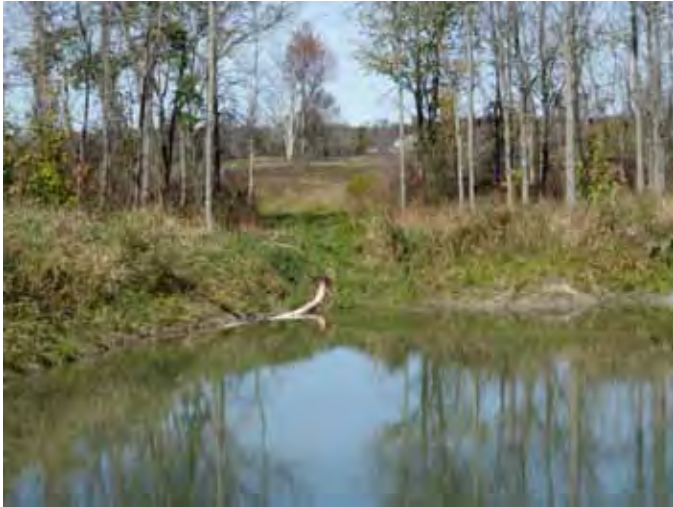
Photo 97: West side of pond looking north at tractor trail returning to farm from this location, water drawing in the past is evident.
Site ID# P14-B-South-Pond

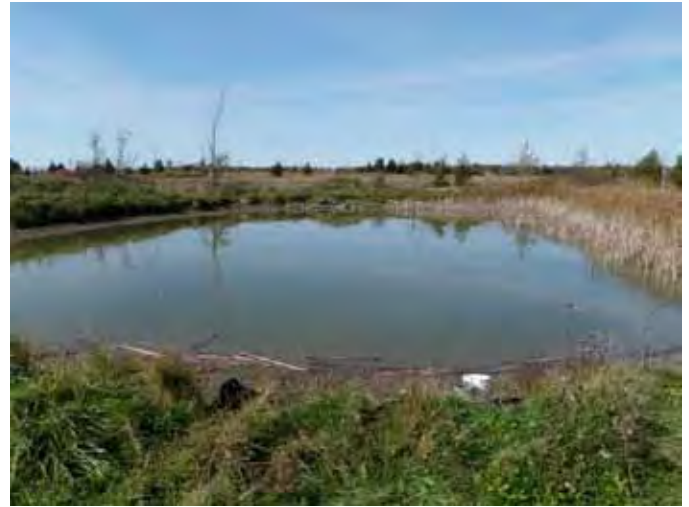
Photo 98: Looking north from south end of standing water pond. East margin is dominated by cattails. No defined inflow or outflow to this man-made feature. **Site ID# P6-B**

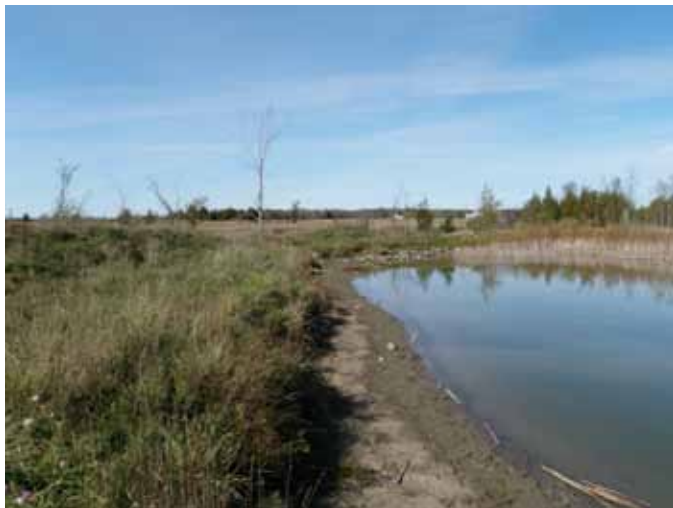
Photo 99: North end of pond has large boulders with a clay and silt substrate. Also shown here is a line of dead trees on the eastern side of the pond extending to the south. **Site ID# P6-B**

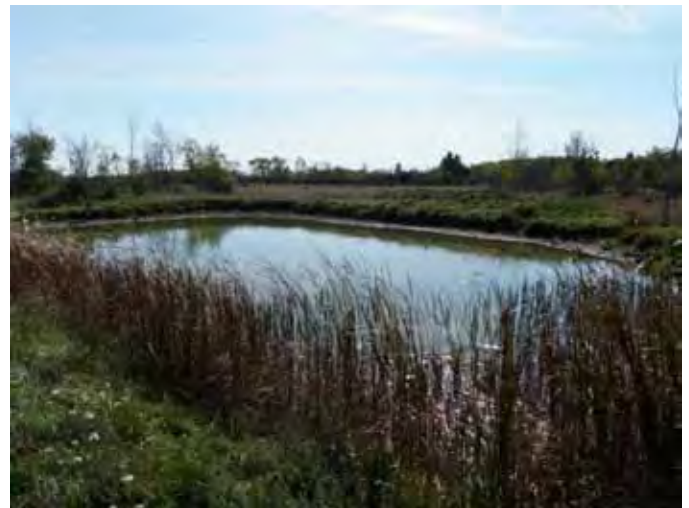
Photo 100: Looking south from depression at the north end of the pond. **Site ID# P6-B**

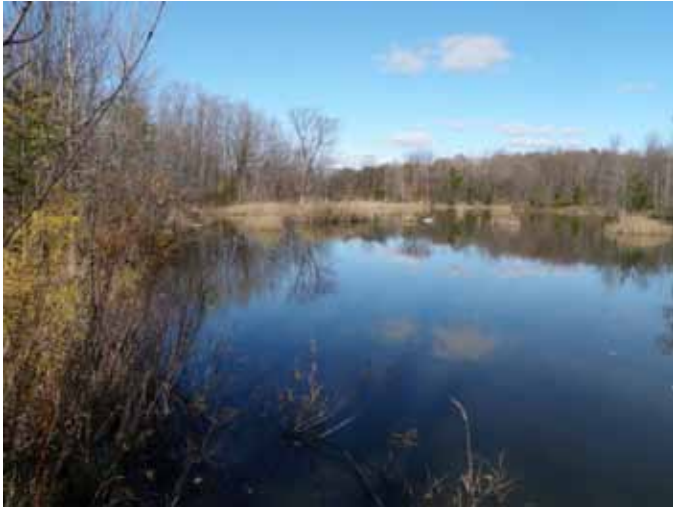
Photo 101: Looking north from south end of pond (habitat type A). **Site ID# P9-Quarry-Pond**

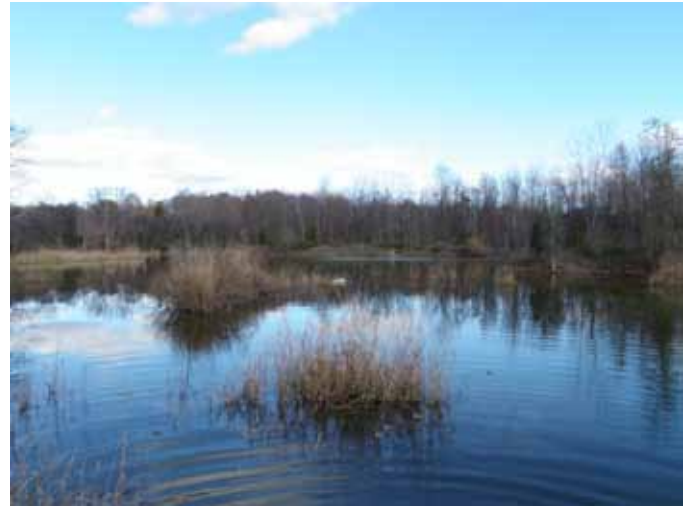
Photo 102: Looking east (habitat type B) silt/muck, cobble, and bedrock substrate. Vegetation is dominated by graminoids with some mixed forest. **ID# P9-Quarry-Pond**

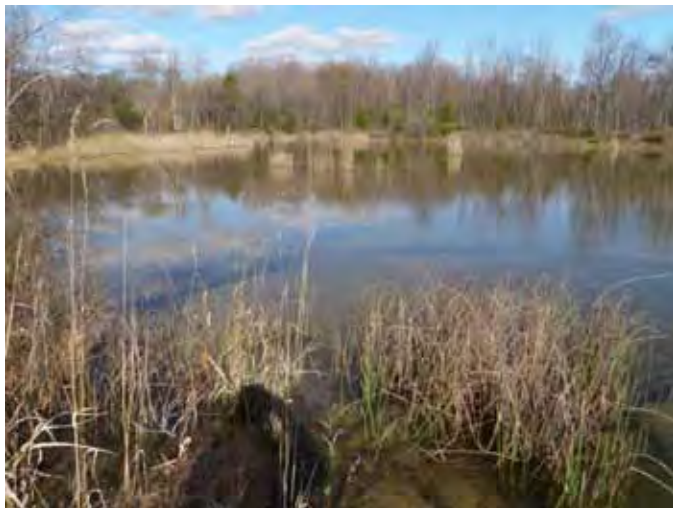
Photo 103: Looking east (habitat type C) substrate is cobble, silt/muck, and bedrock with the vegetation being dominated by graminoids and American elm. **Site ID# P9-Quarry-Pond**

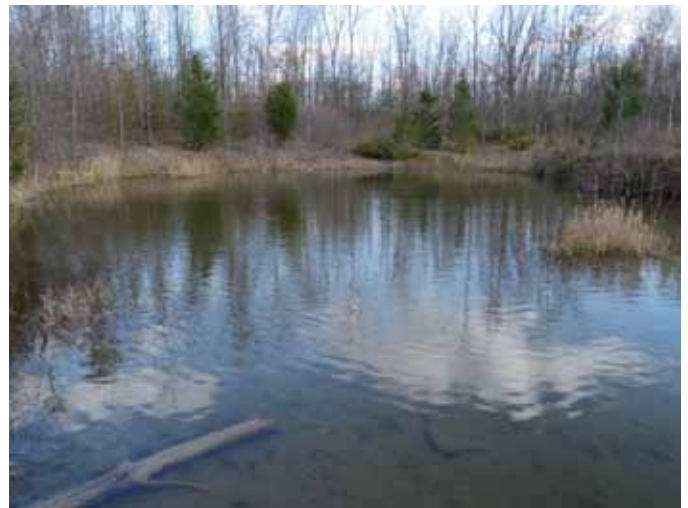
Photo 104: Looking south (habitat type D) substrate consists of cobble, silt/muck, boulders, and bedrock. Vegetation is dominated by graminoids with some mixed forest. **ID# P9-Quarry-Pond**

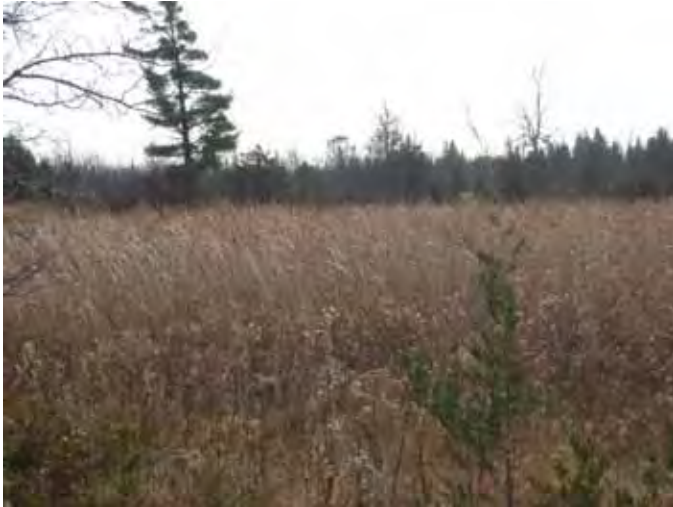
Photo 105: Southerly view of cattail marsh situated north of Glenvale Creek Tributary 2 and south of property 14A. **Site ID# SP14-Cattail Marsh**

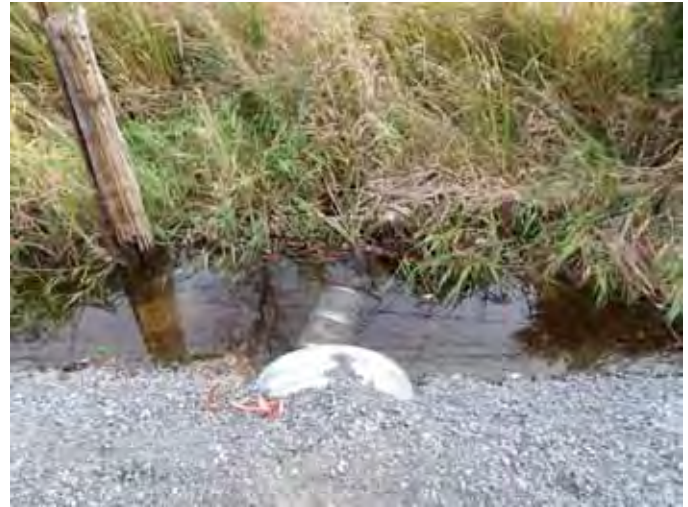
Photo 106: Looking south at intermittent drainage with water at roadside ditch. **Site ID# SP18-D**

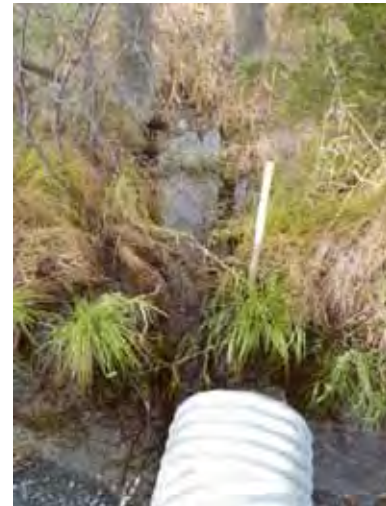
Photo 108: Channel width wetted is 0.85m, with a substrate of silt and limestone. **Site ID# SP18-D**
