WATER ASSESSMENT REPORT

Southgate Solar Project

April 2015

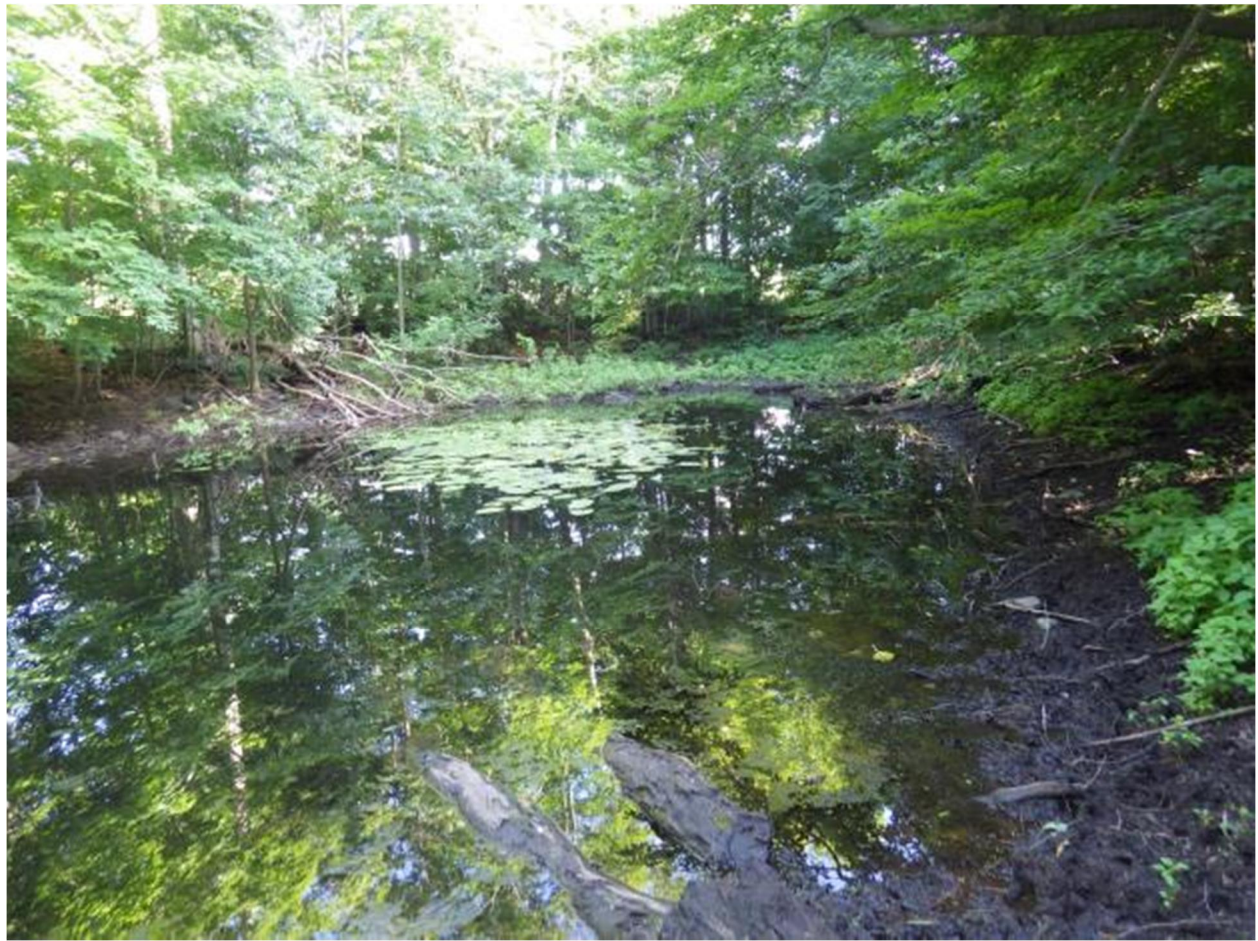
Photograph 1, facing south. Location of Potential Water Body 1, determined to be a dugout pond.

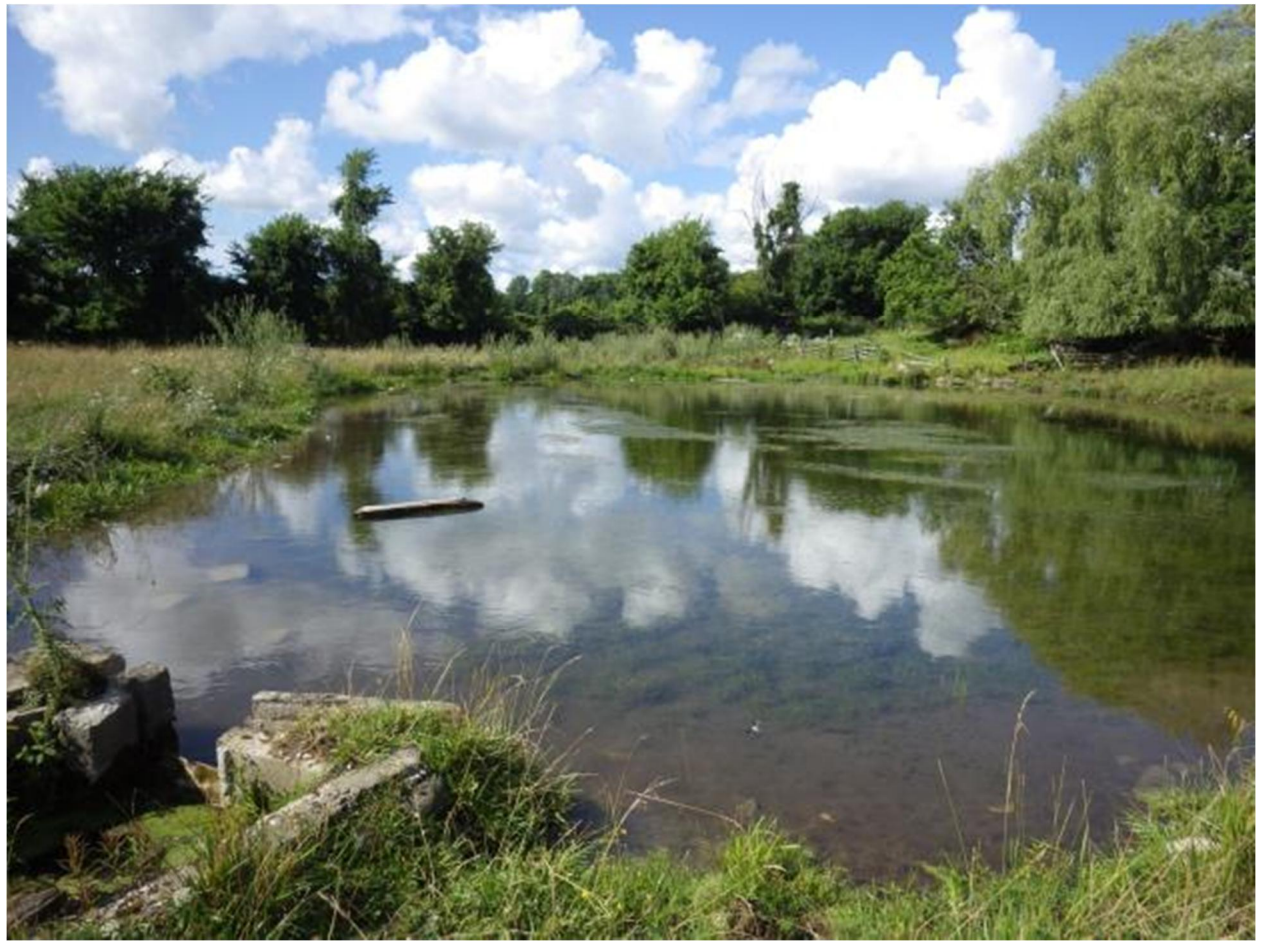
Photograph 2, facing north. Location of Potential Water Body 2, determined to be a dugout pond. The pond is in-line with Unnamed Stream 2, which enters at the north end of the pond (upper right side of photograph), and flows out of the pond over a concrete weir (lower left side of photograph).

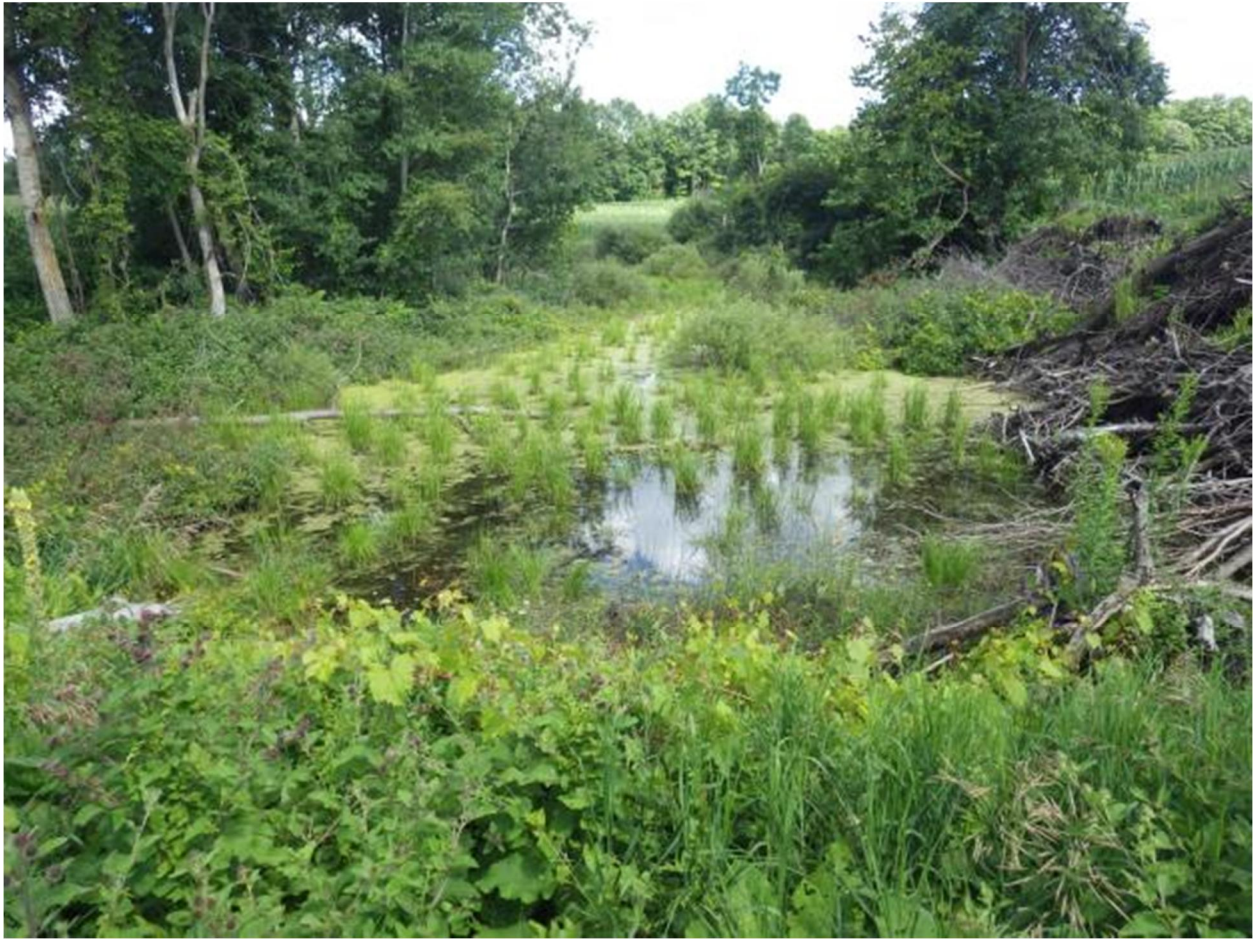
Photograph 3, facing east. Location of Potential Water Body 3, determined to be an area of shallow water that is part of a wetland.

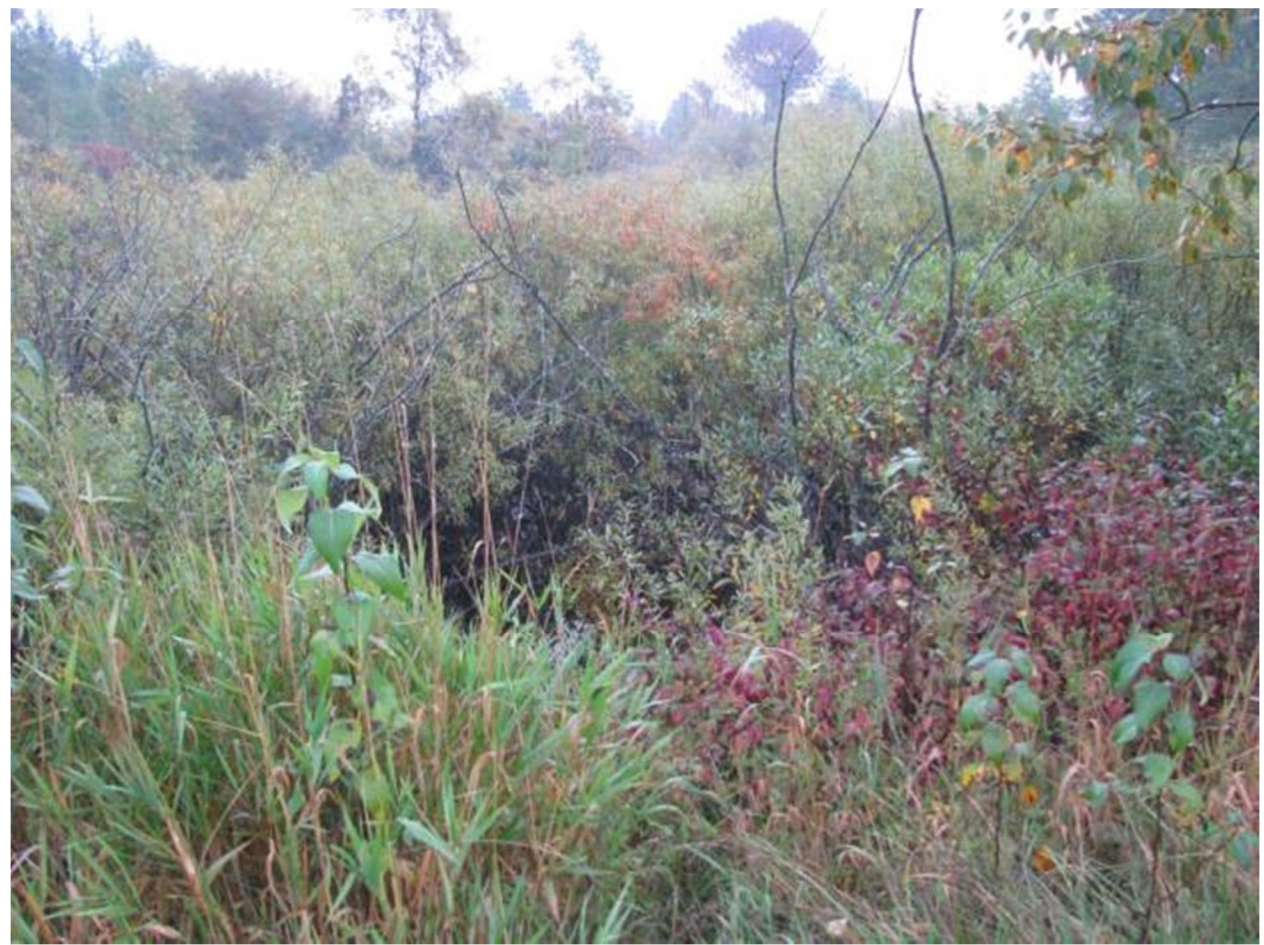
Photograph 4, facing east. Location of Potential Water Body 4, determined to be an area of shallow water that is part of a wetland.

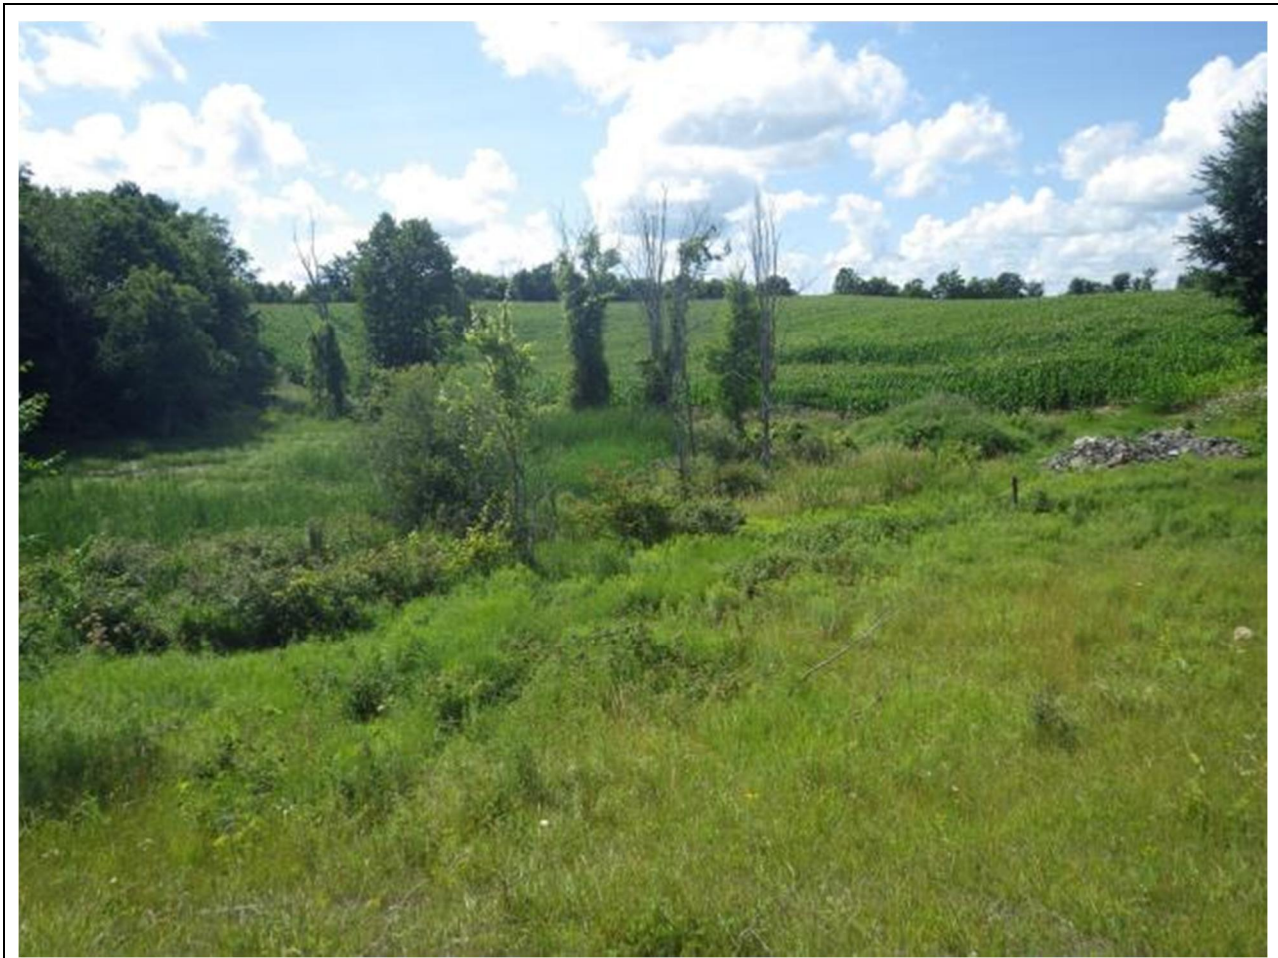
Photograph 5, facing west. Location of Potential Water Body 5, determined to be an area of shallow water that is part of a wetland.

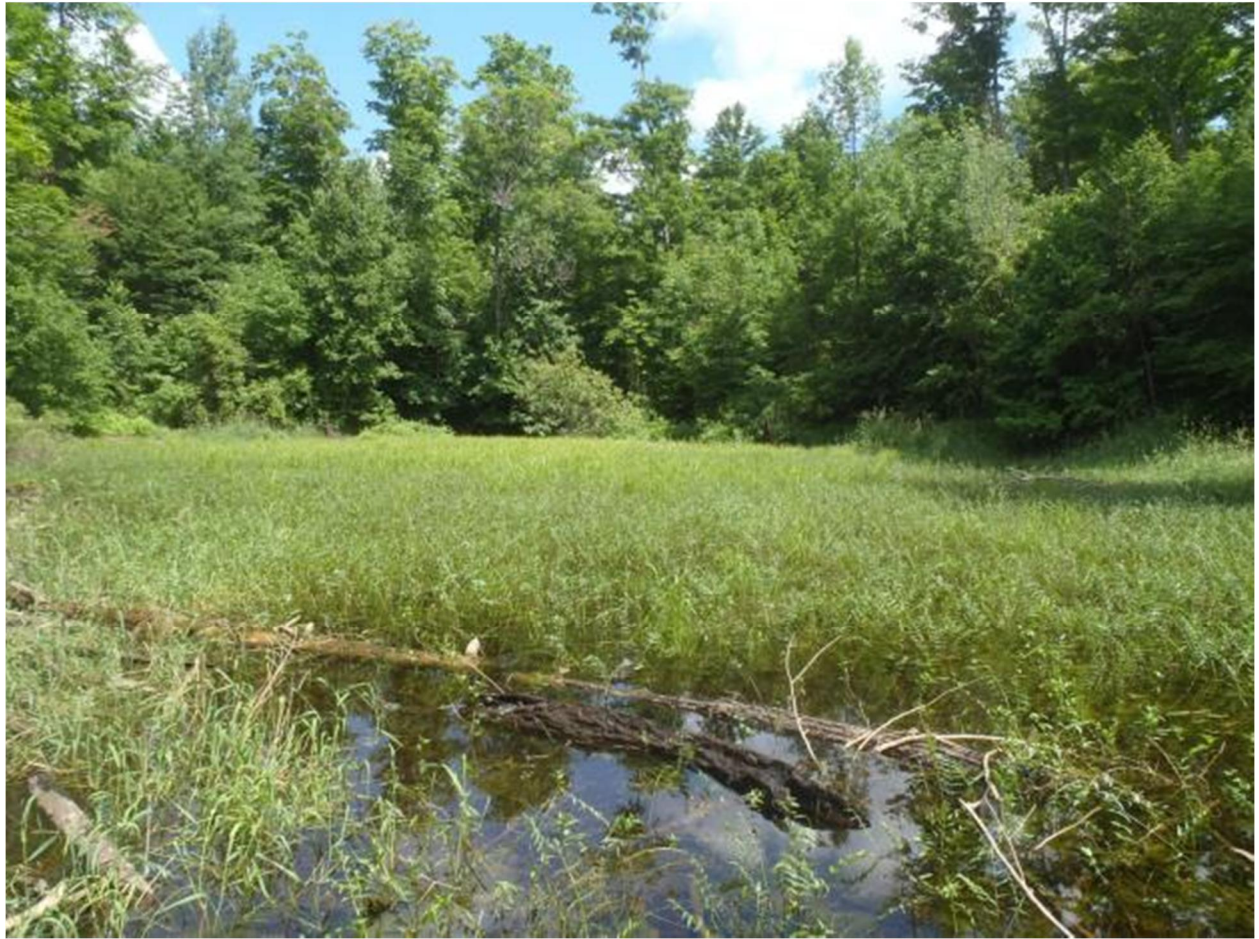
Potential Water Body 6 was determined during the site investigation to be an area of shallow open water that is part of a wetland. It was observed to be connected to Potential Water Body 7, and collectively this area is part of the same wetland (see Photograph 6 in *Appendix D*).

Potential Water Body 7 was determined during the site investigation to be an area of shallow open water that is part of a wetland. It was observed to be connected to Potential Water Body 6, and collectively this area is part of the same wetland (see Photograph 6 in *Appendix D*).

Photograph 6, facing east. Location of Potential Water Body 6 and Potential Water Body 7, determined to collectively be an area of shallow water that is part of a wetland.

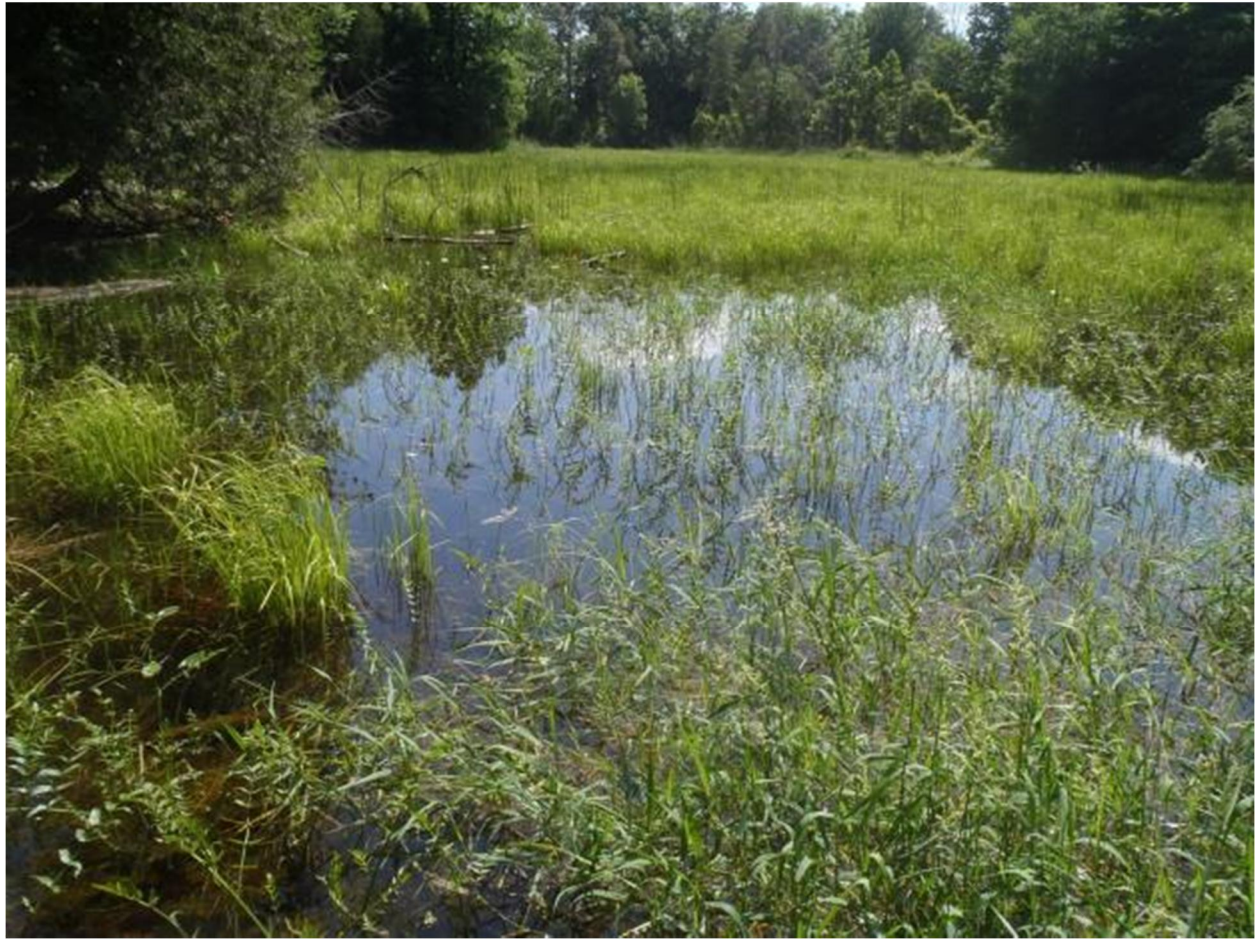
Photograph 7, facing south. Location of Potential Water Body 8, determined to be an area of shallow water that is part of a wetland.

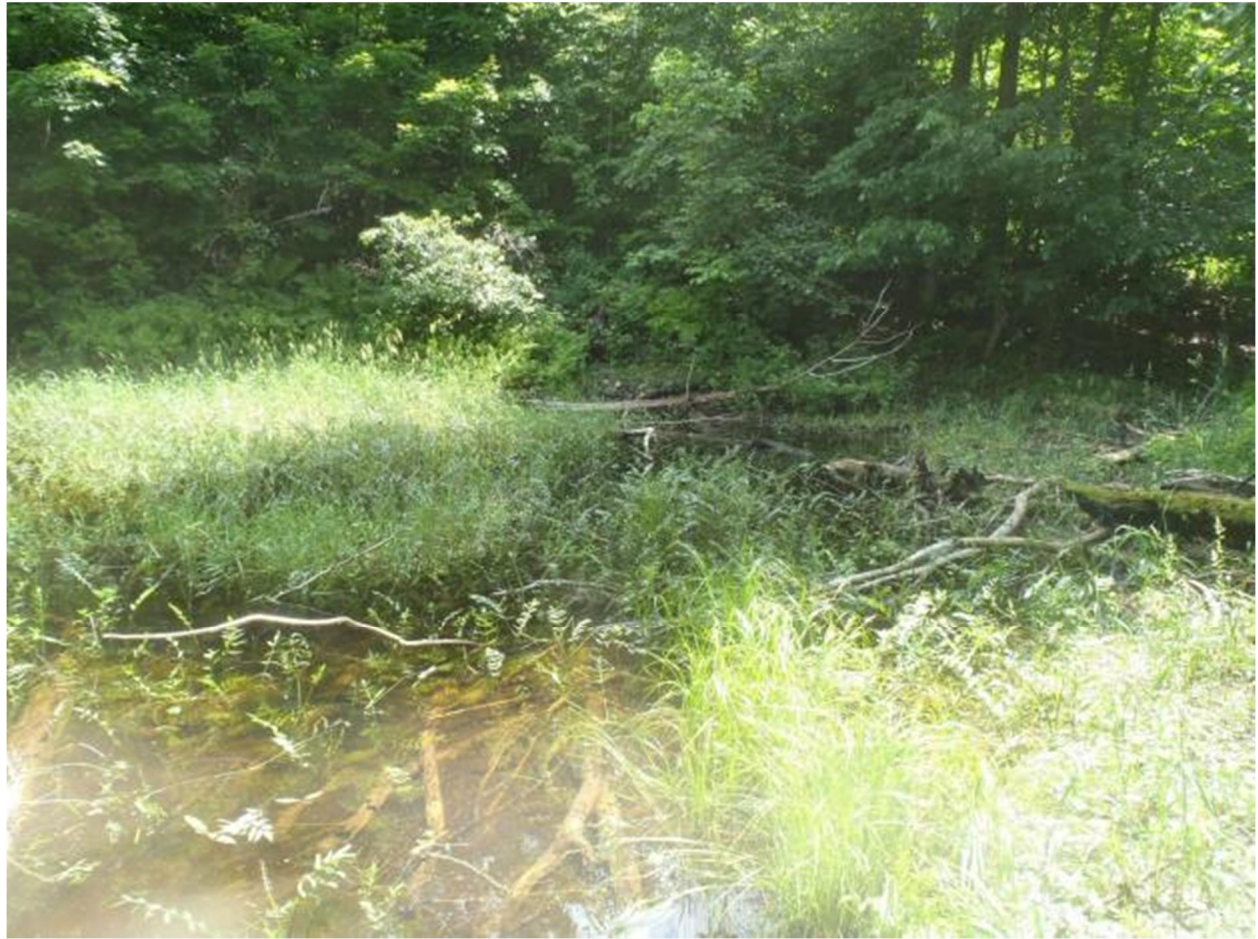
Photograph 8, facing south. Location of Potential Water Body 9, determined to be an area of shallow water that is part of a wetland.

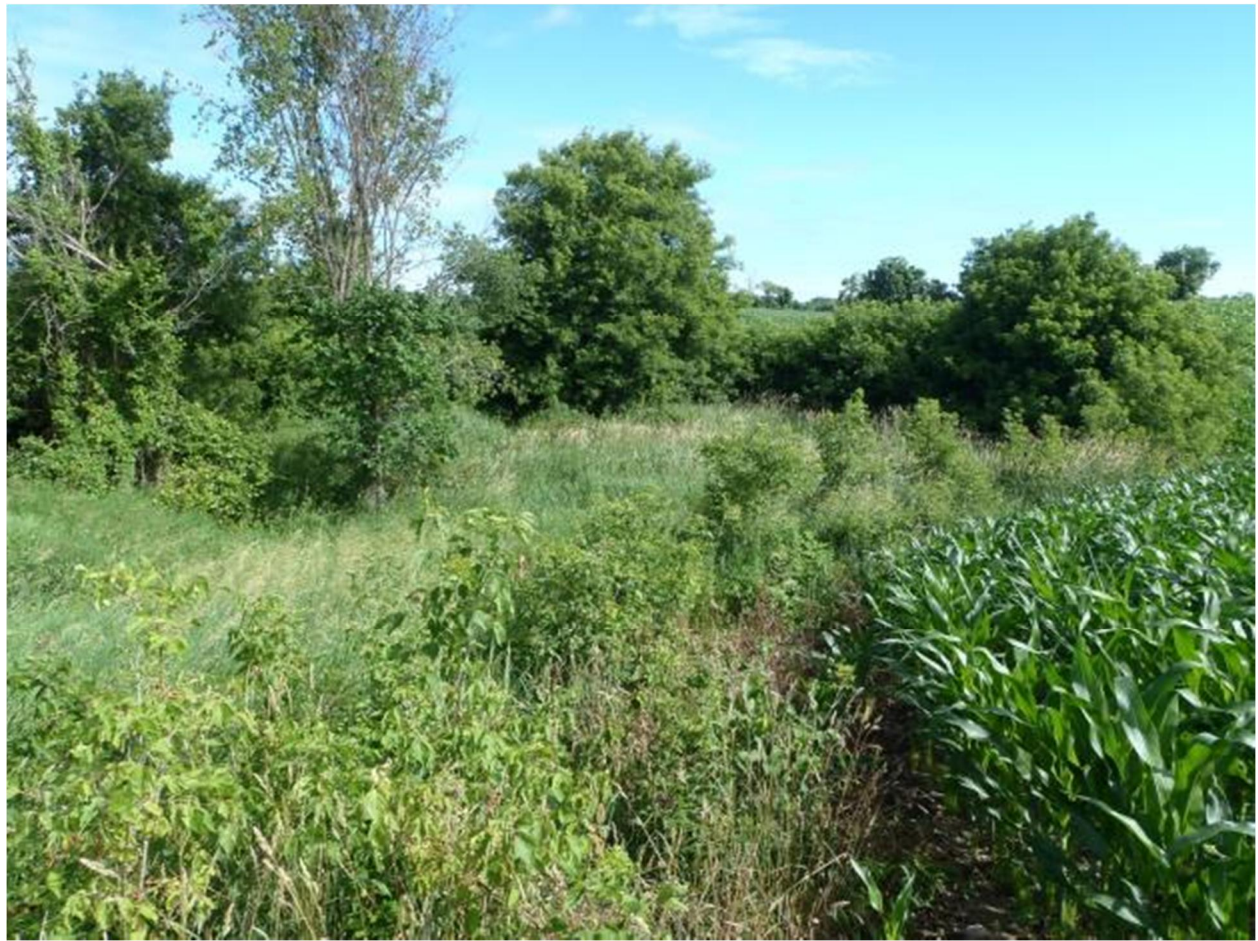
Photograph 9, facing south. Location of Potential Water Body 10, determined to be an area of shallow water that is part of a wetland.

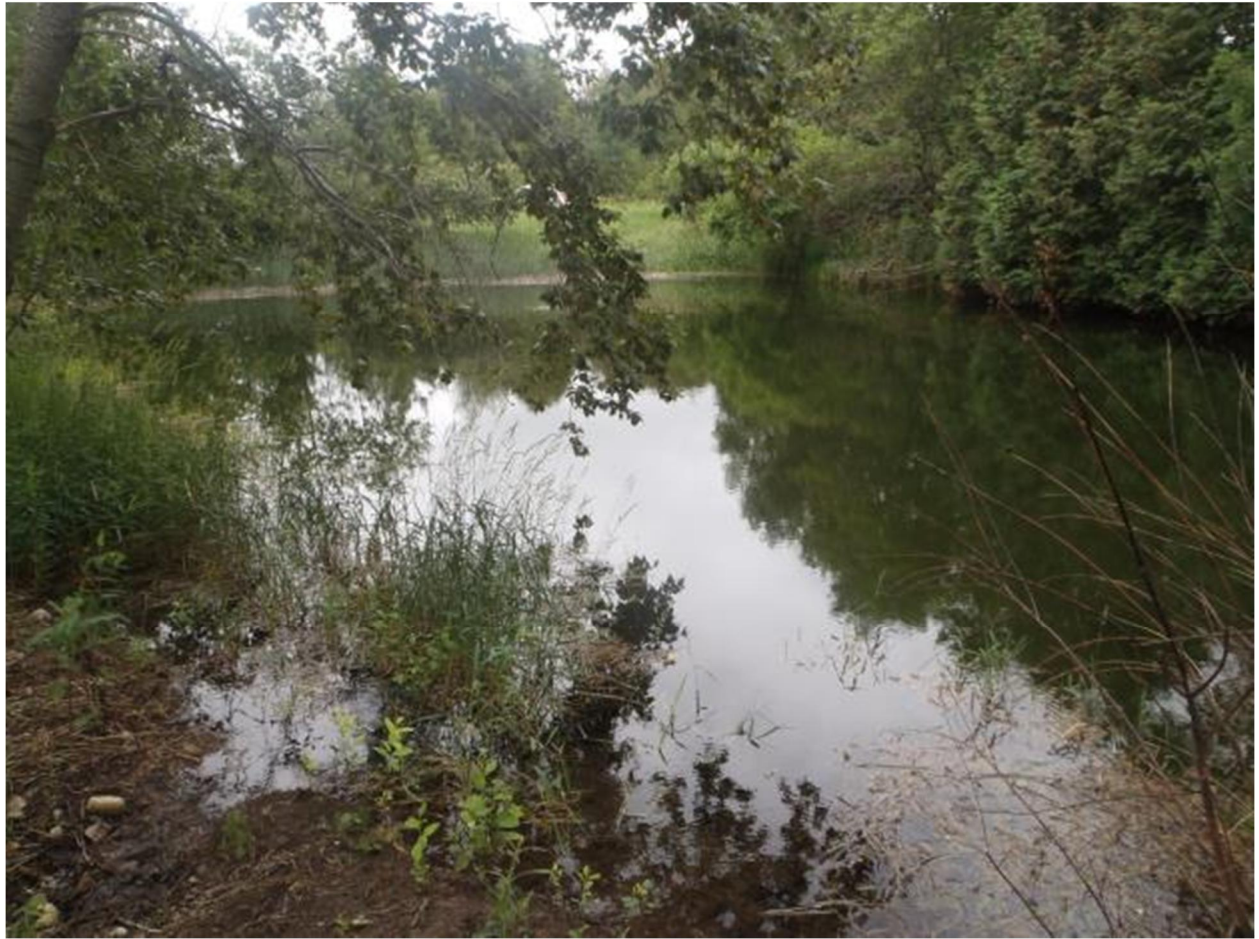
Photograph 10, facing east. Location of Potential Water Body 11, determined to be a dugout pond.

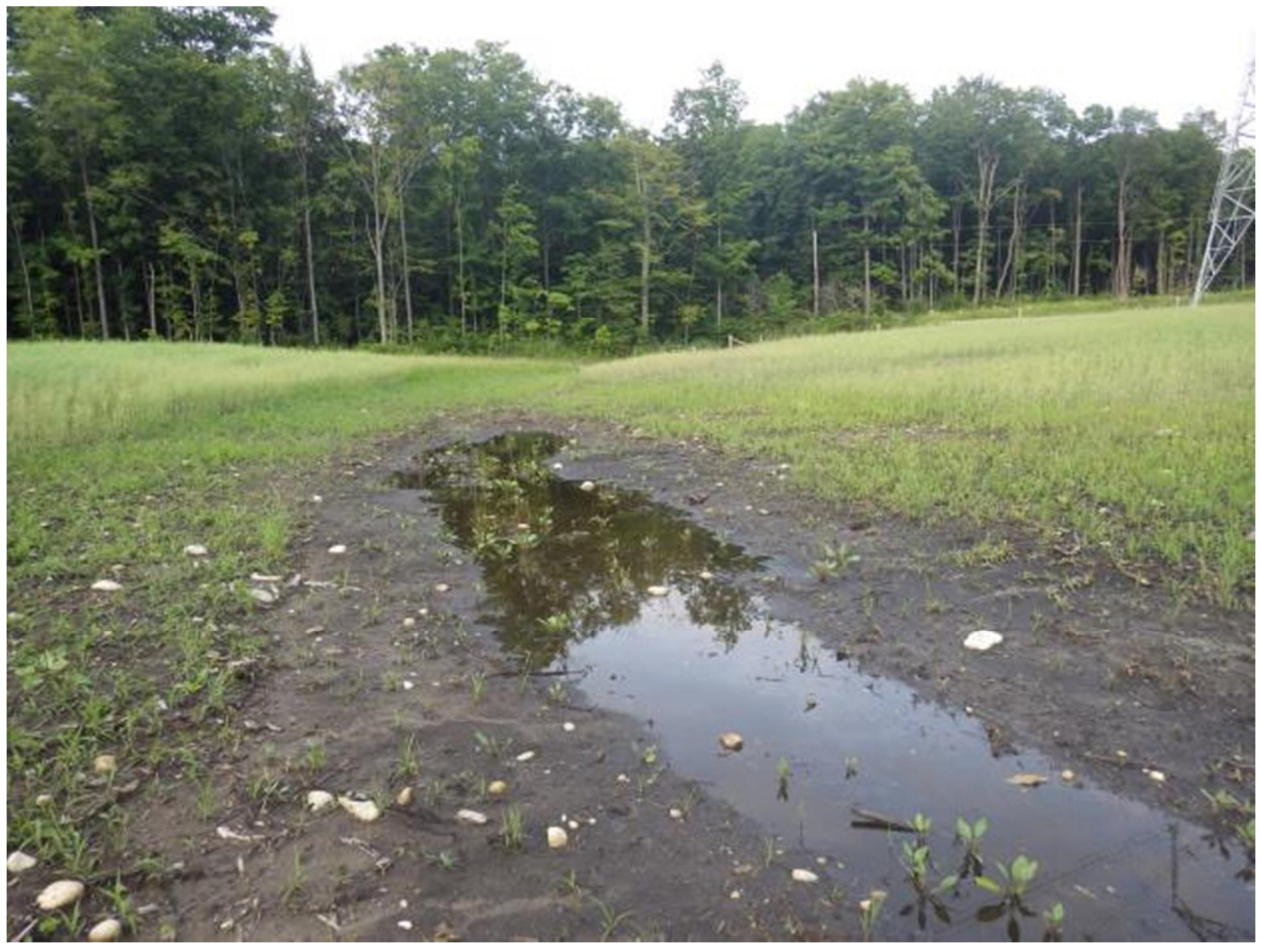
Photograph 11, facing south. Location of Potential Water Body 12, determined to be a temporary channel for surface drainage that can be tilled and driven through.

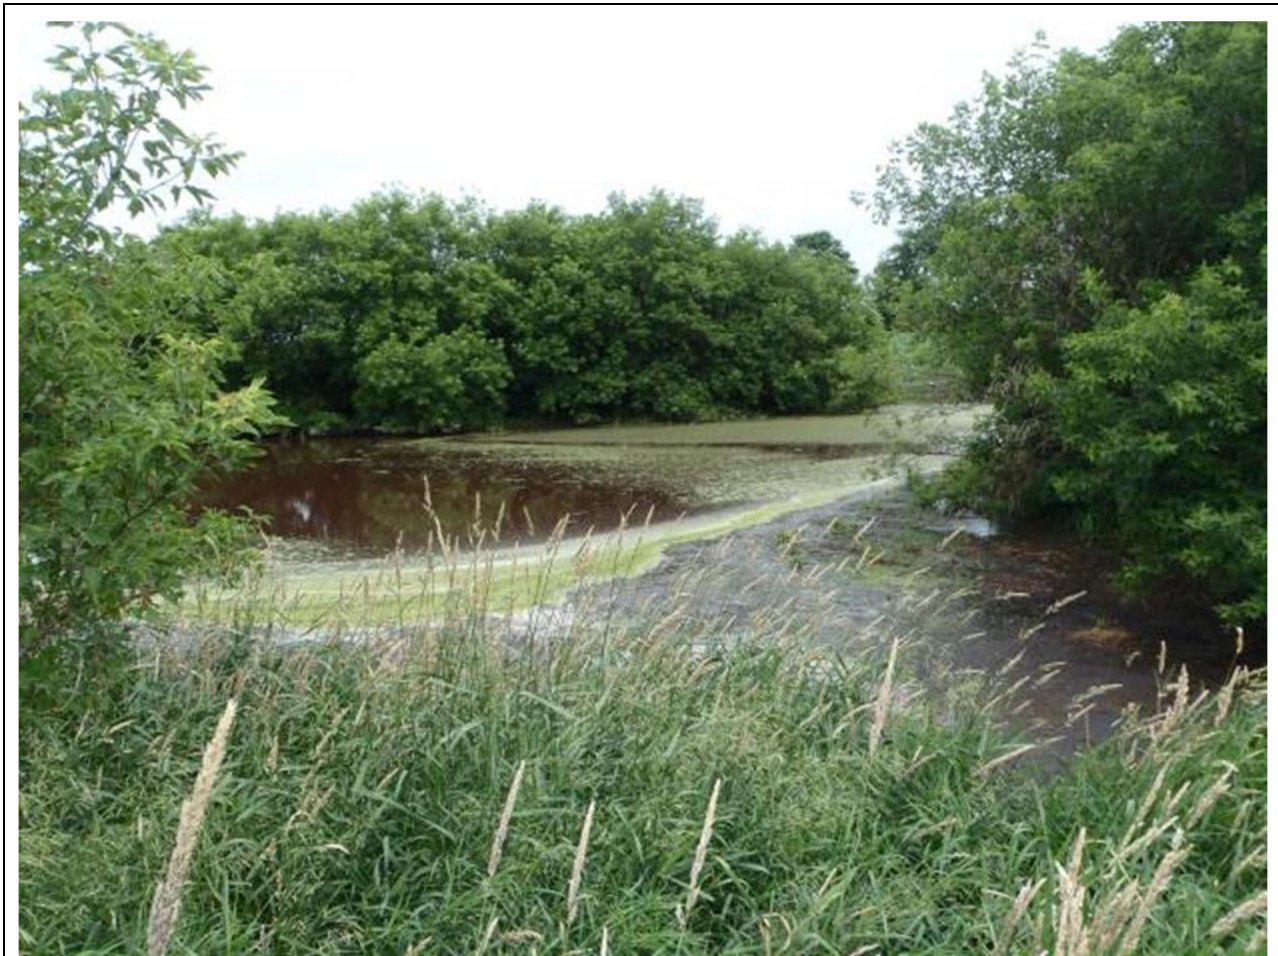
Photograph 12, facing east. Location of Potential Water Body 13, determined to be a dugout pond intended for the storage, treatment or recirculation of runoff from a farm animal yard.

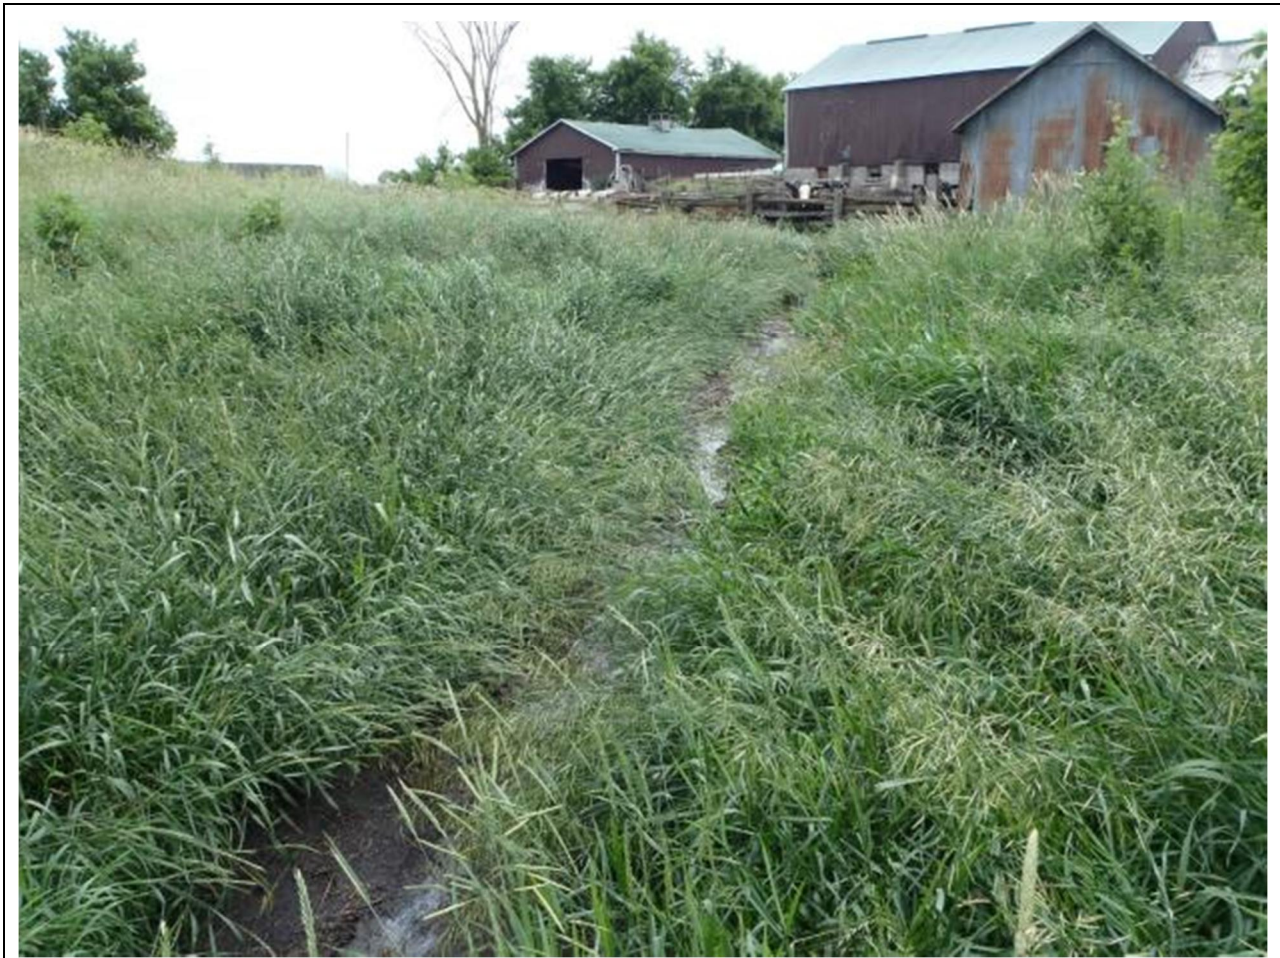
Photograph 13, facing west. Channel of runoff from a farm animal yard located approximately 50 m west of and flowing into Potential Water Body 13, determined to be a dugout pond.

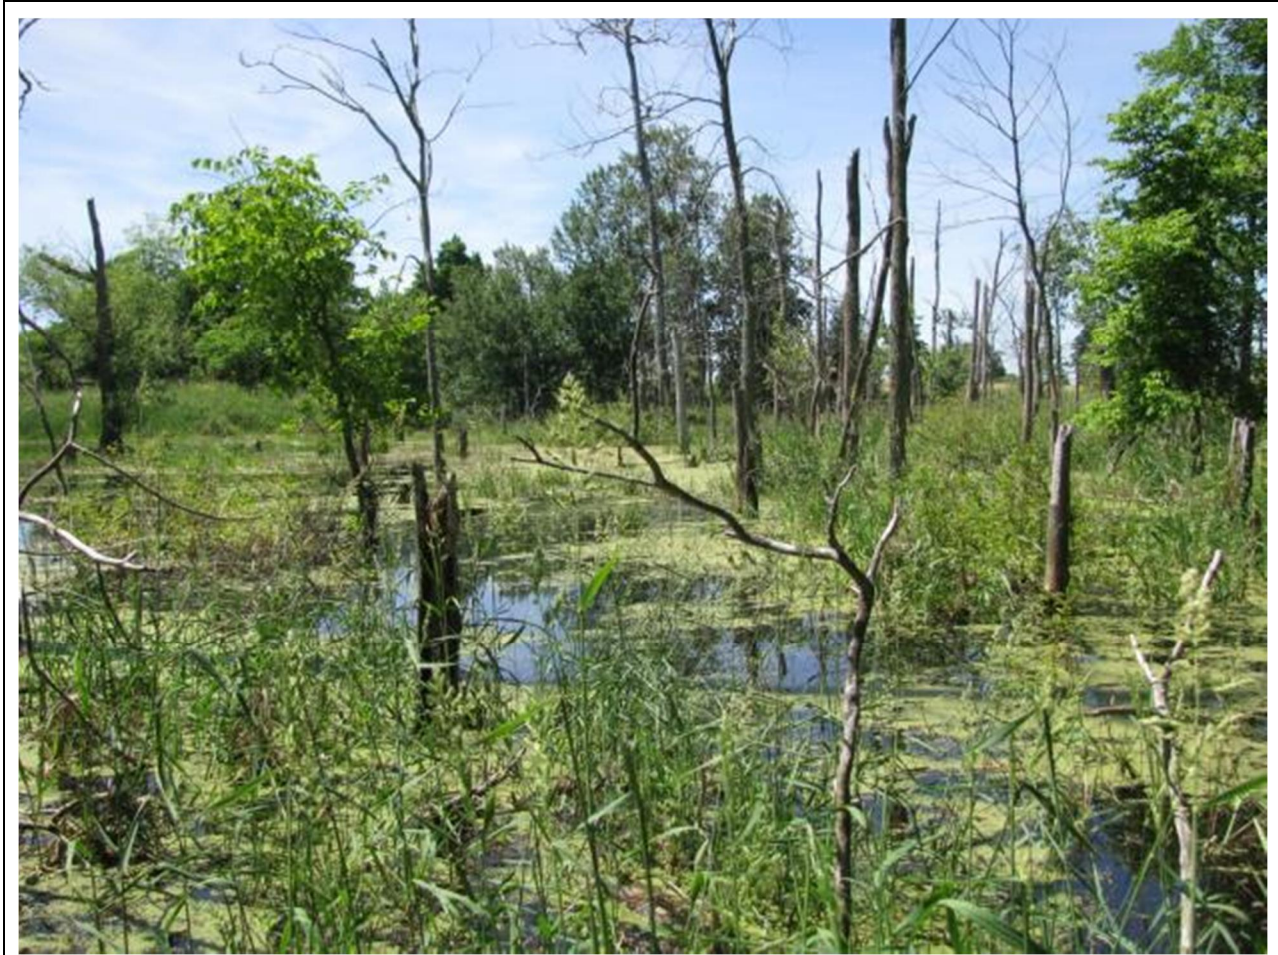
Potential Water Body 14 was determined during the site investigation to be an area of shallow open water that is part of a wetland. It was observed to be connected to Potential Water Body 15, and collectively this area is part of the same wetland (see Photograph 14 in *Appendix D*).

Potential Water Body 15 was determined during the site investigation to be an area of shallow open water that is part of a wetland. It was observed to be connected to Potential Water Body 14, and collectively this area is part of the same wetland (see Photograph 14 in *Appendix D*).

Photograph 14, facing west. Location of Potential Water Body 14 and Potential Water Body 15, determined to collectively be an area of shallow water that is part of a wetland.

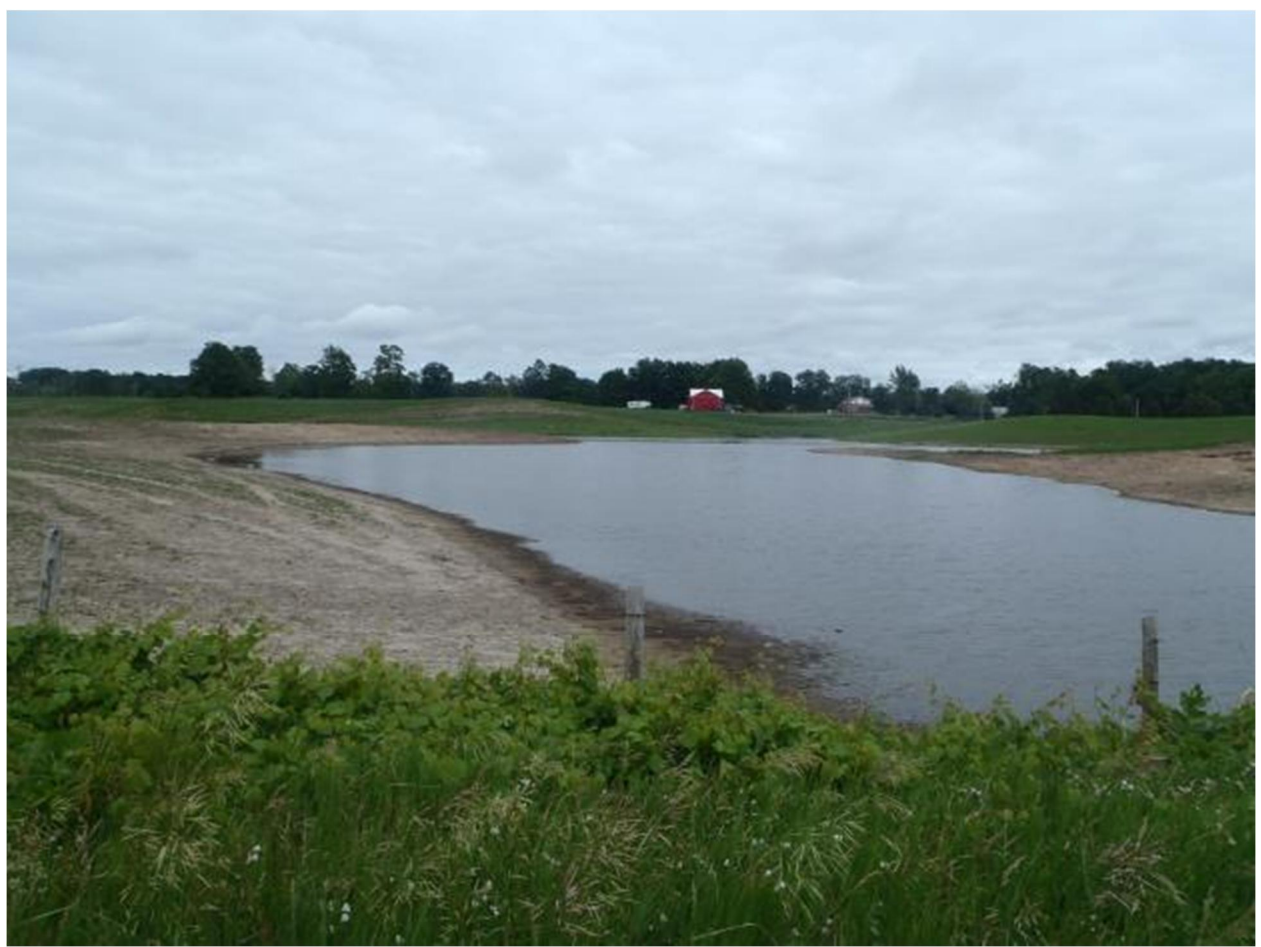
Potential Water Body 16 was determined during the site investigation to be a dugout pond intended for the storage, treatment or recirculation of runoff from a farm animal yard, and was observed to be connected to Potential Water Body 17 and Potential Water Body 18 (see Photograph 15 in *Appendix D*).

Potential Water Body 17 was determined during the site investigation to be a dugout pond intended for the storage, treatment or recirculation of runoff from a farm animal yard, and was observed to be connected to Potential Water Body 16 and Potential Water Body 18 (see Photograph 15 in *Appendix D*).

Potential Water Body 18 was determined during the site investigation to be a dugout pond intended for the storage, treatment or recirculation of runoff from a farm animal yard, and was observed to be connected to Potential Water Body 16 and Potential Water Body 17 (see Photograph 15 in *Appendix D*).

Photograph 15, facing east. Location of Potential Water Body 16, Potential Water Body 17 and Potential Water Body 18, determined to collectively be a dugout pond intended for the storage, treatment or recirculation of runoff from a farm animal yard.

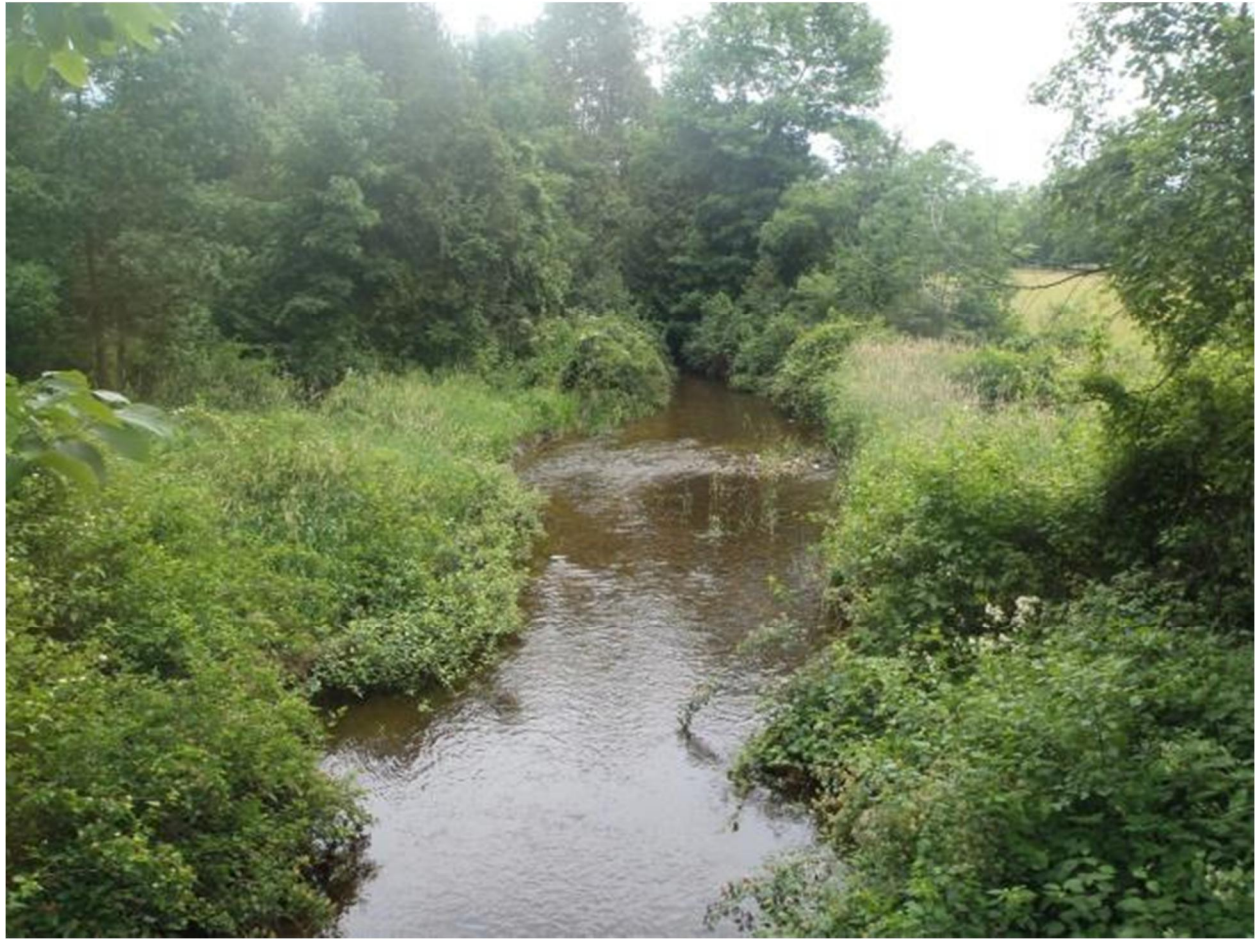
Photograph 16, facing east. The Beatty Saugeen River observed from the bridge at Southgate Side Road 41, flowing westward.

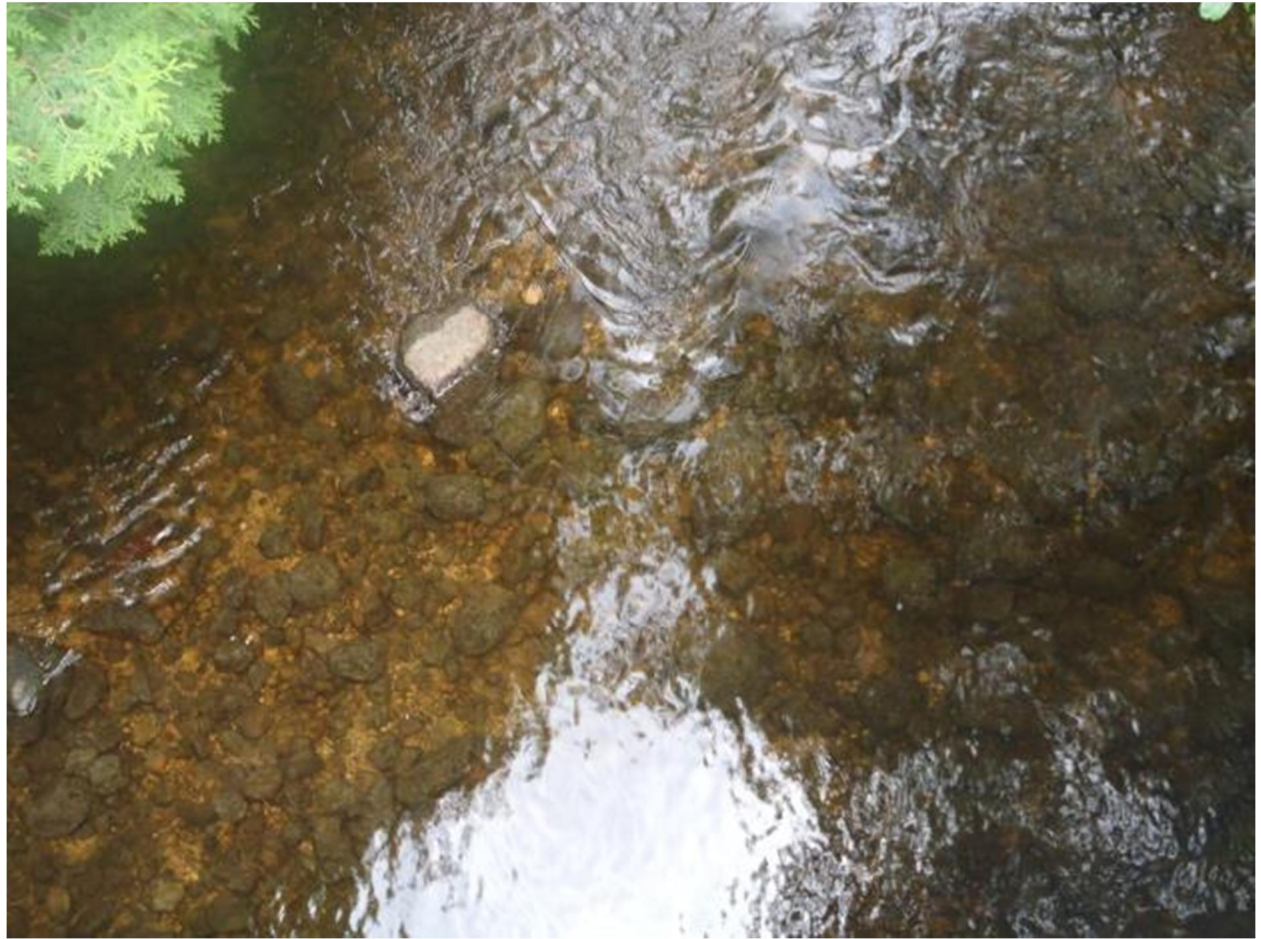
Photograph 17. The Beatty Saugeen River observed near the bridge at Southgate Side Road 41, showing substrates of boulders, cobbles gravel and sand, and with riffles.

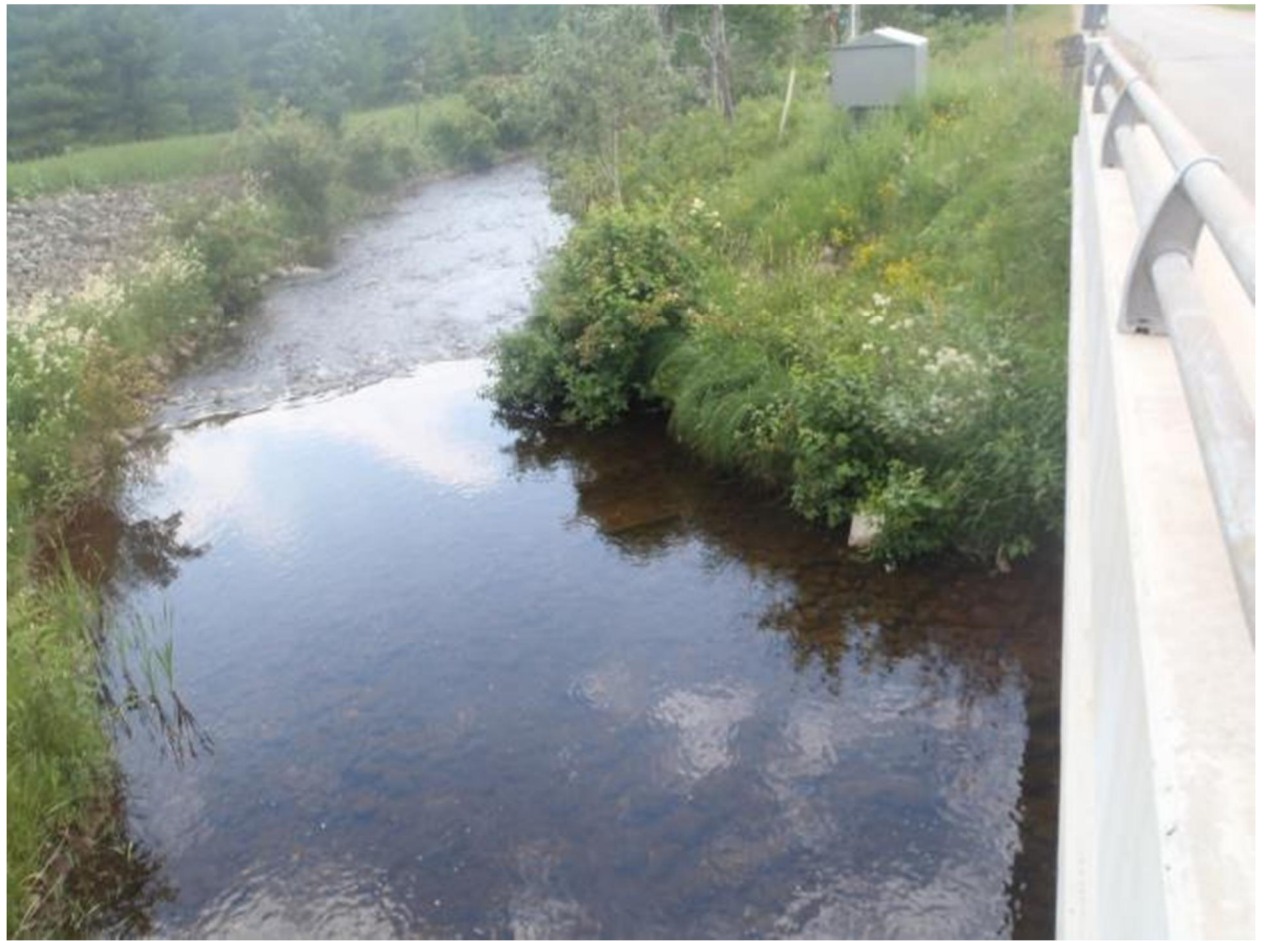
River's crossing with Grey Road 9, located approximately 400 m upstream and northeast of Southgate Side Road 41 (approximately 420 m east of the Project Location; Photograph 18 in *Appendix D*). The second location was approximately 2.1 km upstream and northeast of Southgate Side Road 41 (250 m south of the Project Location; Photograph 19 in *Appendix D*). The River conditions observed at these two additional locations were comparable to the conditions observed near Southgate Side Road 41.

Photograph 18, facing west. Beatty Saugeen River immediately south of the bridge on Grey Road 9, located approximately 420 m east of the project location.
