WATER ASSESSMENT REPORT

Southgate Solar Project

April 2015

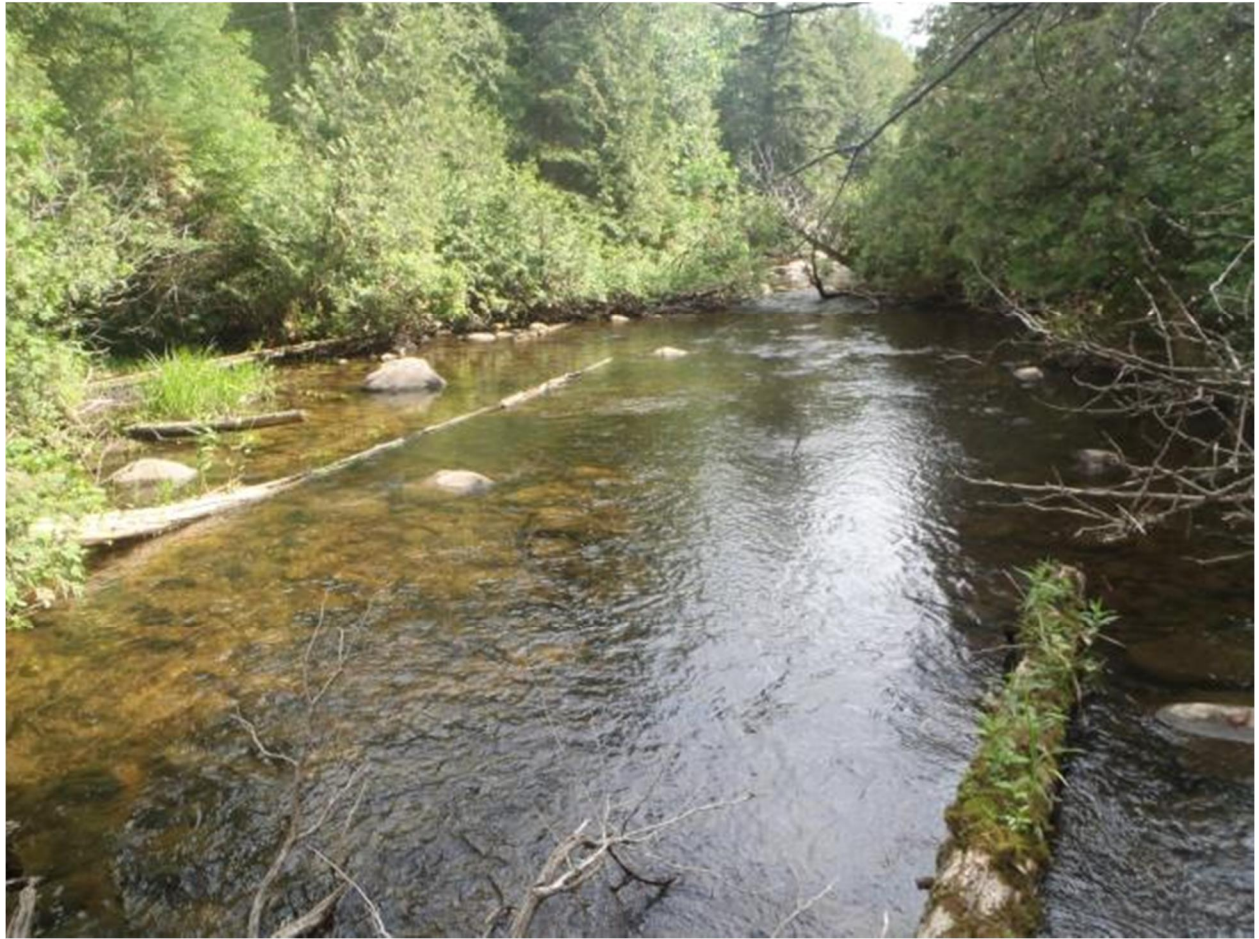
Photograph 19, facing southwest. Beatty Saugeen River flowing southwest approximately 250 m south of the project location.

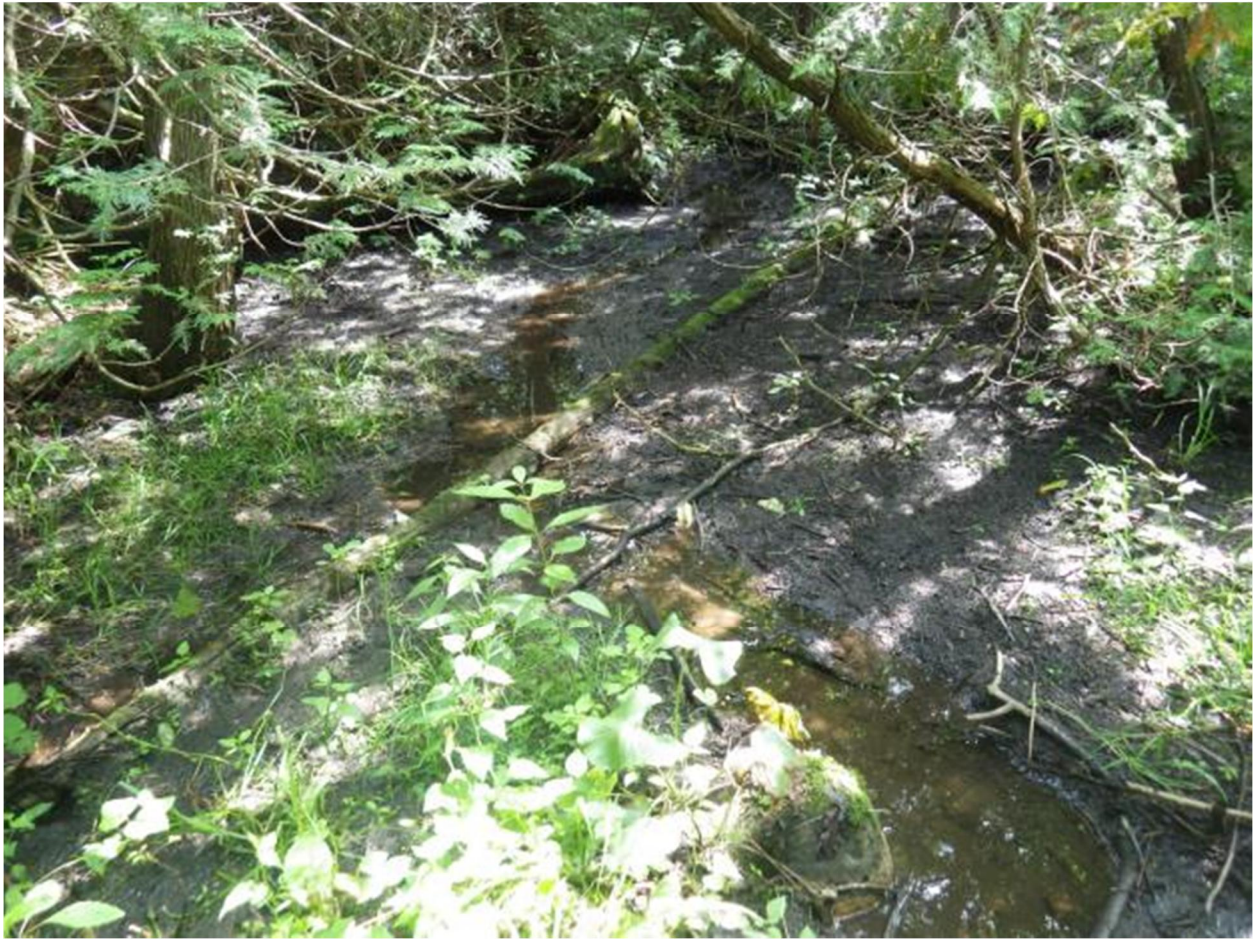
Tributary 1 was observed to be a natural intermittent stream within an associated wetland. Habitat type was a flat morphology type near the origin (Photograph 20 in *Appendix D*), and transitioned to a run morphology type downstream of the origin (Photograph 21 in *Appendix D*). Water flow was steady in the area of run morphology at the time of assessment. Substrates were organic muck and detritus. Mean wetted width was 0.5 m, mean wetted depth was 0.2 m, mean bankfull width was 0.6 m and mean bankfull depth was 0.7 m (widths and depths are approximate).

Photograph 20, facing south. Tributary 1 to the Beatty Saugeen River, near its origin.

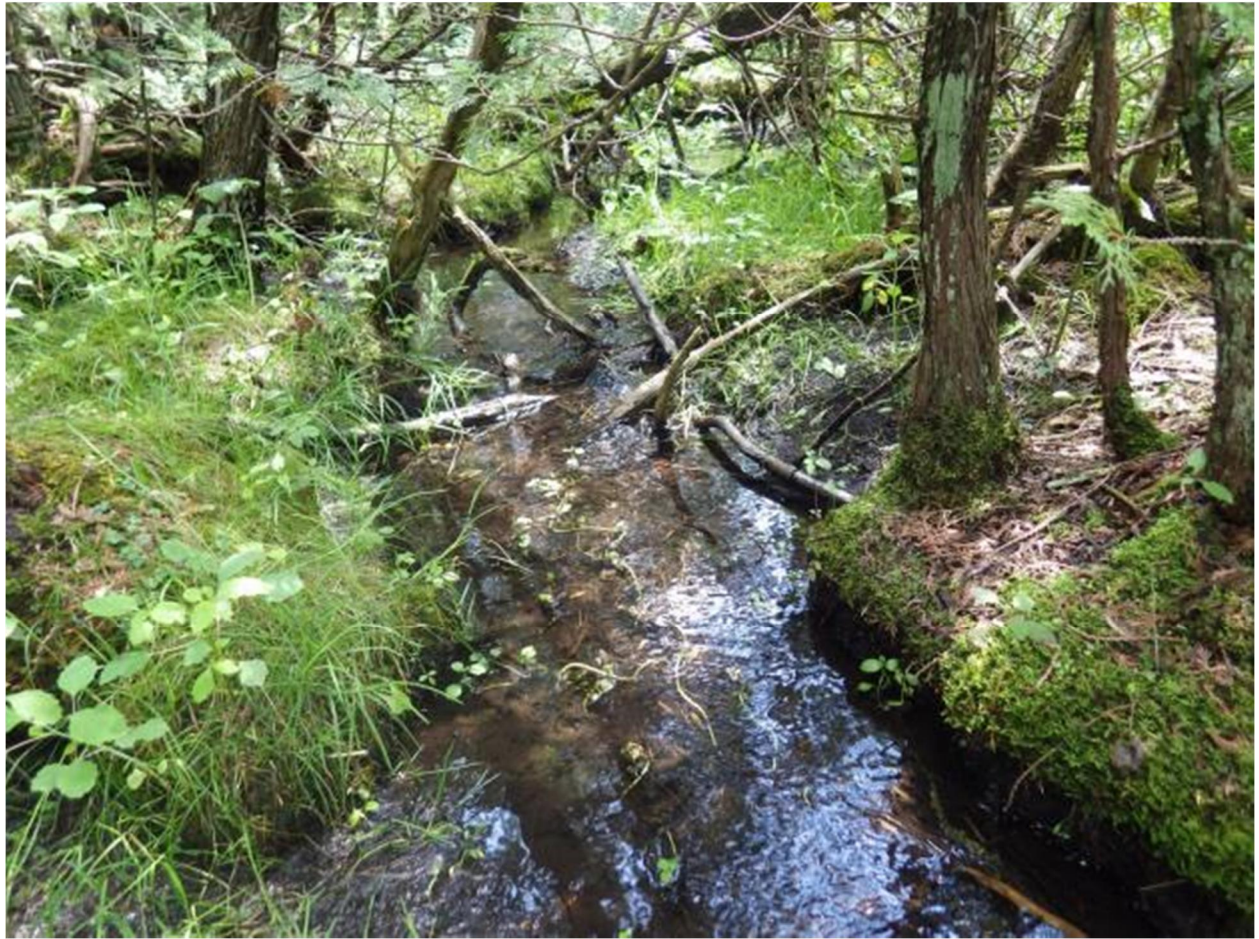
Photograph 21, facing south. Tributary 1 to the Beatty Saugeen River, approximately 100 m south of its origin, near where its morphology type transitioned from a flat to a run type.

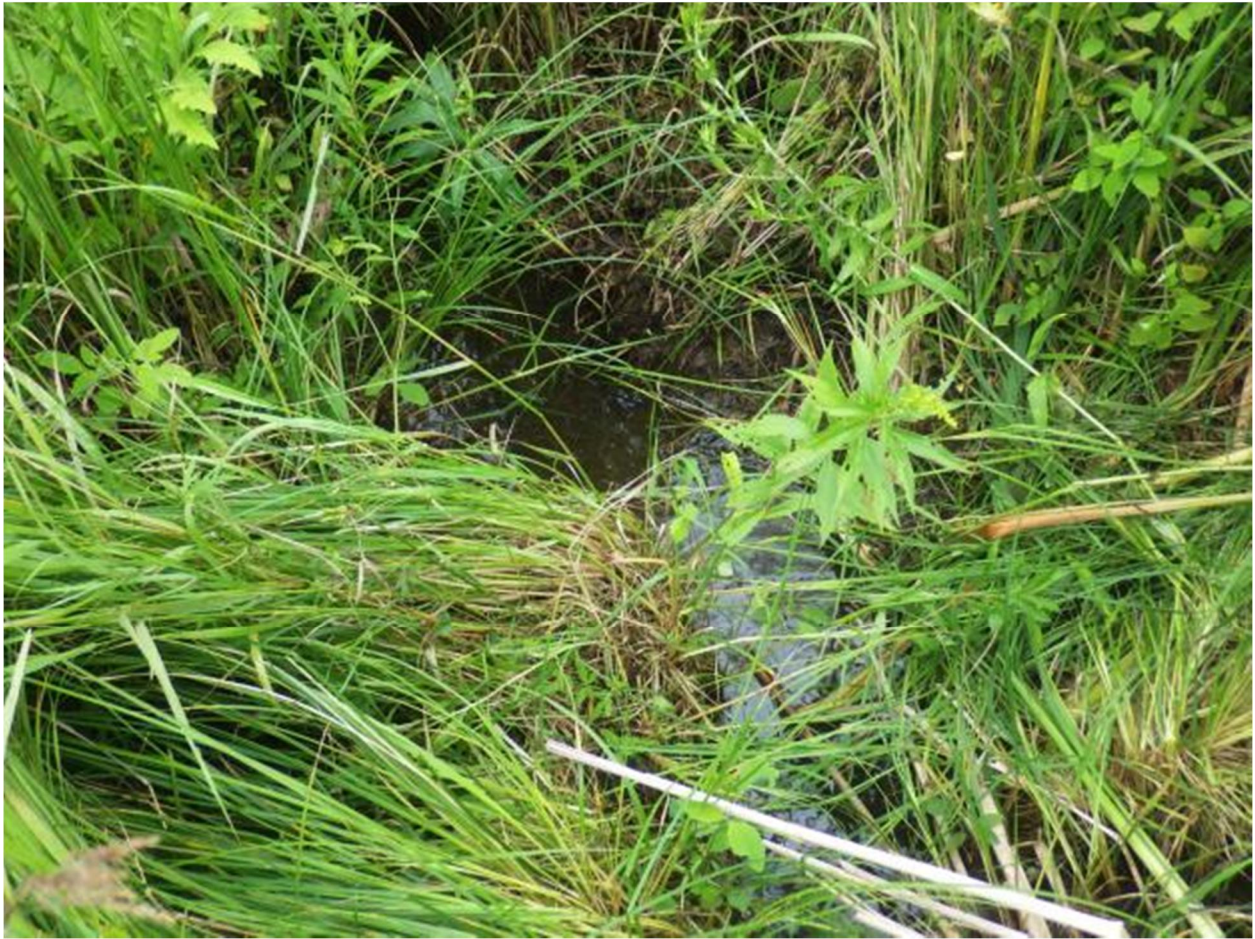
Tributary 2 was observed to be a natural intermittent stream within an associated wetland. Habitat type was a flat morphology type with minimal observable flow at the time of site investigation (Photograph 22 and Photograph 23 in *Appendix D*). Substrates were predominantly organic detritus overlying gravel and sand. Mean wetted width was 0.2 m, mean wetted depth was 0.1 m, mean bankfull width was 0.3 m and mean bankfull depth was 0.2 m (widths and depths are approximate). Banks showed no significant evidence of erosion or vulnerability to erosion. Stream cover was pre-dominantly from dense in-stream and overhanging vegetation and woody debris. The vegetation was pre-dominantly aquatic grasses and cattails (*Typha sp*). The stream surface was approximately 90 – 100% shaded by shore cover. The stream crossed under Grey Road 9 via a corrugated steel pipe (CSP) culvert with a diameter of 1.2 m (Photograph 24 in *Appendix D*). Water depth in the culvert at its upstream end was approximately 0.05 m (Photograph 25 in *Appendix D*), and at its downstream end was approximately 0.1 m. No obstructions to fish migration or spawning were observed along the assessed portion of the stream. The riparian vegetation community surrounding the stream was a cedar swamp wetland.

Photograph 22. Tributary 2 to the Beatty Saugeen River, immediately south of Grey Road 9 within the project location 120 m setback.

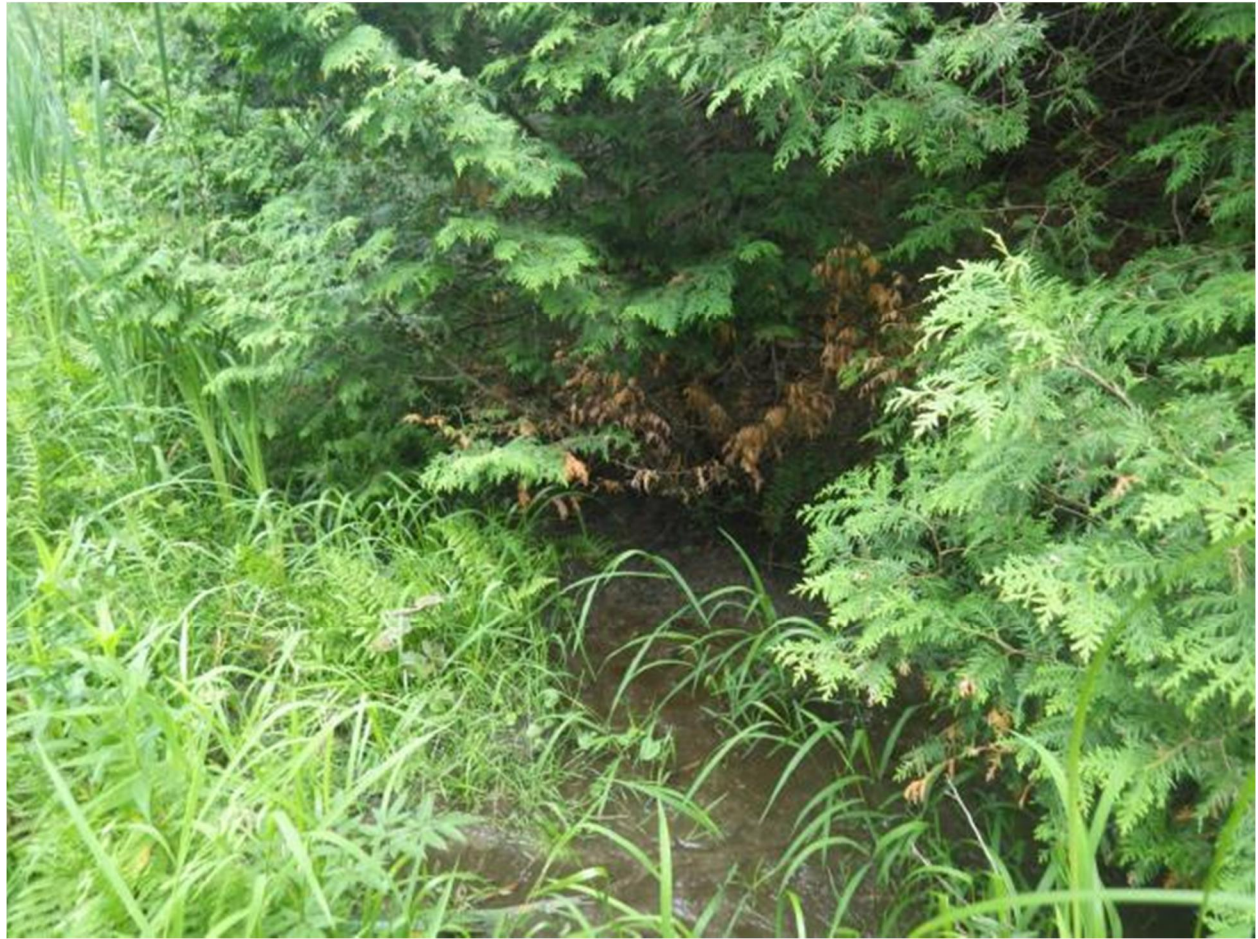
Photograph 23, facing east. Tributary 2 to the Beatty Saugeen River, immediately north of Grey Road 9 within the project location 120 m setback.

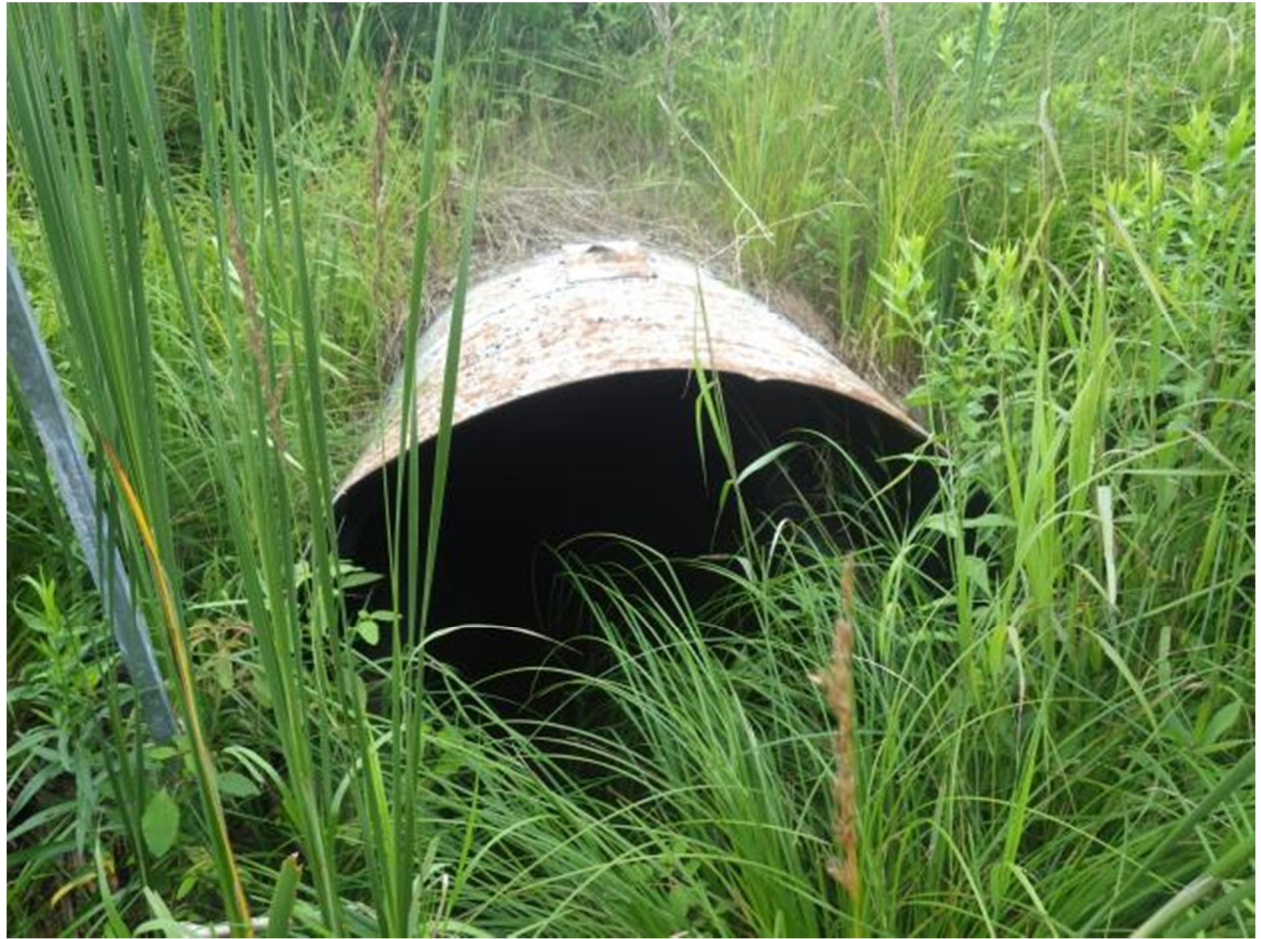
Photograph 24, facing north. Tributary 2 to the Beatty Saugeen River, flowing southward within the project location, under Grey Road 9 via a CSP culvert.

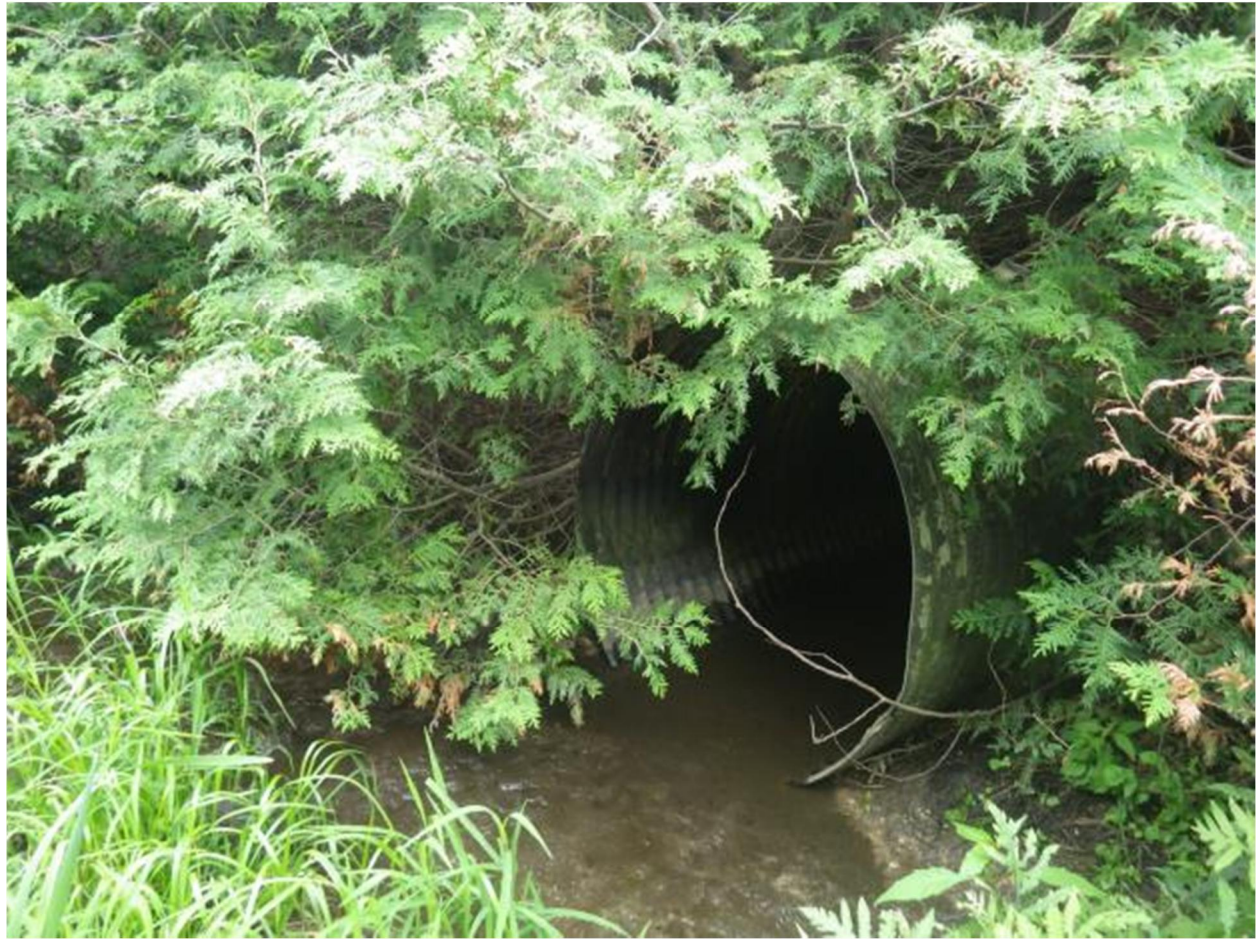
Photograph 25, facing southeast. Tributary 2 to the Beatty Saugeen River, immediately north of Grey Road 9.

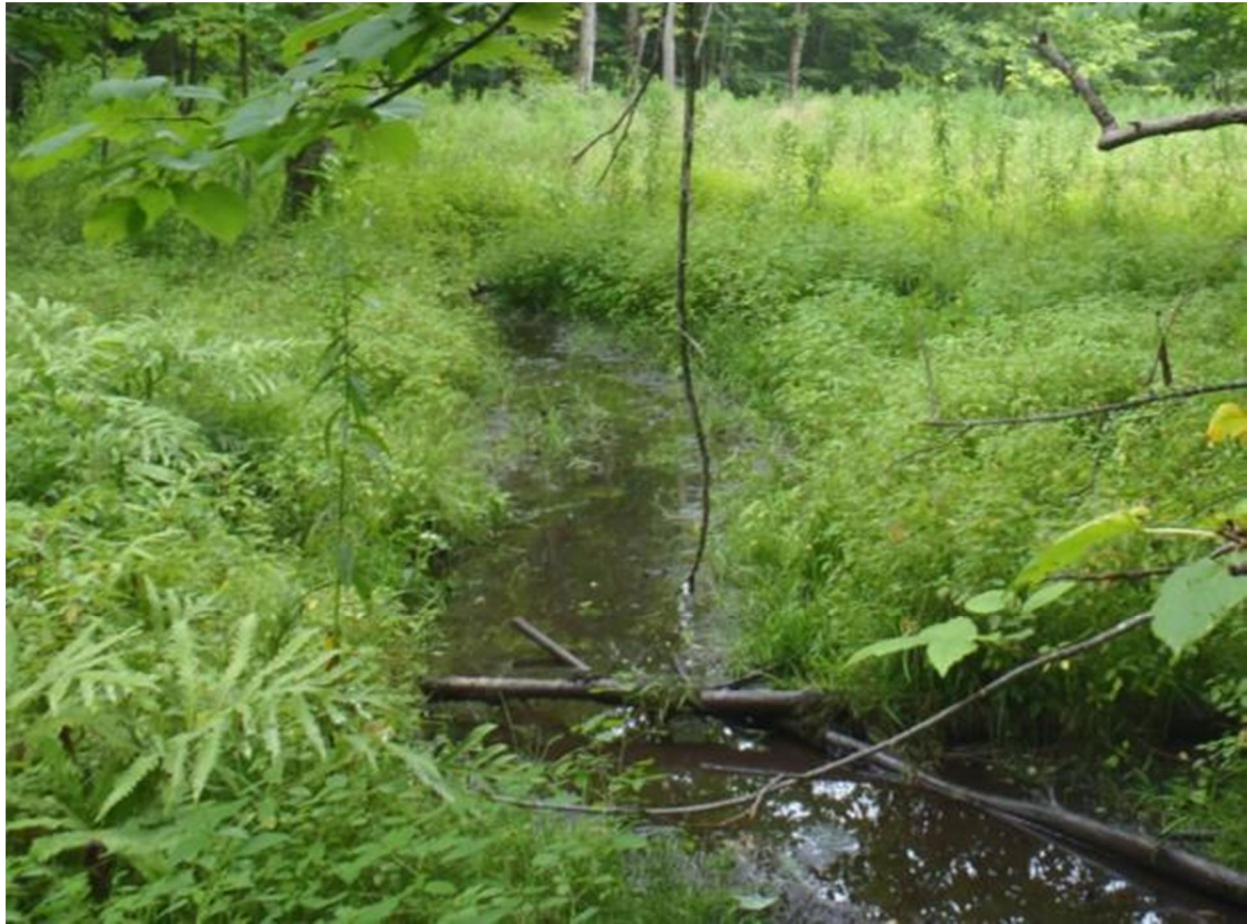
Stream 1 was observed to be a natural intermittent stream. Habitat type was a flat morphology type with minimal observable flow at the time of site investigation (Photograph 26 in *Appendix D*). Substrates were pre-dominantly organic detritus. Mean wetted width was 0.7 m, mean wetted depth was 0.2 m, mean bankfull width was 0.9 m and mean bankfull depth was 0.3 m (widths and depths are approximate). Stream cover was pre-dominantly from dense overhanging vegetation, with sparse areas of woody debris. The vegetation was pre-dominantly Touch-me-not species (*Impatiens sp*).

Photograph 26, facing southeast. Unnamed Stream 1.

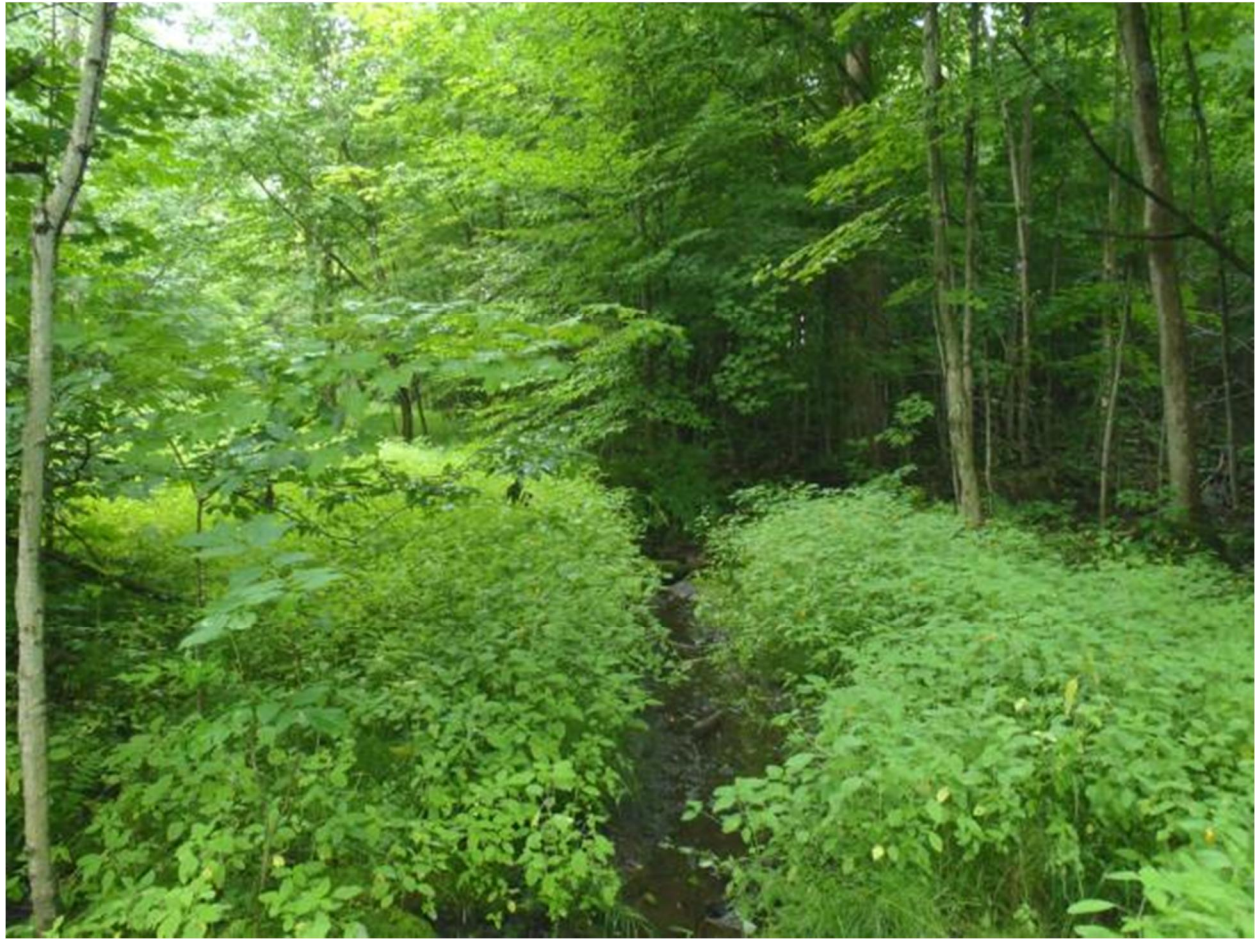
Photograph 27, facing south. Unnamed Stream 1 at the south-western perimeter of the surrounding wetland, where the stream dissipates.

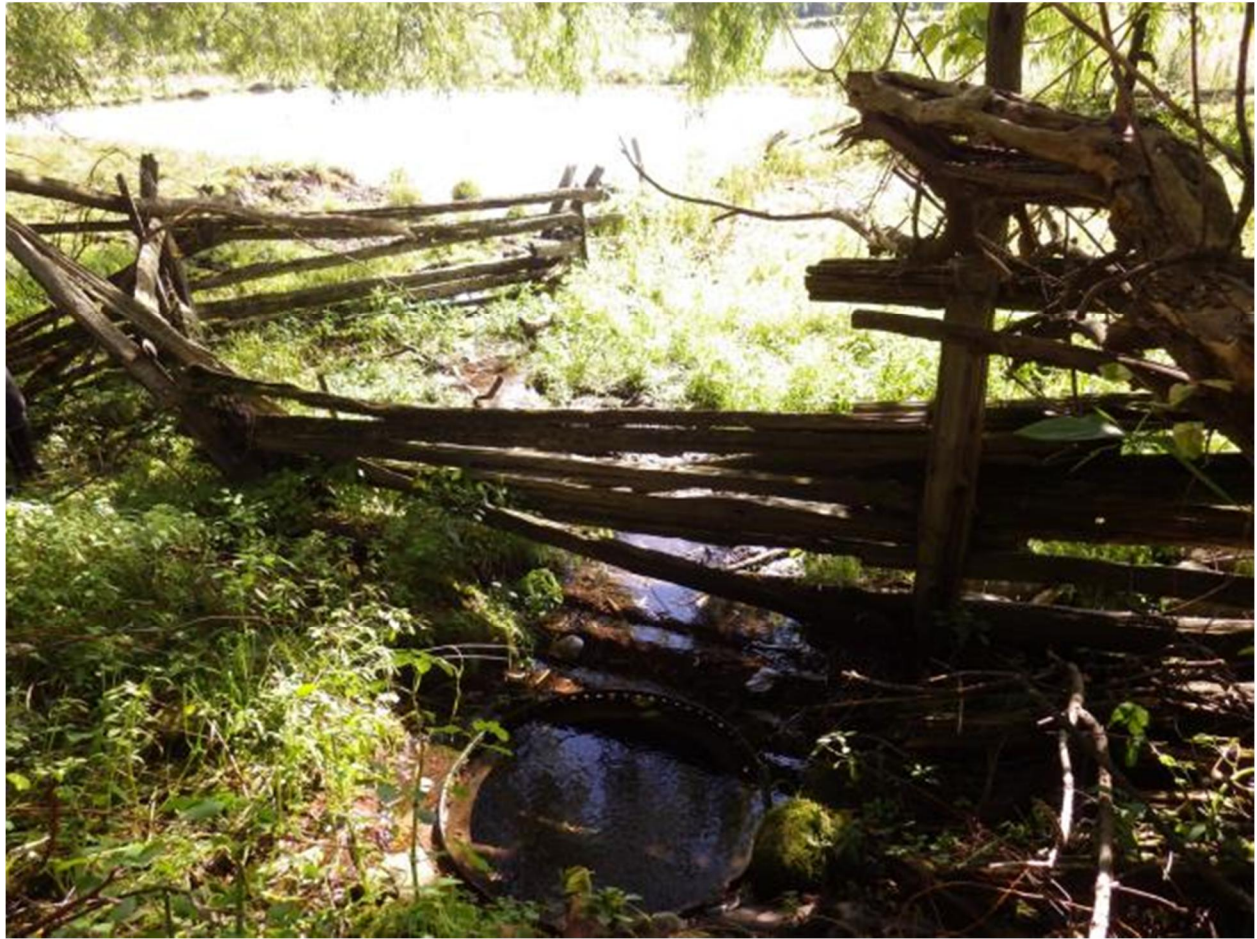
Photograph 28, facing southwest. Unnamed Stream 2 originating from Seepage Area 1 (contained within the circular steel ring in the foreground) and flowing south-westward approximately 10 m into a dugout pond (Potential Water Body 2; background of photograph).

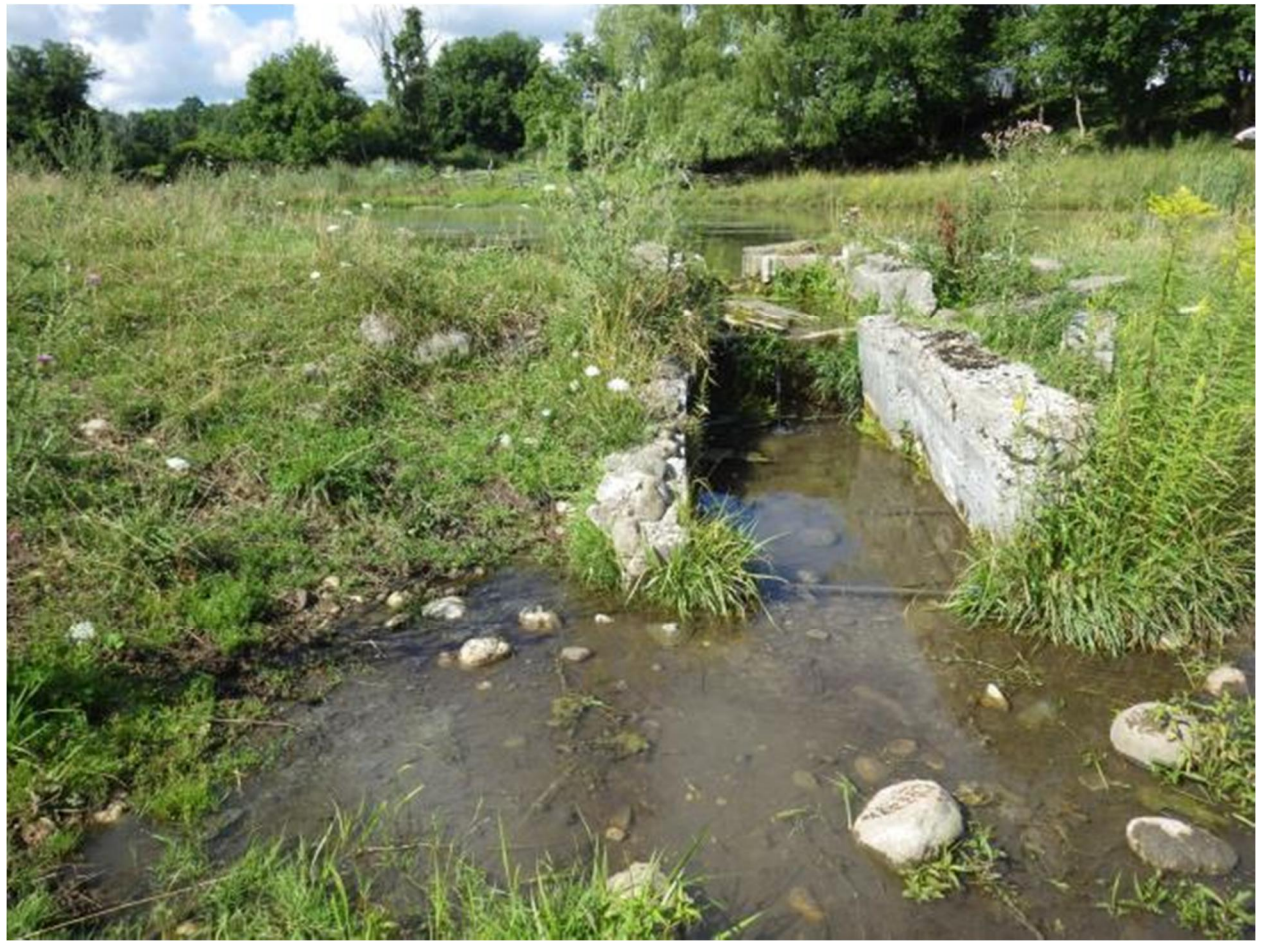
Photograph 29, facing northeast. Unnamed Stream 2 flowing from a dug pond and over a concrete weir.

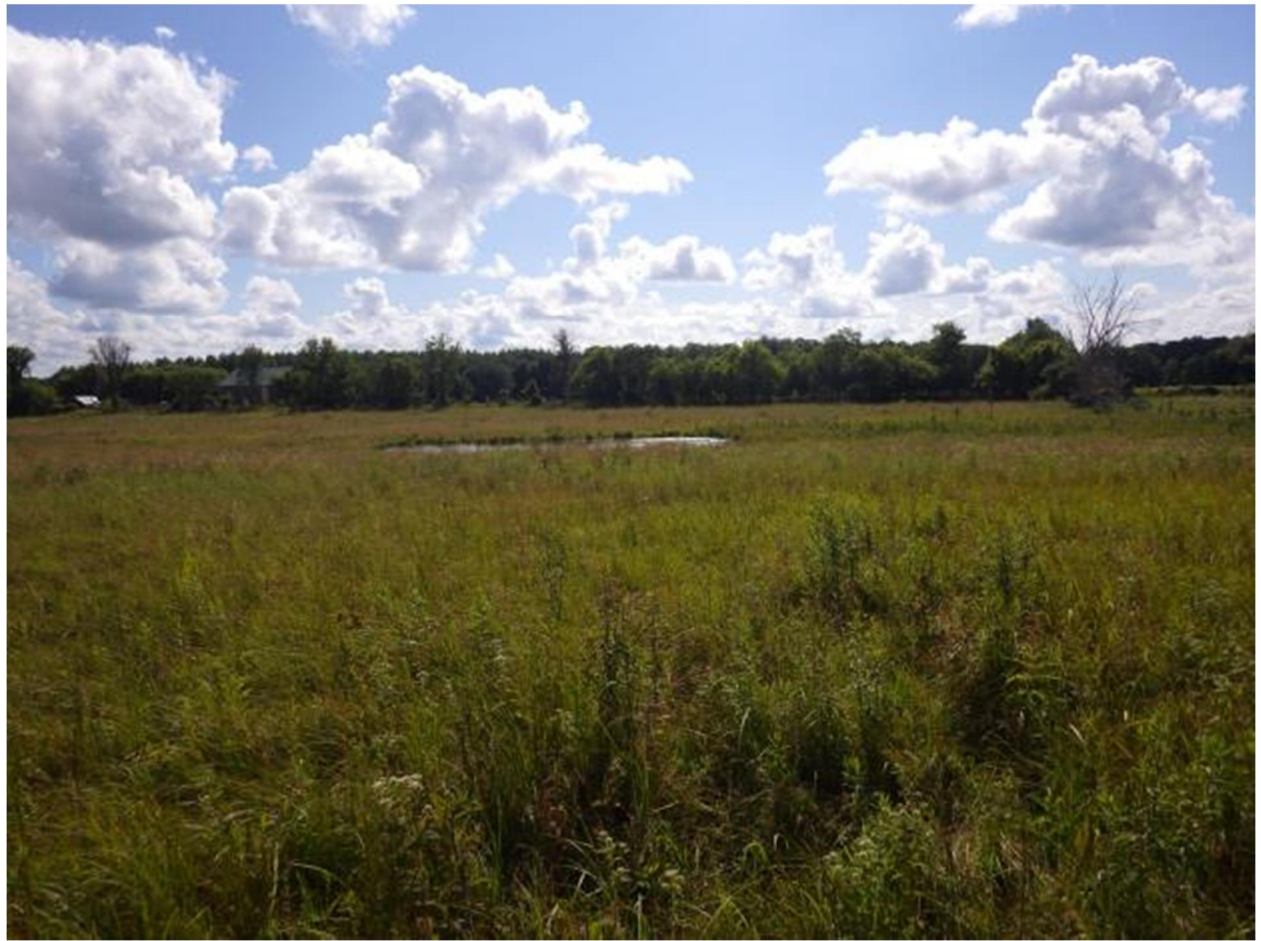
Unnamed Stream 2 (hereafter referred to as “Stream 2”) was not shown on the reviewed records (Table 2, Figure 3). It was found during the site investigation to occur within the 120 m setback. It originates from a groundwater seepage area (Seepage Area 1; Figure 4; see Photograph 28 in *Appendix D*) near a pasture. Stream 2 flows south-westward for approximately 10 m into a dugout pond (Potential Water Body 2; see Photograph 2 in *Appendix D*), empties from the pond over a concrete weir (approximately 1 m wide; Photograph 29 in *Appendix D*), continues generally southward for 70 m, forms a confluence with Unnamed Stream 3 from the east (see Section 9.3.6), continues generally southward for 60 m, then empties into and dissipates within an area of shallow water (approximately 30 m x 30 m) in a meadow marsh wetland (Photograph 30 in *Appendix D*; Figure 4).

Photograph 30, facing west. Meadow marsh wetland containing an area of shallow open water into which Unnamed Stream 2 flows and in which it dissipates.

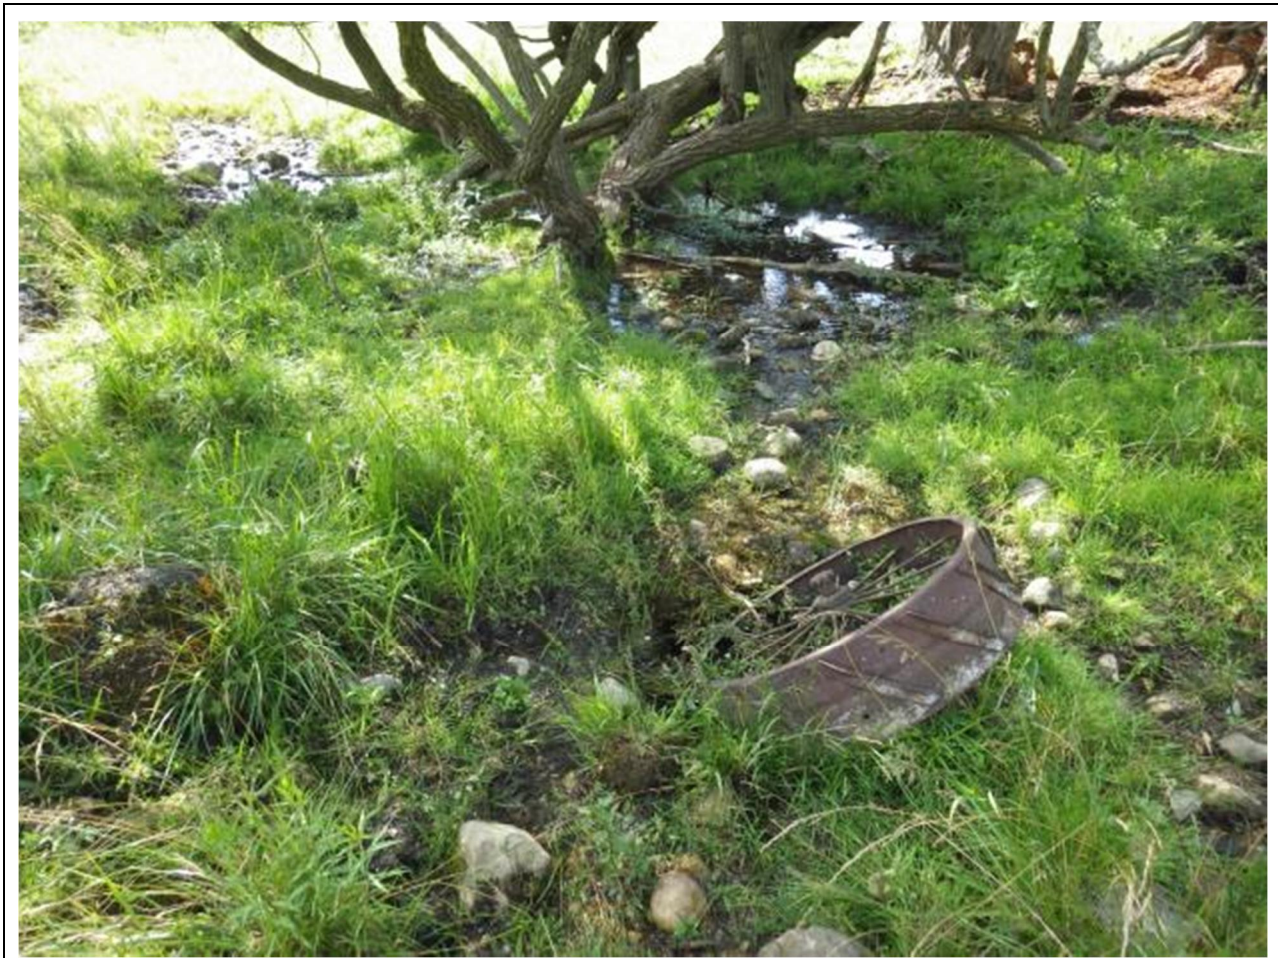
Photograph 31, facing west. Unnamed Stream 3 originating from Seepage Area 2 and flowing westward.

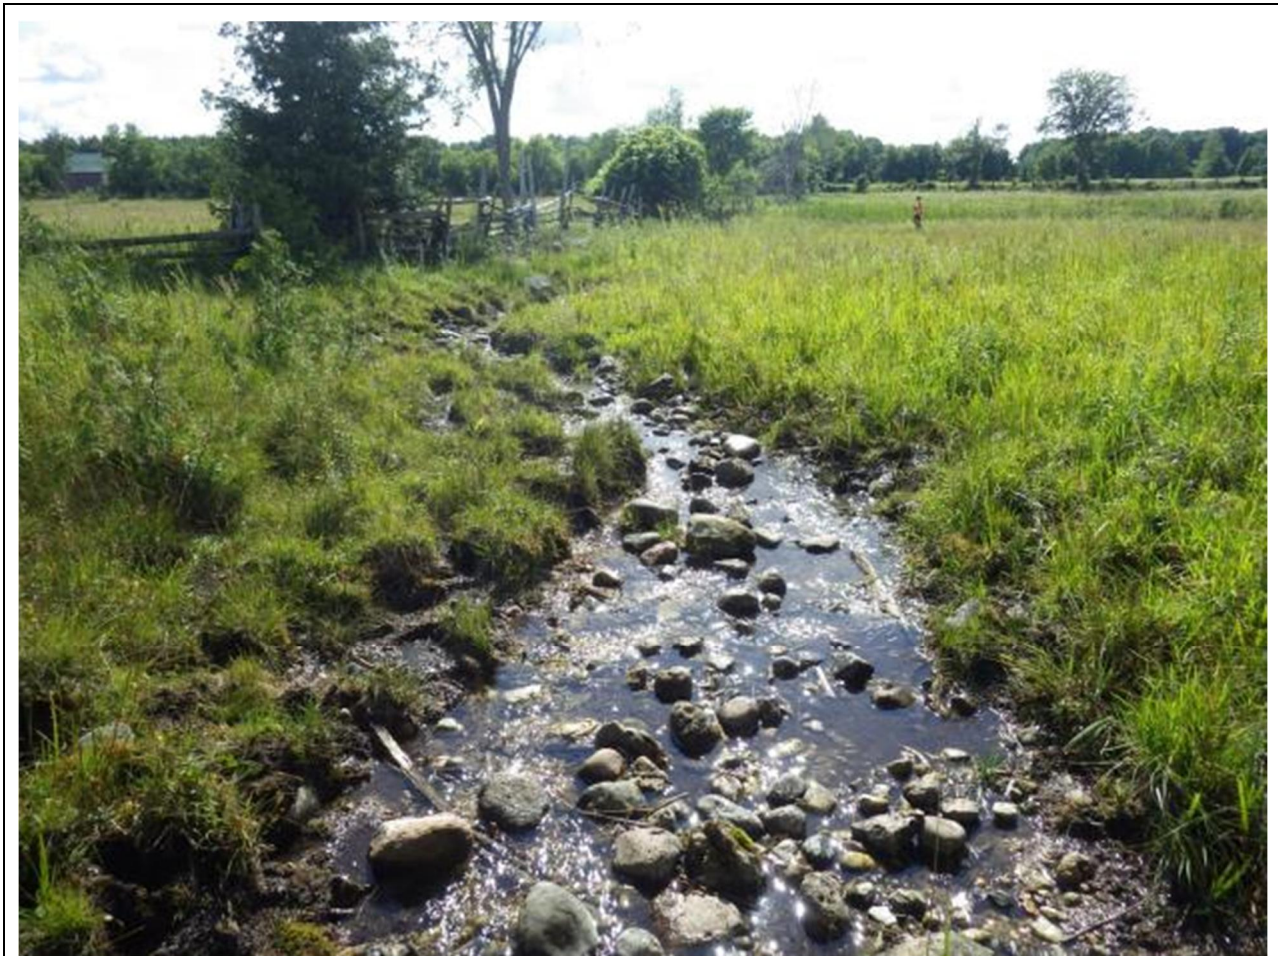
Unnamed Stream 3 (hereafter referred to as “Stream 3”) was not shown on the reviewed records (Table 2, Figure 3). It was found during the site investigation to occur within the 120 m setback. It originates from a groundwater seepage area (Seepage Area 2, Figure 4; see Photograph 31 in *Appendix D*) located approximately 120 m southeast of Seepage Area 1 in the same pasture. Stream 3 flows generally westward for approximately 100 m (Photograph 32 in *Appendix D*) and then forms a confluence with Stream 2 (Figure 4).

Photograph 32, facing west. Unnamed Stream 3 flowing westward toward its confluence with Unnamed Stream 2 (approximately 60 m into the foreground of the photograph).

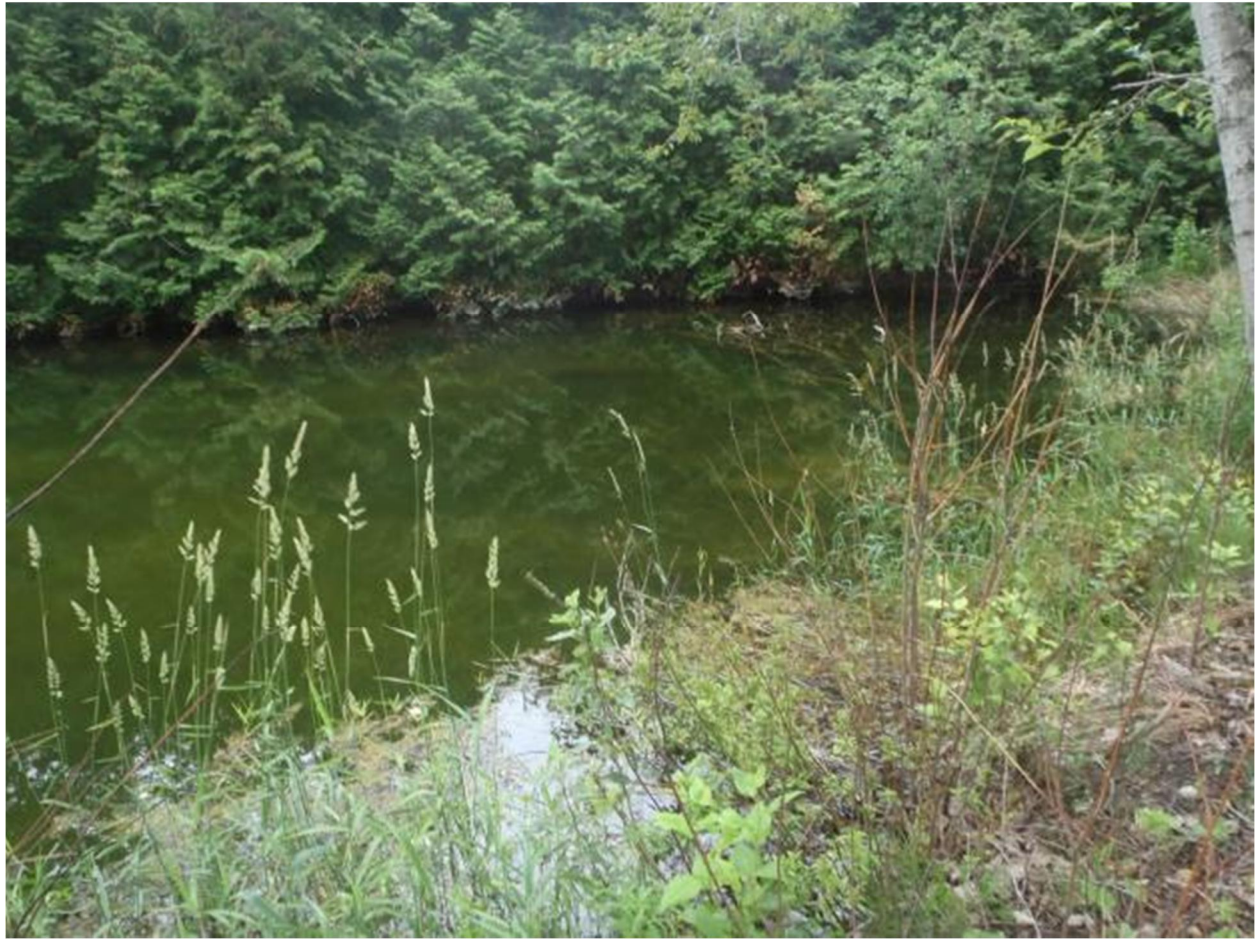
Photograph 33, facing south. Dugout pond (Potential Water Body 11), with an outlet on the southwest corner of the pond being the origin of Unnamed Stream 4.

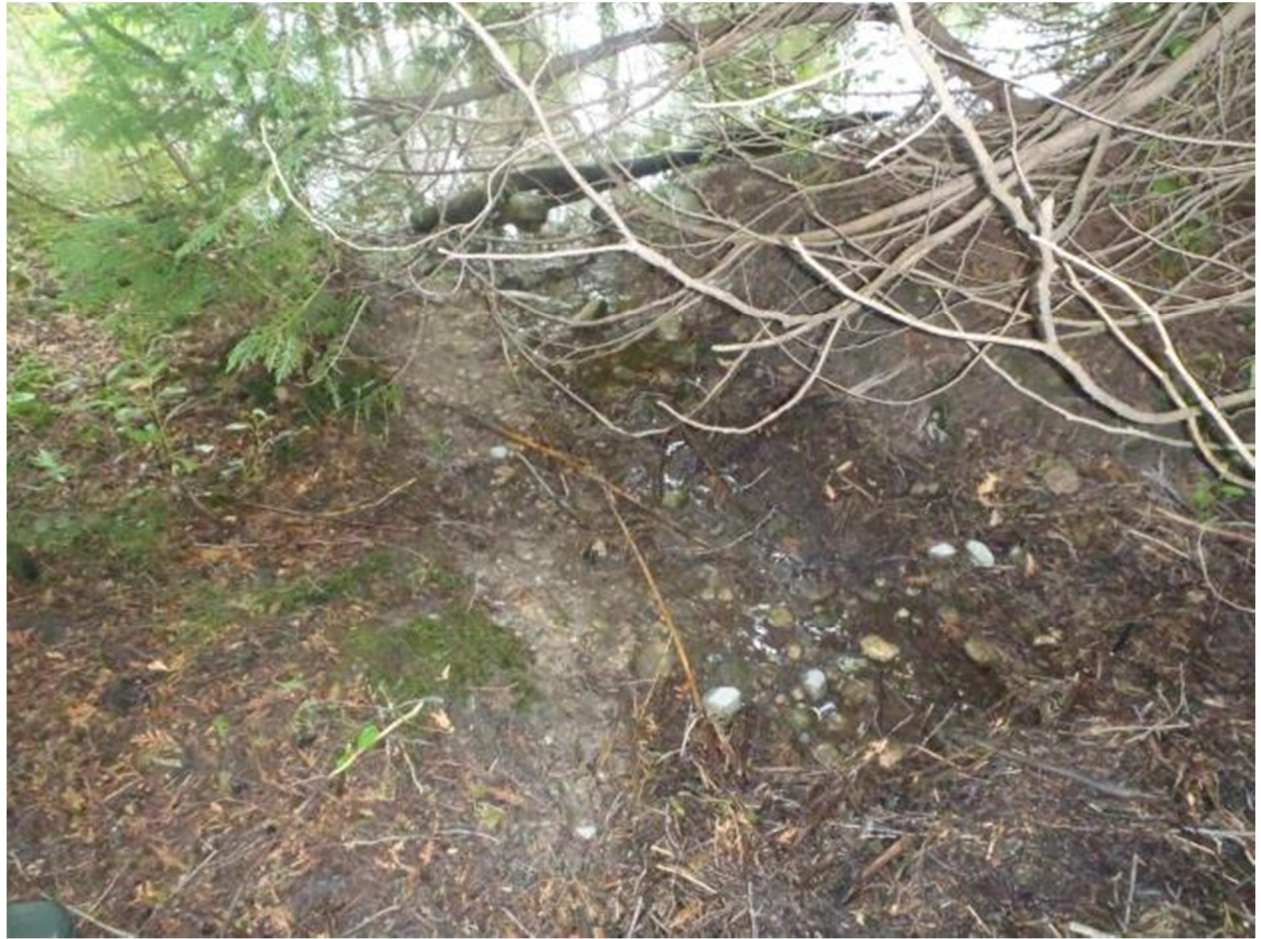
Photograph 34, facing northeast. The origin of Unnamed Stream 4, located at the southwest corner of a dugout pond (Potential Water Body 11).

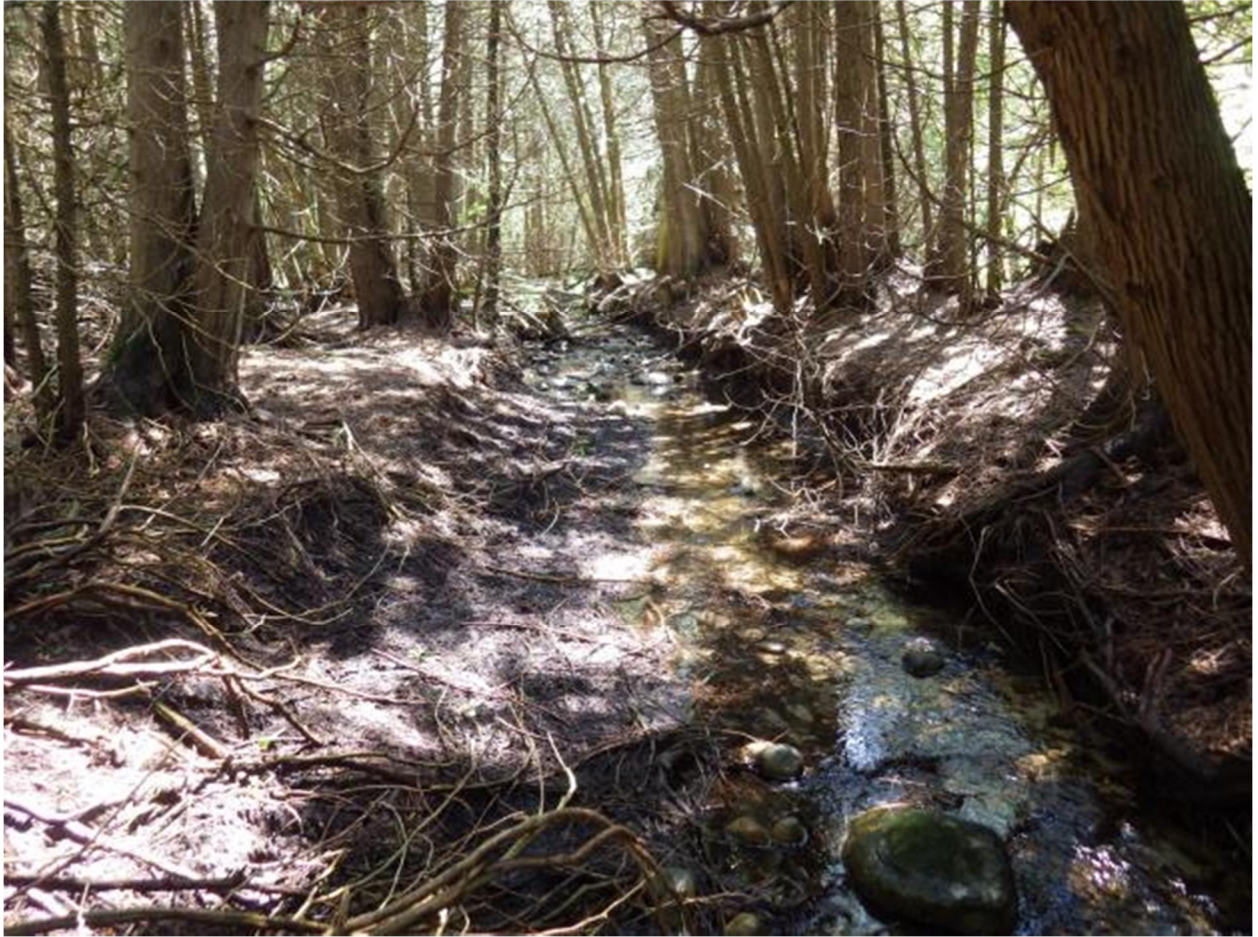
Stream 4 was observed to be a natural intermittent stream. At the origin of the stream (at the point of outflow from the dugout pond), water flow rate and volume was minimal at the time of assessment, and habitat morphology type was flat. As the stream proceeded through the swamp wetland, water flow rate and volume increased and habitat morphology type transitioned to a run (Photograph 35 in *Appendix D*).

Photograph 35, facing east. Unnamed Stream 4 flowing through a forested wetland, approximately 100 m west of its origin.

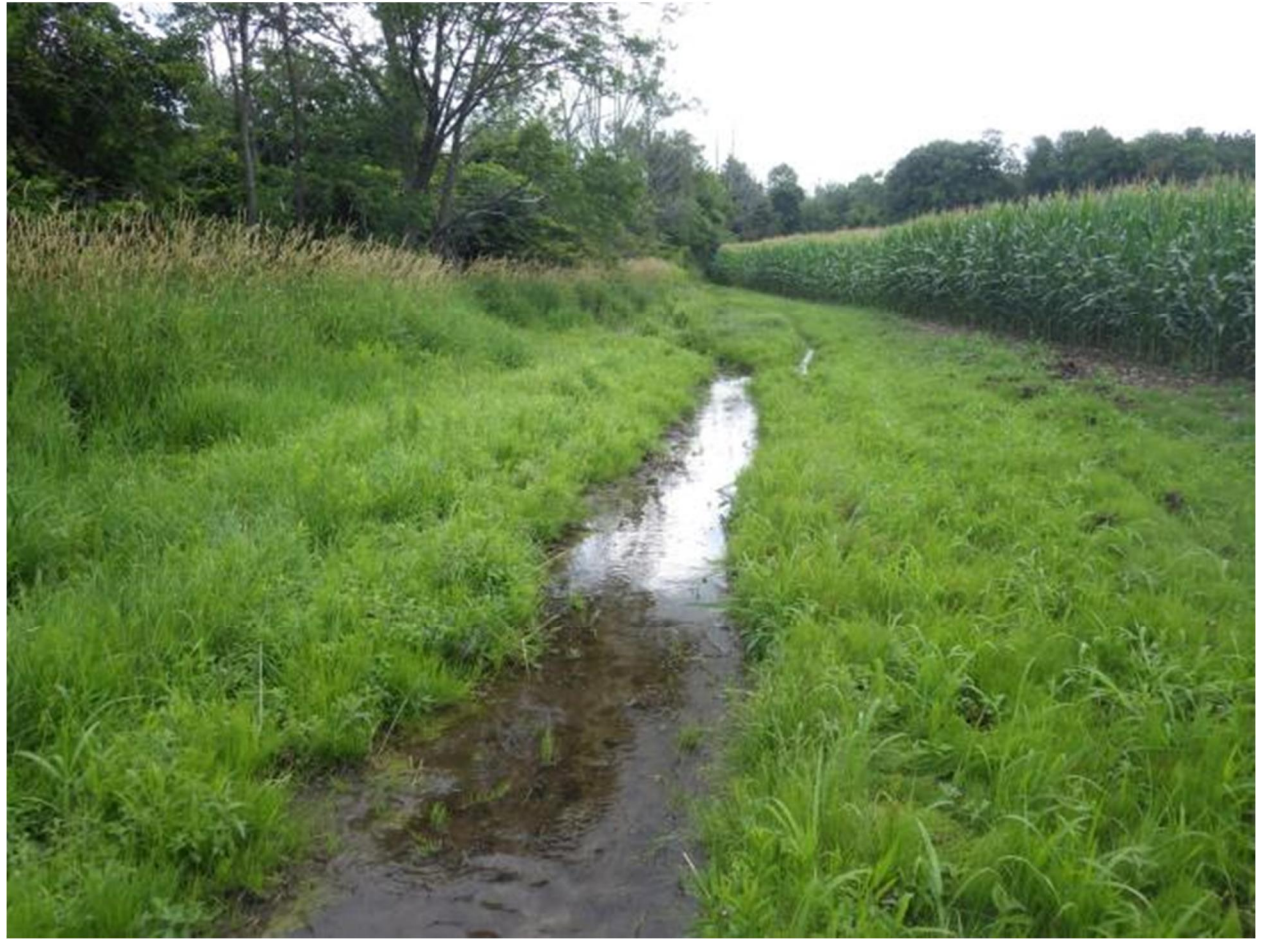
Photograph 36, facing east. Unnamed Stream 4 emerging from a forested wetland and into an agricultural field.
