WATER ASSESSMENT REPORT

Southgate Solar Project

April 2015

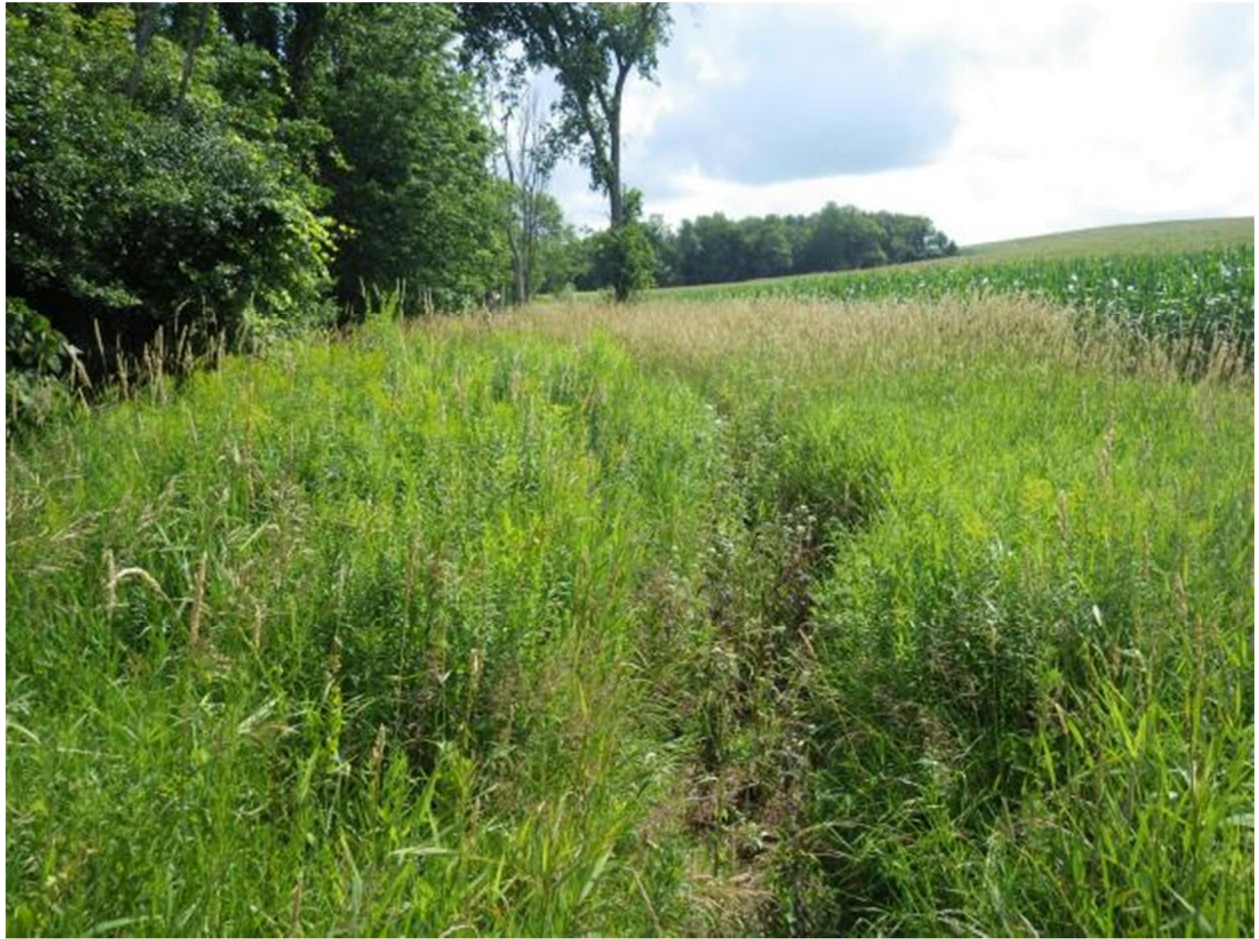
Photograph 37, facing east. The location at which Unnamed Stream 4 dissipates below the ground surface.

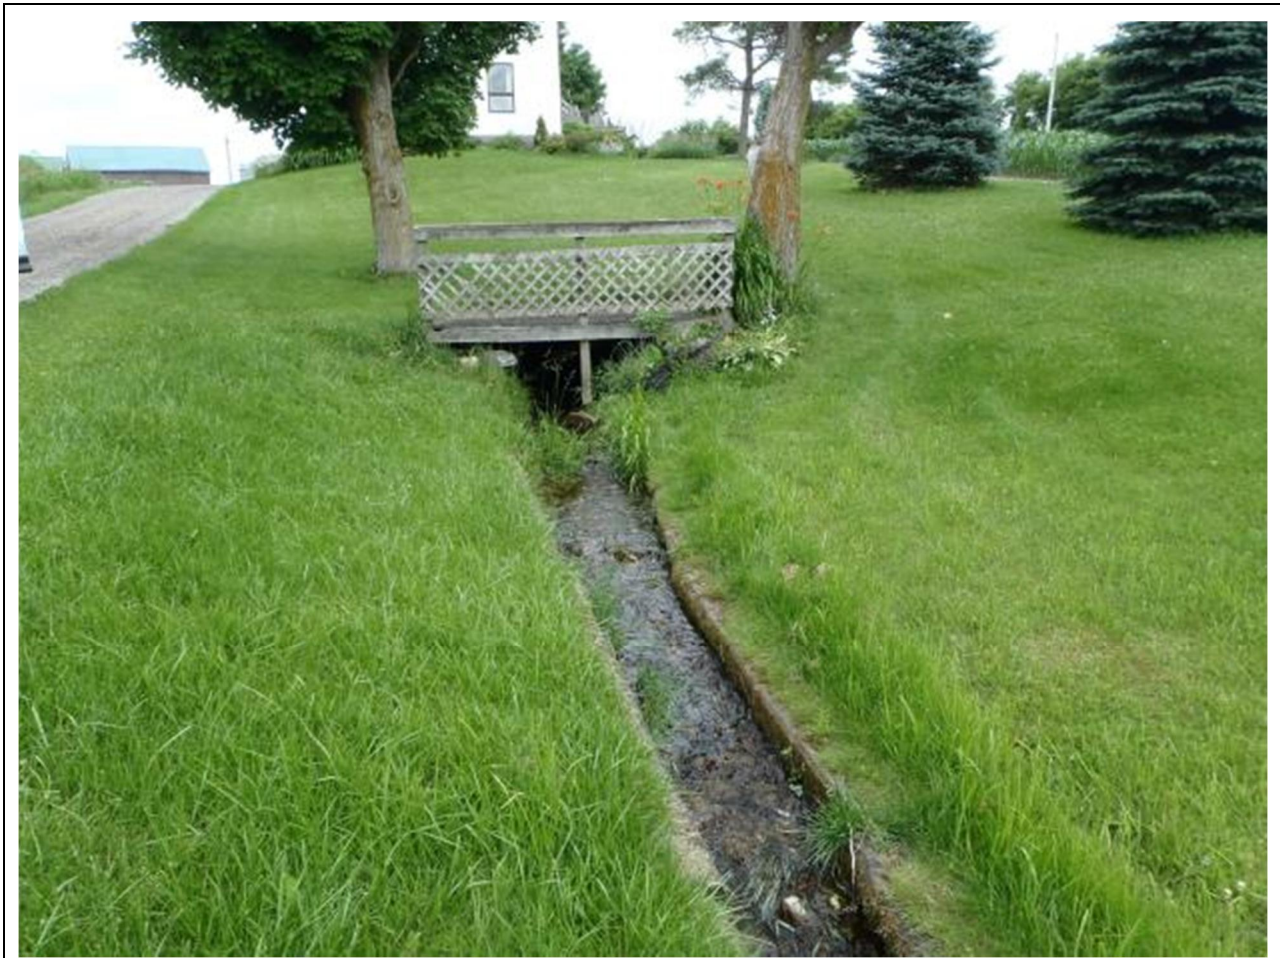
Photograph 38, facing east. Origin of Unnamed Stream 5 from Seepage Area 3 located on a west-facing hillside west of a house.

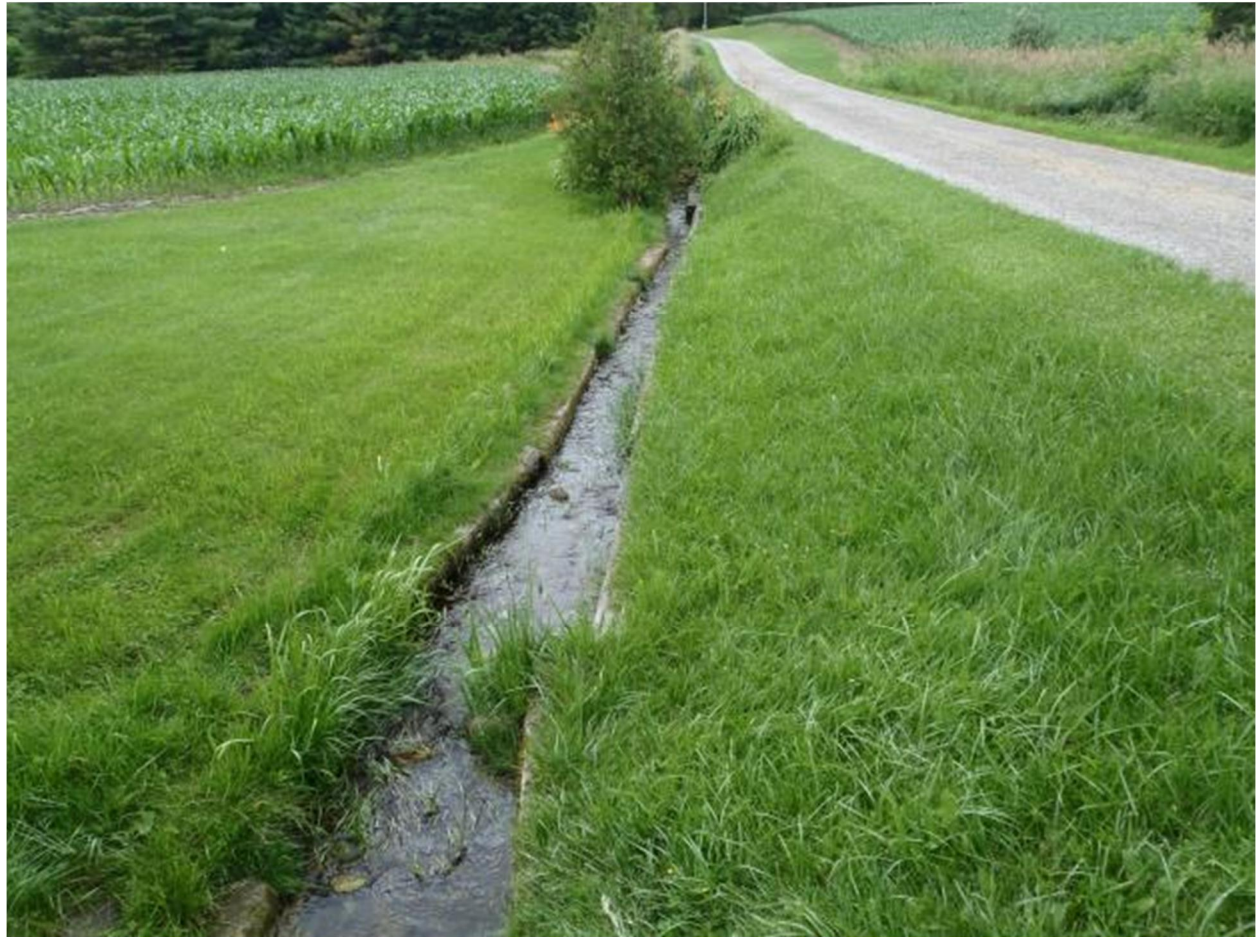
Stream 5 was observed to be an intermittent stream within a channelized ditch. The ditch was located along the side of a residential driveway. From the stream origin, the ditch was located on the south side of the driveway (Photograph 39 in *Appendix D*), crossed northward under the driveway via a CSP culvert (0.3 m diameter), continued westward on the north side of the driveway, crossed southward under the driveway via a second CSP culvert (0.3 m diameter; Photograph 40 and Photograph 41 in *Appendix D*), then continued westward into the wetland. The habitat type was a run morphology type with steady observable flow at the time of site investigation. Substrates were pre-dominantly gravel and cobbles. Mean wetted width and mean bankfull width was 0.4 m, mean wetted depth was 0.1 m, and mean bankfull depth was 0.2 m (widths and depths are approximate). In the upper south portion of the ditch, the stream banks were lined with concrete railroad ties. The stream was flowing near the bankfull capacity of the channelized ditch. Banks showed minimal evidence of erosion or vulnerability to erosion. Stream cover was sparse and was provided by emergent cobbles and occasional over-hanging and in-stream vegetation. Shaded shore cover was less than 30%.

Photograph 39, facing west. Unnamed Stream 5 flowing west within a channelized ditch lined with concrete railroad ties on the south side of a residential driveway.

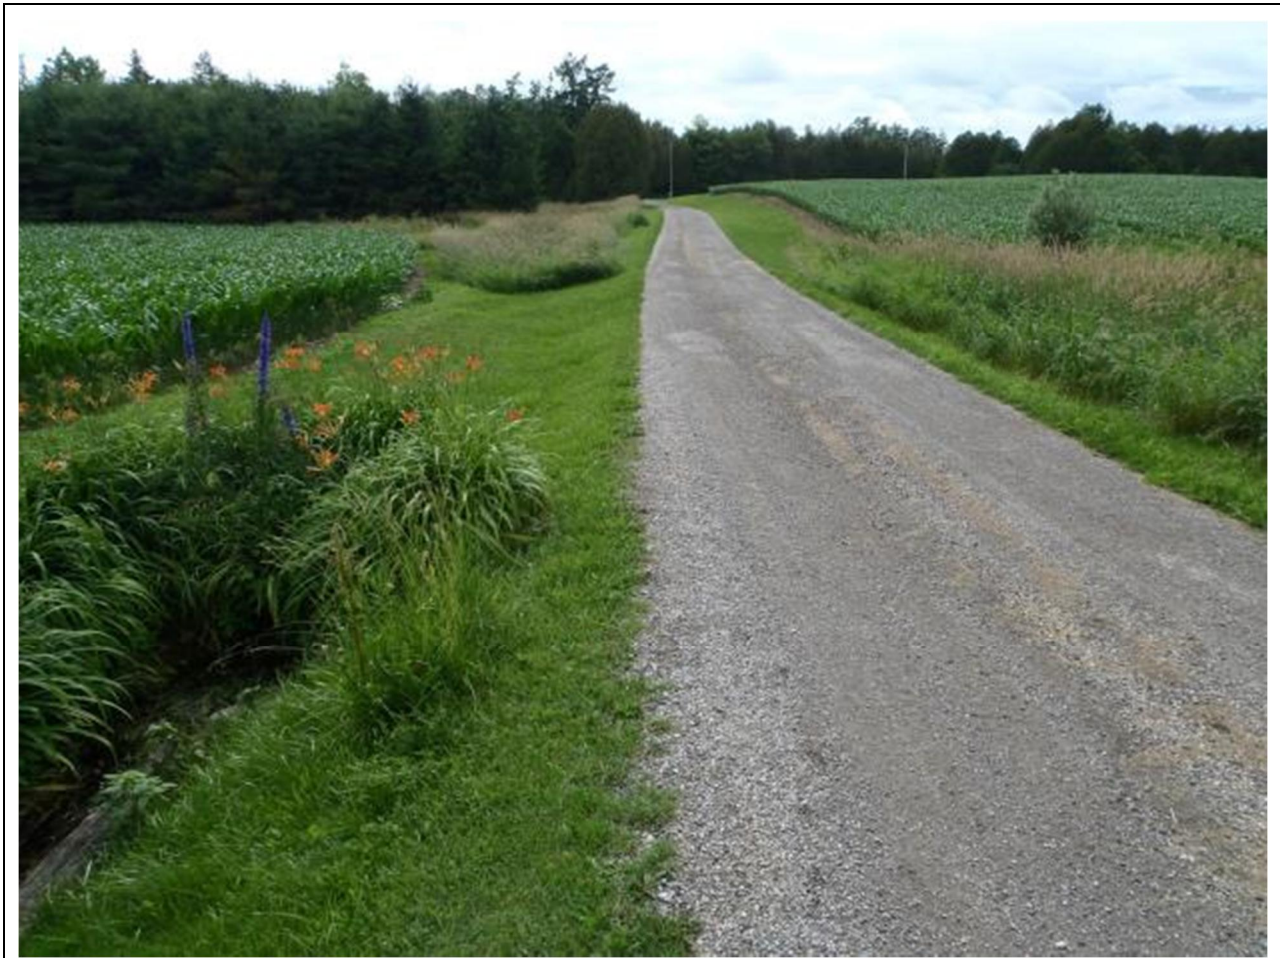
Photograph 40, facing west. Location where Unnamed Stream 5 turns northward and crosses under the residential driveway (foreground), then turns and flows westward in a ditch along the north side of the residential driveway (right side of photograph), then turns southward and crosses under the driveway and turns westward and dissipates in a forested wetland (upper left side of photograph).

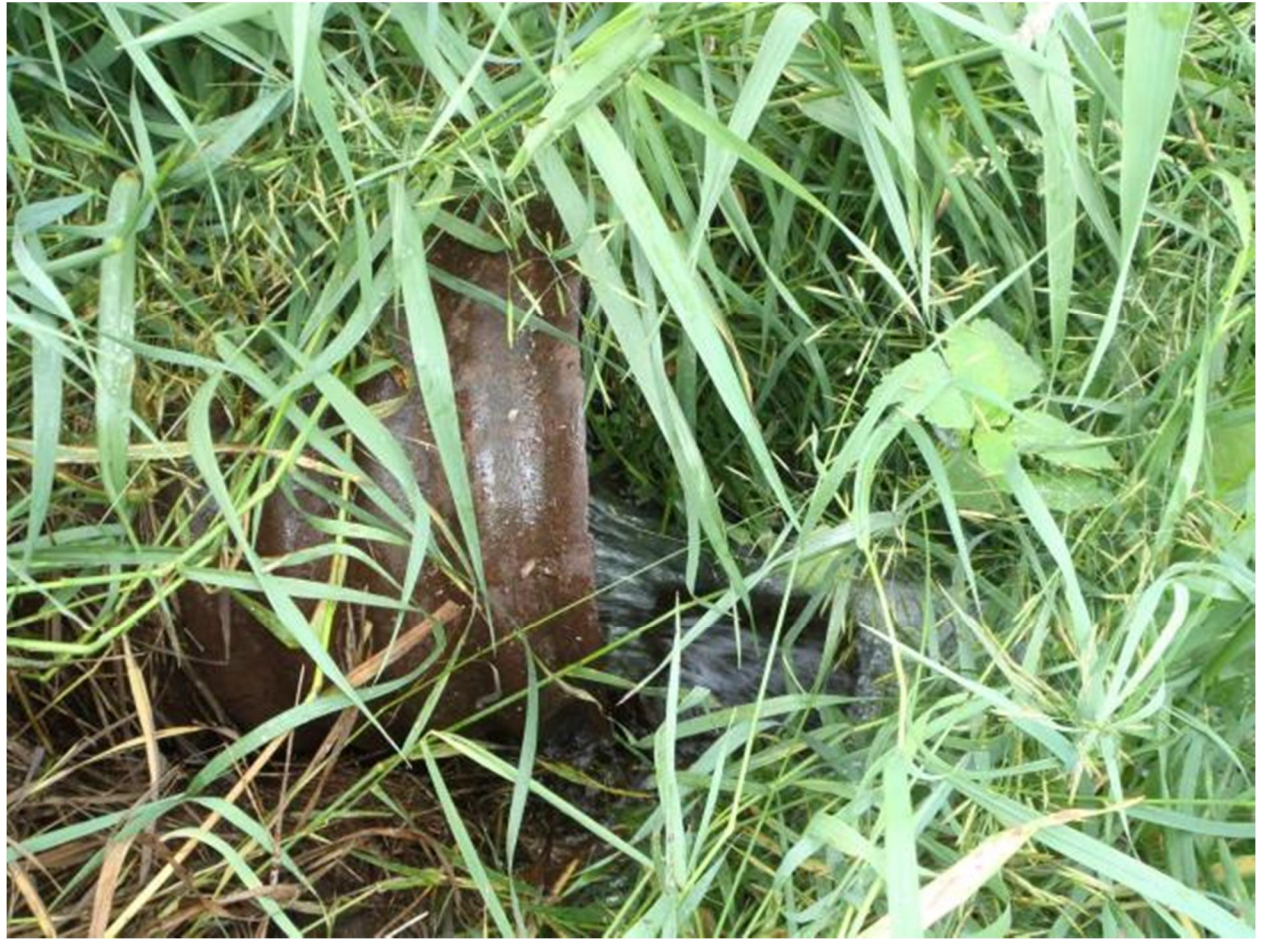
Photograph 41. Unnamed Stream 5 flowing through a CSP culvert crossing under the residential driveway.

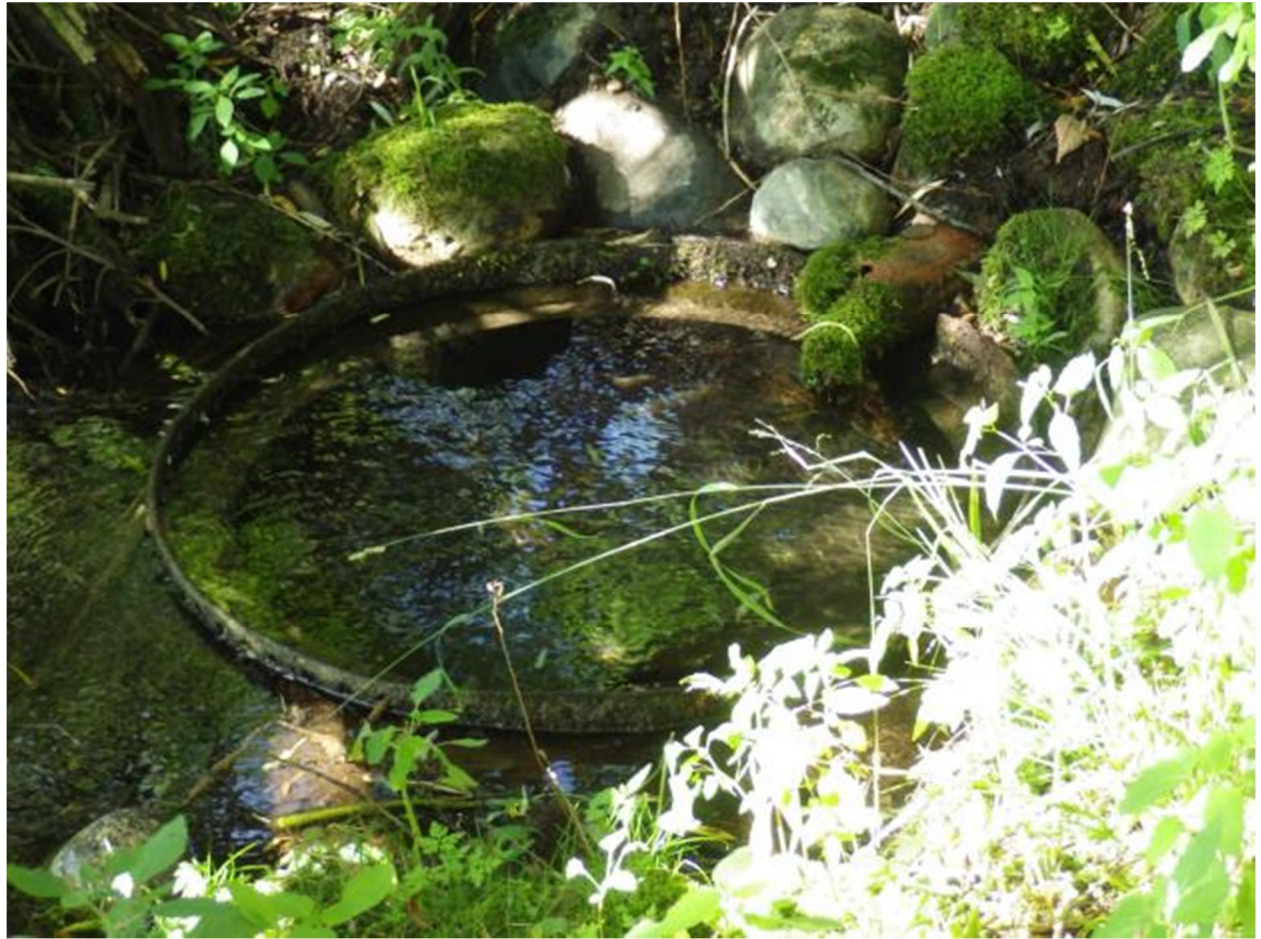
Seepage Area 1 was found during the site investigation to occur within the 120 m setback, near the northwest area of the Project Location (44° 06' 49.15" N, 80° 44' 39.63" W, Figure 4). It occurred as a point source of groundwater emerging from the ground near a fence line adjacent to a cattle pasture (Photograph 28 in *Appendix D*). The Seepage Area was surrounded by a horizontal circular steel cylinder with an approximate diameter of 1 m, set into a substrate base of sand, gravel and organic soil (Photograph 42 in *Appendix D*). Groundwater was emerging from the substrates, filling the cylinder, flowing over its wall and feeding Stream 2.

Photograph 42. Seepage Area 1 flowing from a horizontal circular steel cylinder (approximate diameter 1 m).

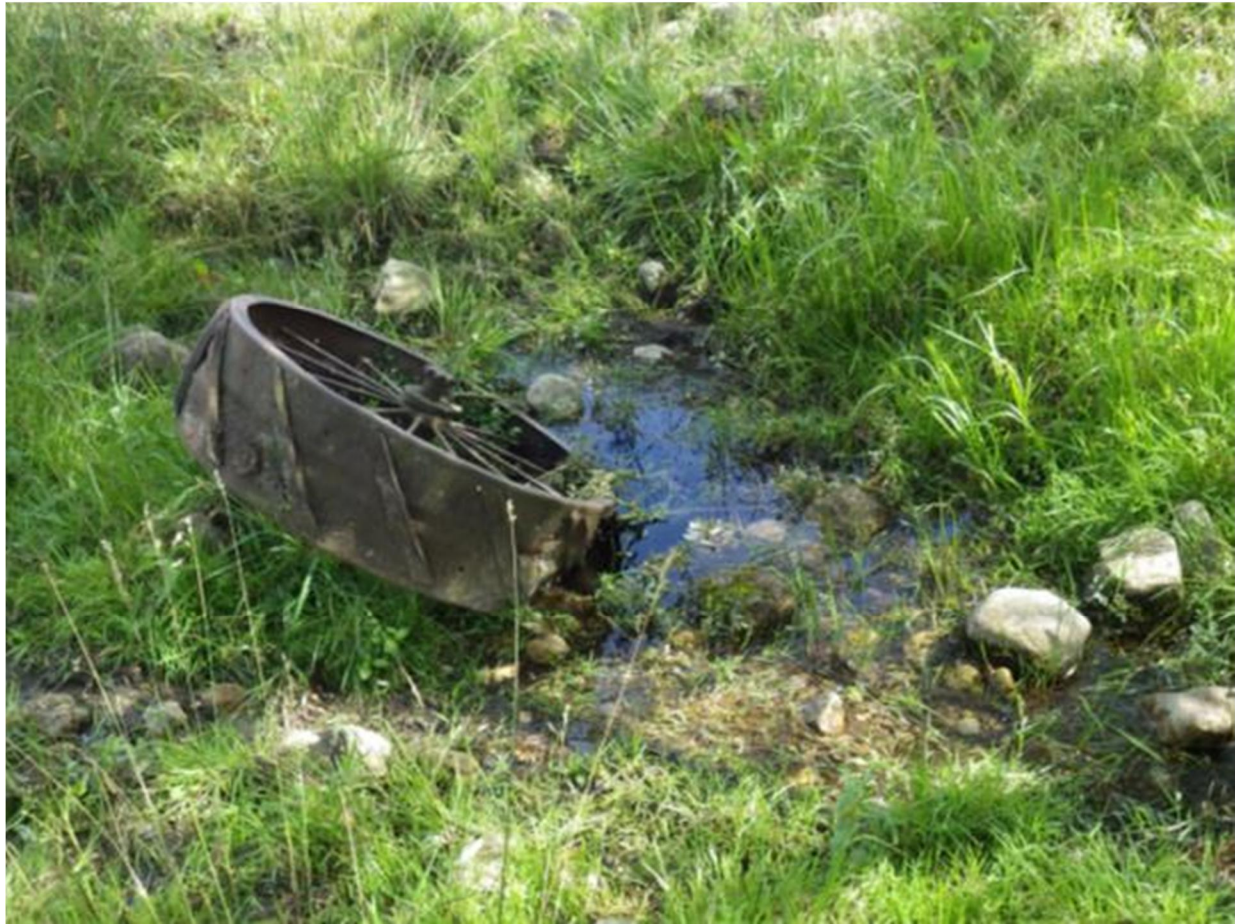
Seepage Area 2 was found during the site investigation to occur within 120 m setback, near the northwest area of the Project Location (44° 06' 45.89" N, 80° 44' 37.83" W, Figure 4), approximately 120 m southeast of Seepage Area 1. It occurred as a point source of groundwater emerging from the ground in a cattle pasture (Photograph 31 in *Appendix D*). The Seepage Area was surrounded by a horizontal circular steel cylinder with an approximate diameter of 1 m, set into a substrate base of sand, gravel and organic soil (Photograph 43 in *Appendix D*). Groundwater was emerging from the substrates, filling the cylinder, flowing over its wall and feeding Stream 3.

Photograph 43, facing south. Seepage Area 2 flowing from a horizontal steel cylinder (below the water surface, approximate diameter 1 m).

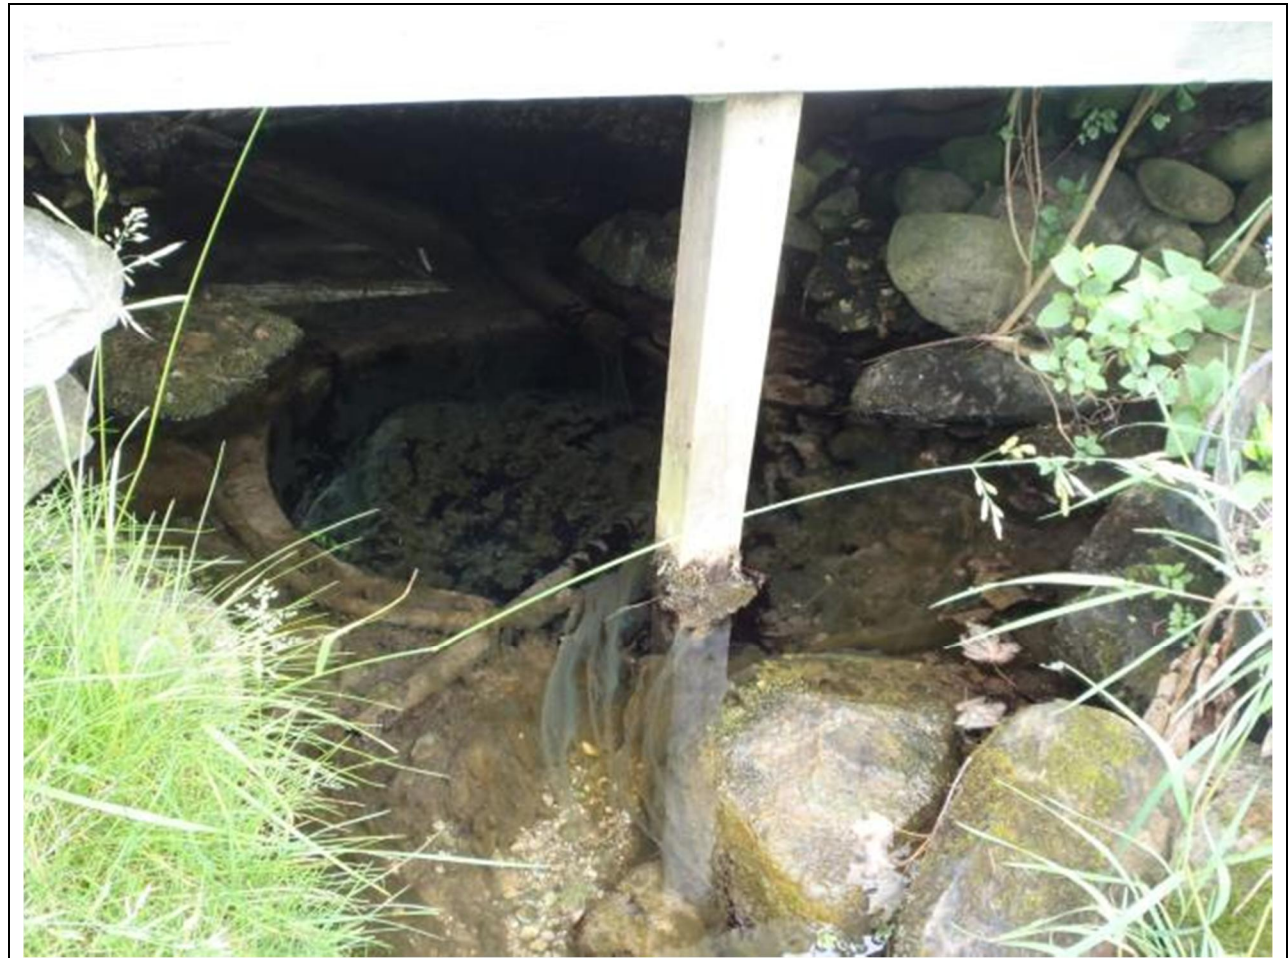
Seepage Area 3 was found during the site investigation to occur within the 120 m setback, near the western portion of the Project Location (44° 05' 44.26" N, 80° 45' 56.72" W, Figure 4). It occurred as a single point source of groundwater emerging from a west-facing hillside on a residential lawn, approximately 30 m west of a house (Photograph 38 in *Appendix D*). The Seepage Area was surrounded by a horizontal circular concrete cylinder with an approximate diameter of 1.0 m, set into a substrate base of sand and gravel (Photograph 44 in *Appendix D*). Groundwater was emerging from the substrates, filling the concrete cylinder, flowing over its wall and feeding Stream 5. The Seepage Area and concrete cylinder were covered by a constructed wood roof. A drainage pipe (0.1 m diameter) was also contained under the roof, emerging from the hillside and from the direction of the house, and was suspected to be a sump pump outlet drain from the house. It was not flowing at the time of site investigation.

Photograph 44, facing east. Seepage Area 3 filling and over flowing from a concrete cylinder and feeding Unnamed Stream 5.
