Client/Project	January 2011
SAMSUNG C&T	160960577
GRAND RENEWABLE ENERGY PARK

Title
HEMLOCK CREEK SUBWATERSHED PHOTOS

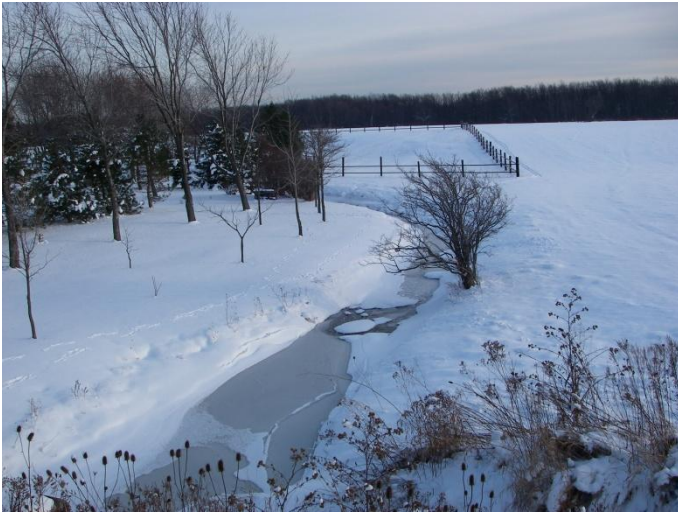
Photo 7: Evans-a (tile 9) - Looking downstream (south) from Rainham Road at channel flowing through farm lands. Site is located on Rainham Road, between Brookers Road and Haldimand Road 50.

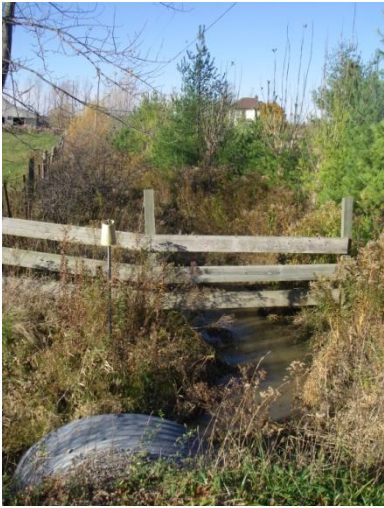
Photo 8: Evans-c (tile 12) - Looking at upstream (north) from CSP culvert flowing under Bains Road, south of Haldimand Road 20, between Haldimand Road 50 and South Cayuga Road.

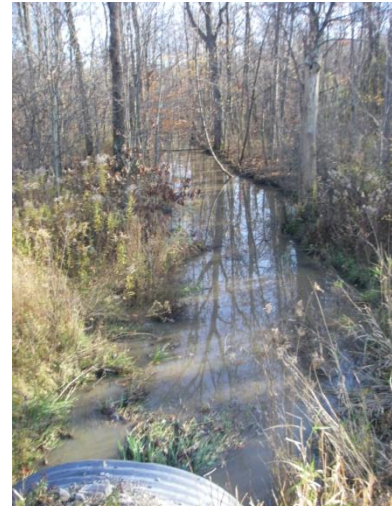
Photo 9: Evans-c (tile 12) - Looking at downstream (south) from CSP culvert flowing under Bains Road, south of Haldimand Road 20, between Haldimand Road 50 and South Cayuga Road.

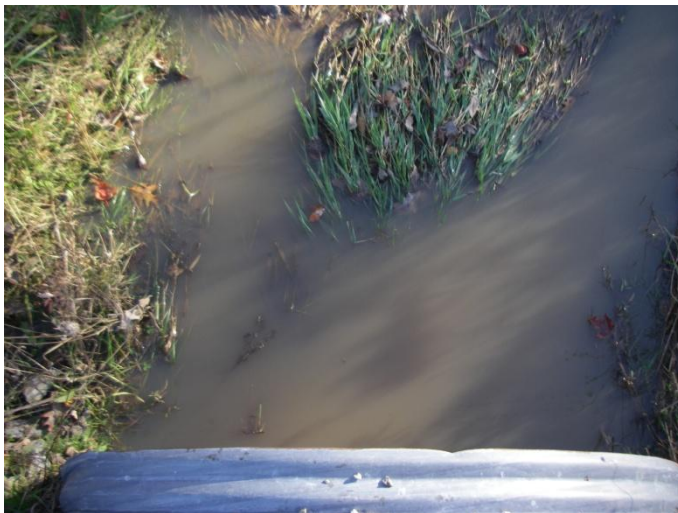
Photo 10: Evans-c (tile 12) - Looking at substrate at CSP culvert flowing under Bains Road, south of Haldimand Road 20, between Haldimand Road 50 and South Cayuga Road.

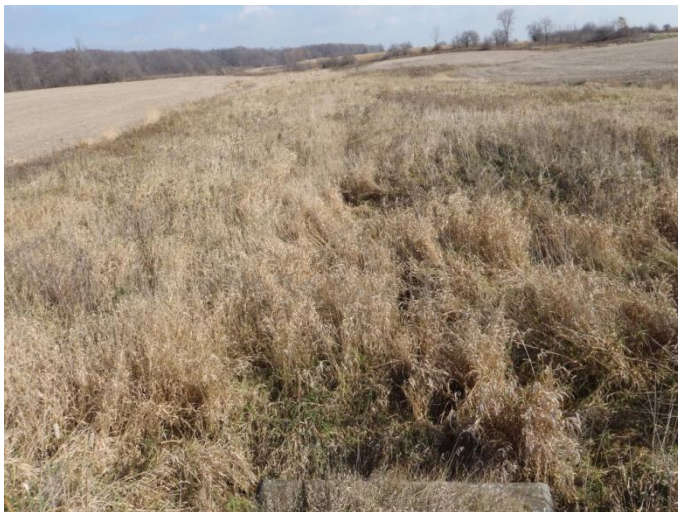
Photo 12: Evans-c (tile 12) - Looking upstream (west) at concrete culvert and water feature on Haldimand Road 50, between Bains Road and Rainham Road.

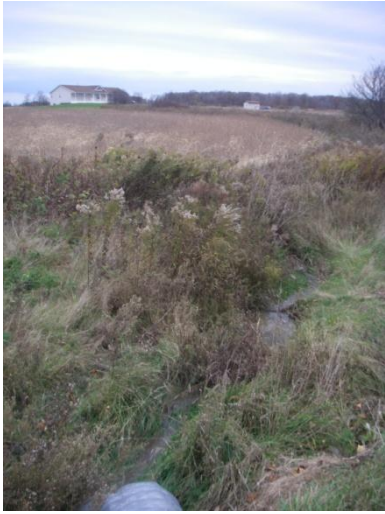
Photo 144: Evans-d (tile 12) - Looking at upstream (north) from CSP culvert flowing under Bains Road, south of Haldimand Road 20, between Haldimand Road 50 and South Cayuga Road.

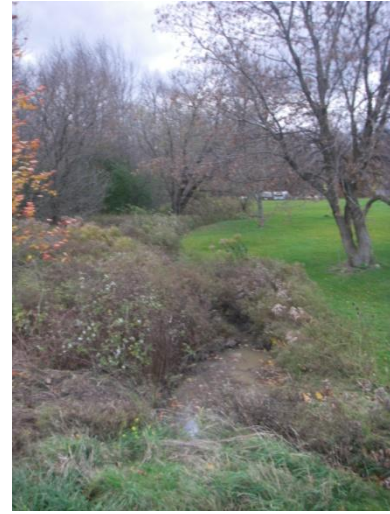
Photo 155: Evans-d (tile 12) - Looking at downstream (south) from CSP culvert flowing under Bains Road, south of Haldimand Road 20, between Haldimand Road 50 and South Cayuga Road.

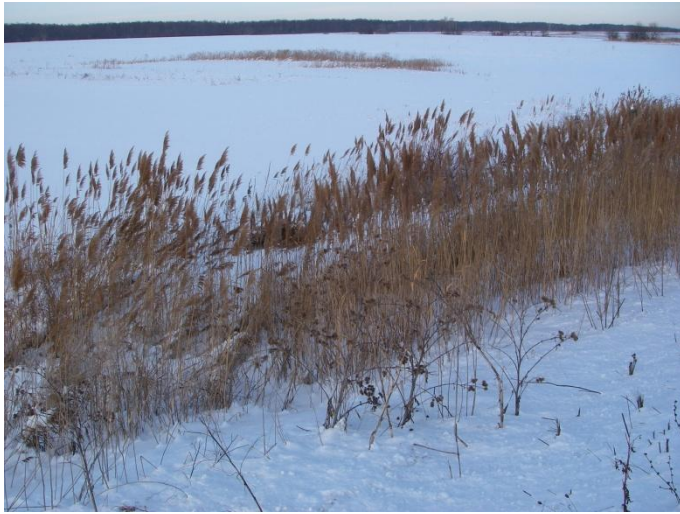
Photo16: Evans-e (tile 9) - Looking upstream (north) from Rainham Road at channel flowing though farm lands. Site is located on Rainham Road, between Brookers Road and Haldimand Road 50.

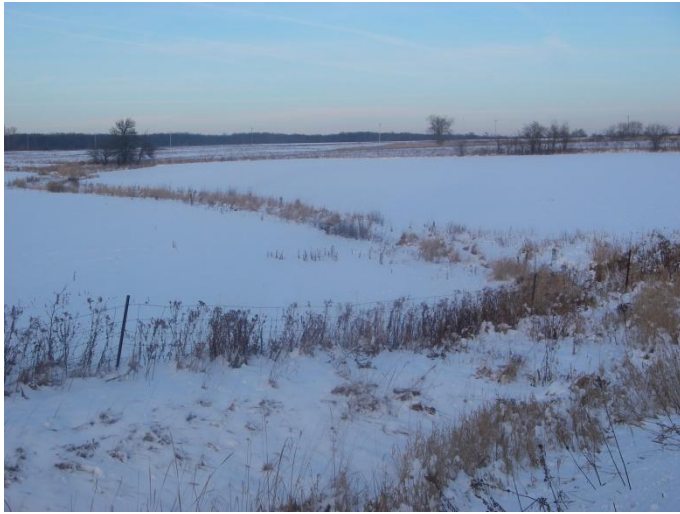
Photo 18: Evans-f (tile 9) - Looking upstream (north) from Rainham Road at channel flowing through farm lands. Site is located on Rainham Road, between Brookers Road and Haldimand Road 50.

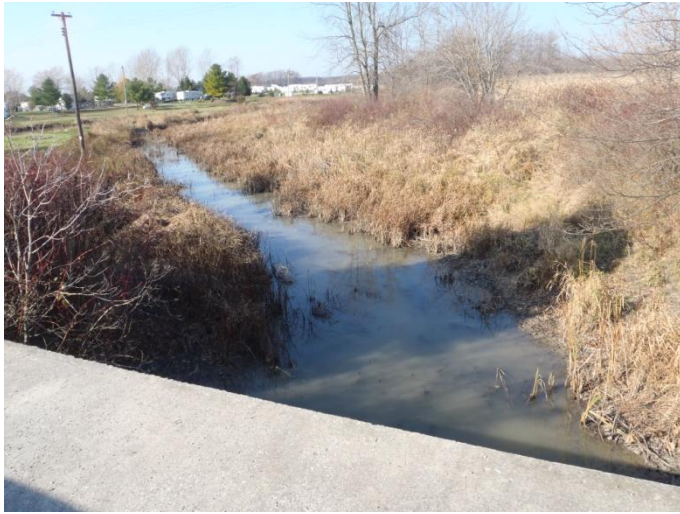
Photo 20: Evans-h (tile 10) - Looking upstream (north) from concrete culvert at Lakeshore Road. Site is located west of White Cap Lane and Haldimand Road 50, approximately 50 m north of the lake shore.

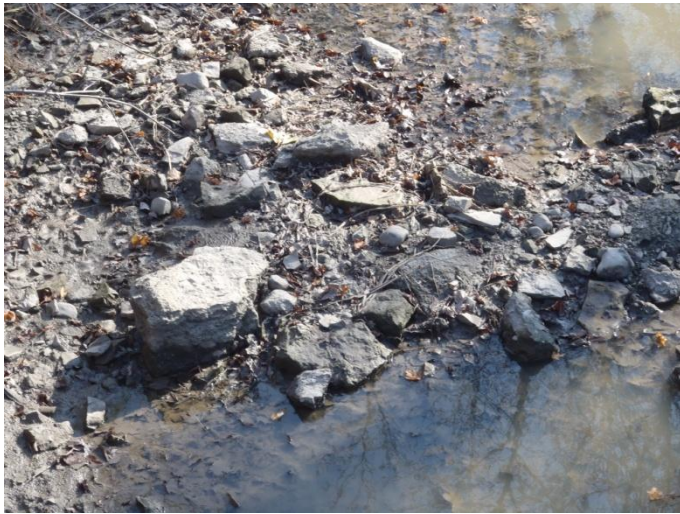
Photo 22: Evans-h (tile 10) - Looking at substrate at concrete culvert on Lakeshore Road. Site is located west of White Cap Lane and Haldimand Road 50, approximately 20 m north of the lake shore.

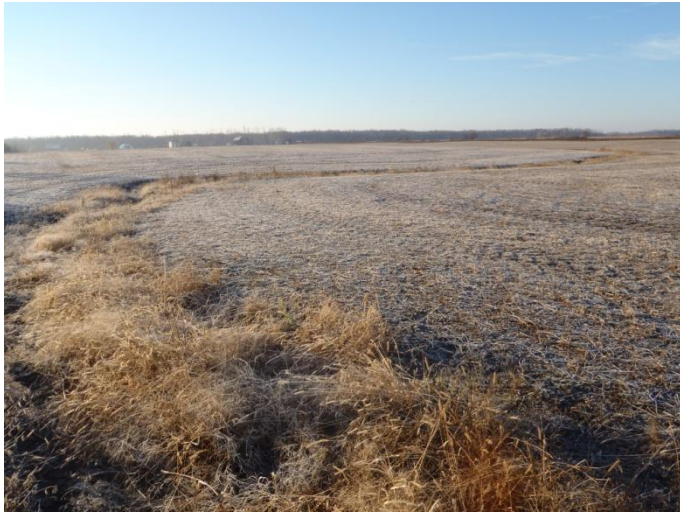
Photo 16: Evans-i (tile 11) (field data sheet 33.0) - Looking downstream (south) at ill-defined channel flowing through an agricultural field. Site is located north of Bains Road between Haldimand Road 50 and South Cayuga Road.

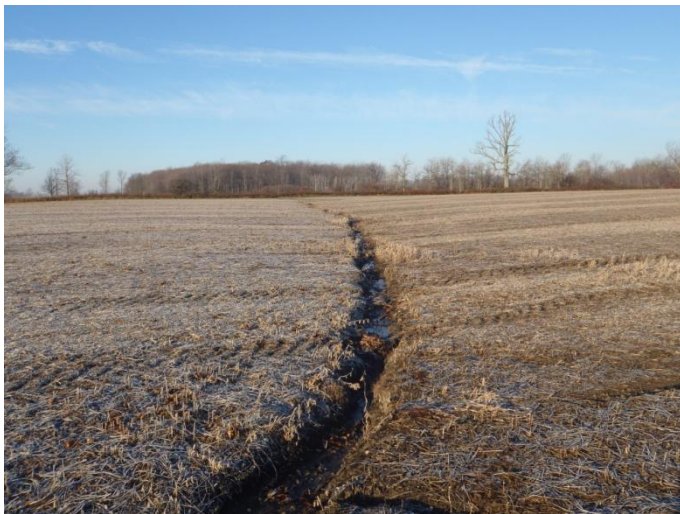
Photo 20: Evans-i (tile 11) (field data sheet 33.1) - Looking upstream (north) at plowed-through water feature flowing through an agricultural field. Site is located north of Bains Road between Haldimand Road 50 and South Cayuga Road.

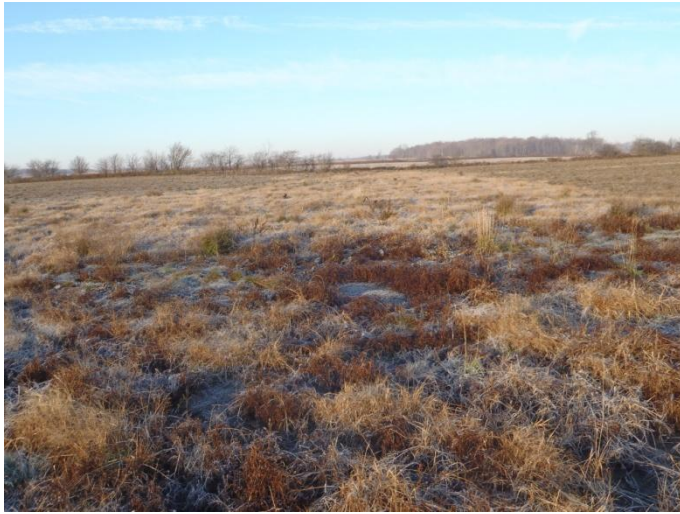
Photo 22: Evans-k (Tile 11) (field data sheet 33.2) - Looking downstream (west) at undefined channel flowing through an agricultural field. Site is located north of Bains Road between Haldimand Road 50 and South Cayuga Road.
