GRAND RENEWABLE ENERGY PARK

WATER ASSESSMENT AND WATER BODY REPORT

File No. 161010646/161010624 October 2011

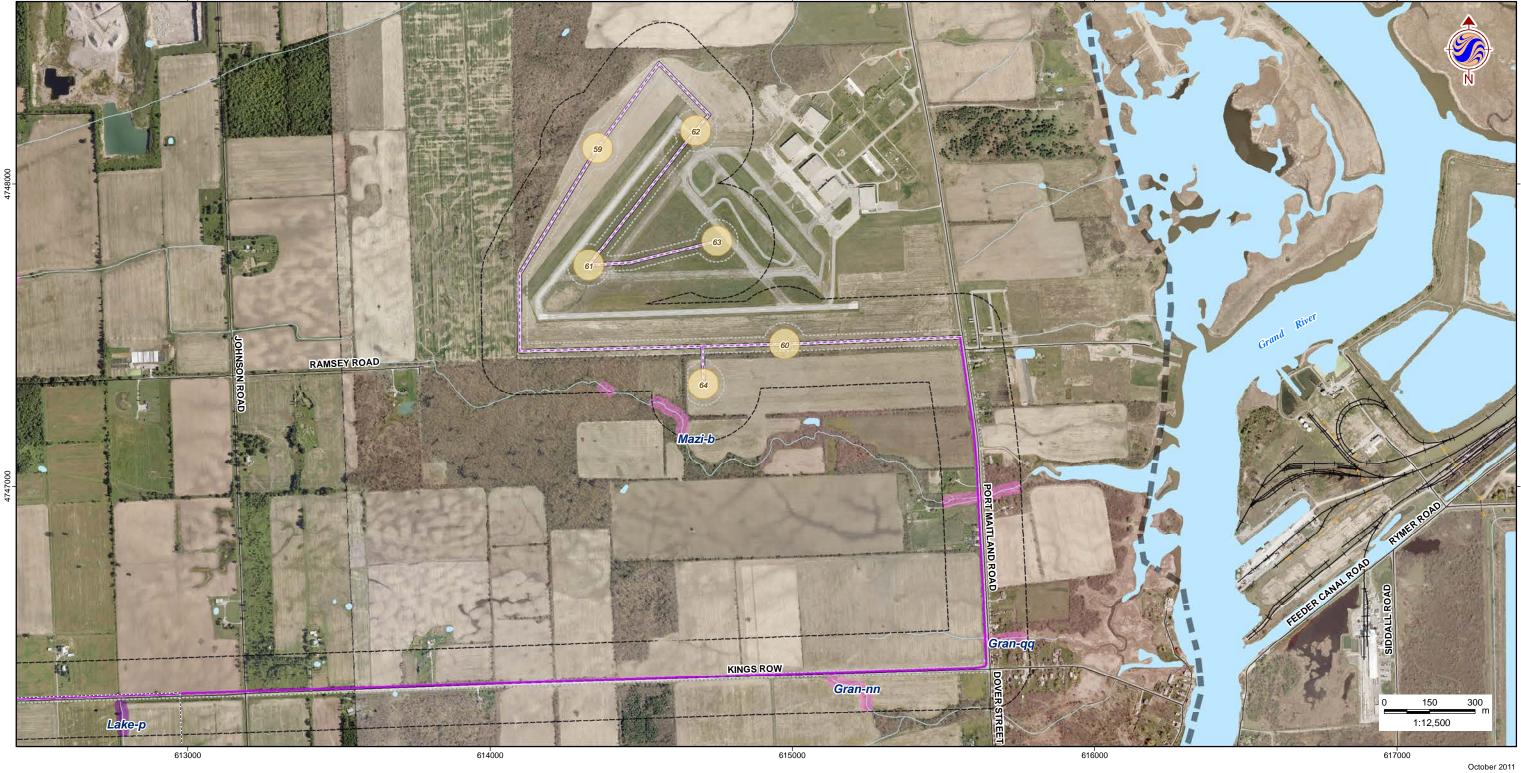
Figure No. 3.16 Title

> **FISHERIES HABITAT** Tile 16 of 20

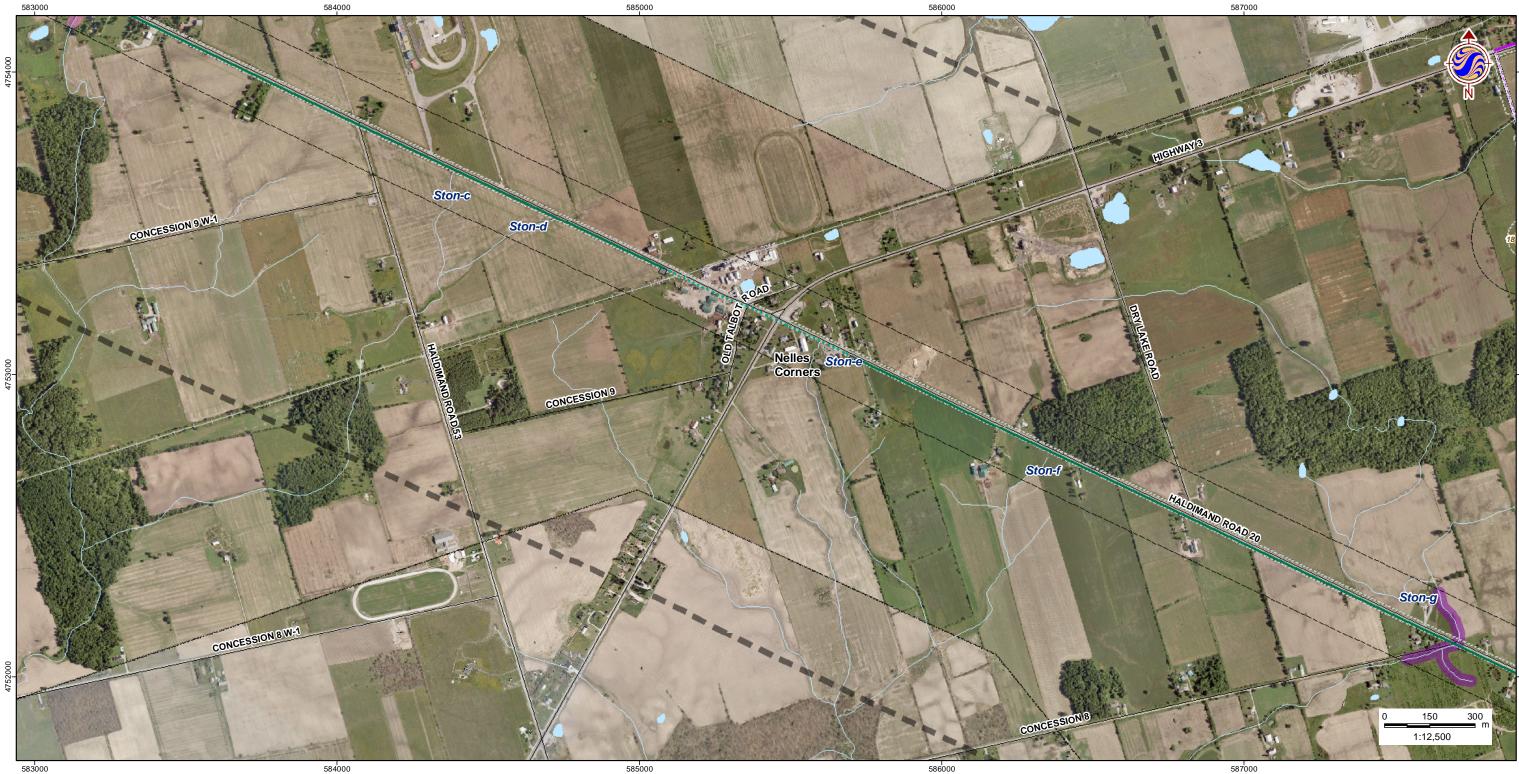
FISHERIES HABITAT Tile 18 of 20

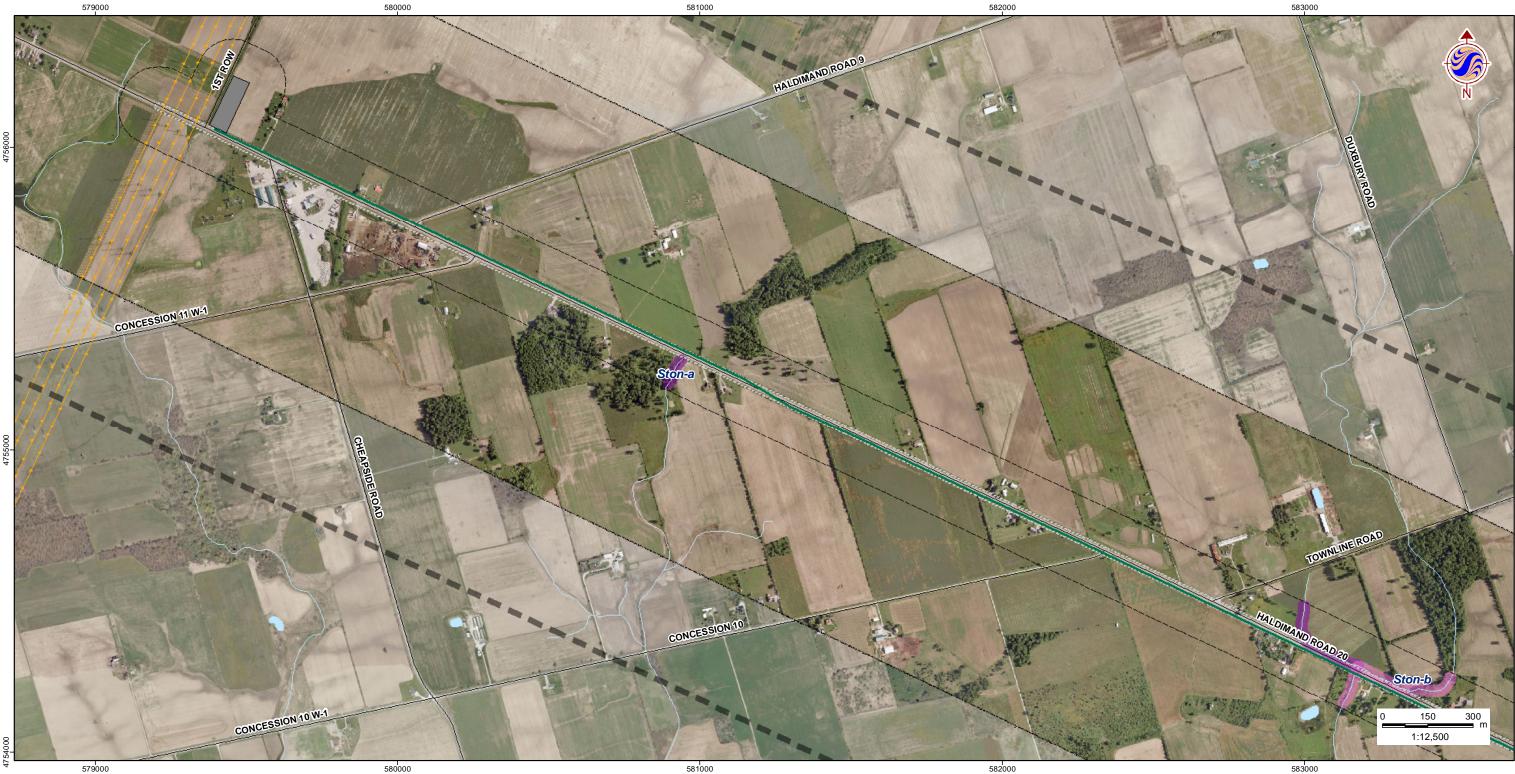
Figure No. 3.19 Title

FISHERIES HABITAT Tile 19 of 20

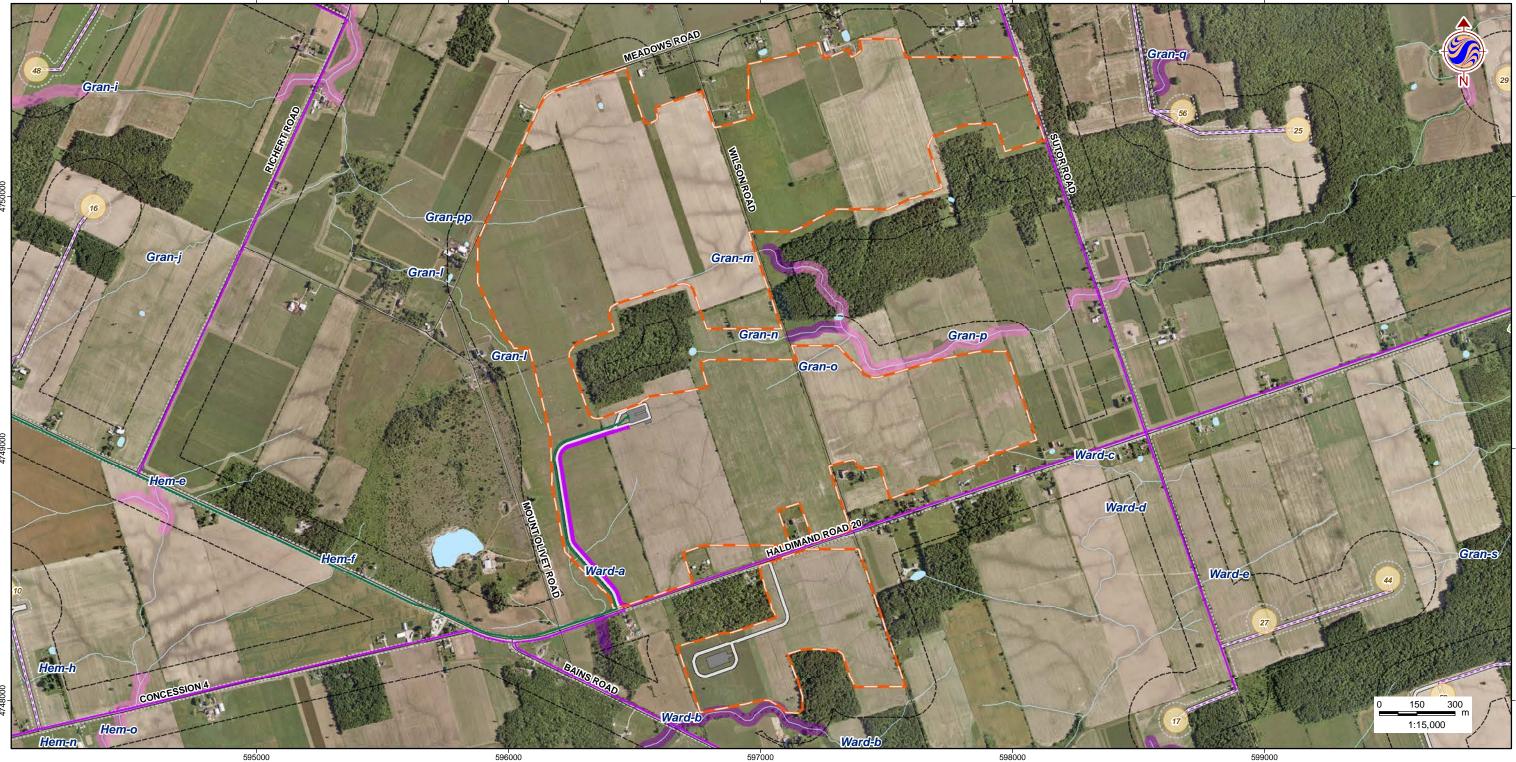
WATER BODY LOCATIONS Solar Lands

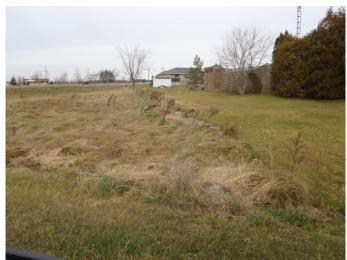
Ston-e (tile 18) - Looking upstream (northeast) from concrete culvert at area of channel. Site is located on Haldimand Road 20 between Dry Lake Road and Highway 3. Photo 15:

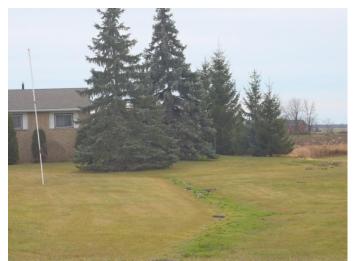
Photo 16: Ston-e (tile 18) - Looking downstream (southwest) from concrete culvert at channel flowing through a residential property. Site is located on Haldimand Road 20 between Dry Lake Road and Highway 3.

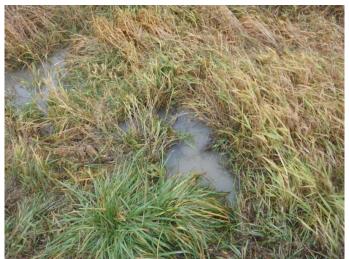
Photo 7: Hem-a (tile 4) - Existing substrate conditions in upstream area. Site is located 100 m south of Haldimand Road 20 between Concession 6 and Link Road.

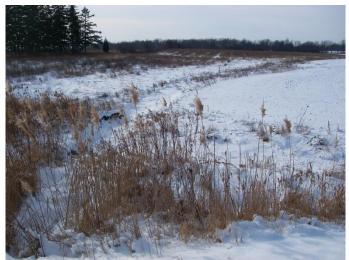
Photo 39: Hem-I (tile 6) - Looking southwest at channel flowing through an agricultural field. Site is located on Kohler Road between Concession 4 and Concession 5.

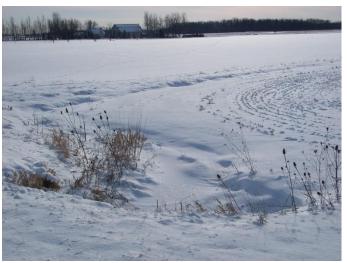
Photo 41: Hem-m (tile 6) - Looking downstream (southwest) at roadside drain and channel flowing through an agricultural field. Site is located on Kohler Road between Concession 4 and Concession 5.

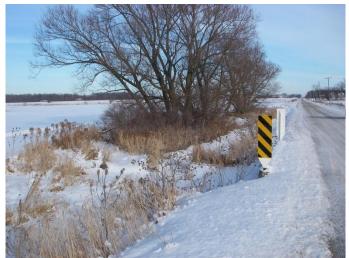
Photo 45: Hem-o (tile 6) - Looking east at upstream end of concrete culvert on north side of Concession 4. Site is located on Concession 4, between Kohler Road and Haldimand Road 20.

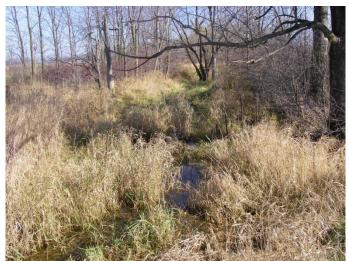
Ward-b (tile 6) - Looking upstream (south) from concrete culvert on Bains Road, between Haldimand Road 20 and Wilson Road. Photo 4:

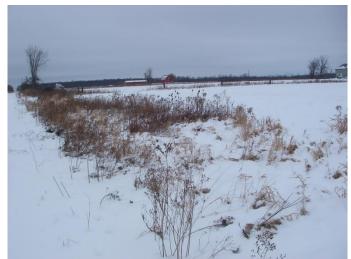
Ward-d (tile 8) - Looking downstream (west) from Sutor Road at channel location. Site is located on Sutor Road, south of Haldimand Photo 8: Road 20.

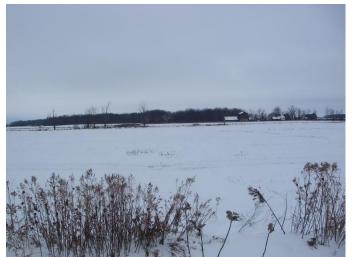
Ward-d (tile 8) - Looking upstream (east) from Sutor Road at channel location. Site is located on Sutor Road, south of Haldimand Road 20. Photo 9:

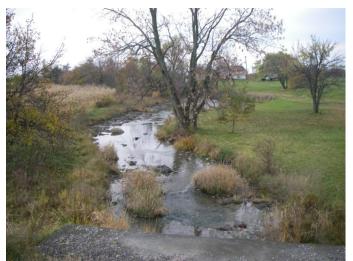
Ward-f (tile 8) - Looking downstream (southeast) at water body flowing from concrete culvert and adjacent to agriculture and Photo 13: residential land uses. This site is located on Bains Road between Wilson Road and Haldimand Road 50.

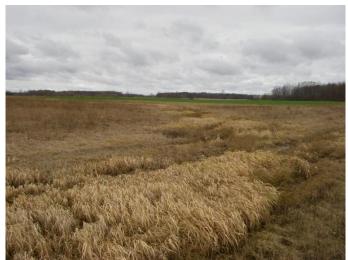
Photo 15: Ward-g (tile 8) - Looking upstream at grassy wetted area in a field. Site is located west of Sutor Road and north of Bains Road.

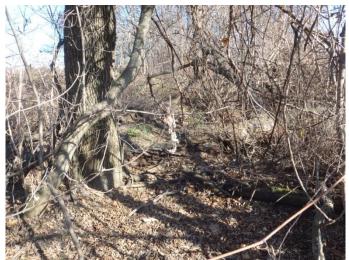
Photo 1: Gran-a (tile 1) - Looking downstream (northeast) at dry channel flowing through a wooded area. Site is located south of Highway 3 between Decewsville Road and Dry Lake Road.

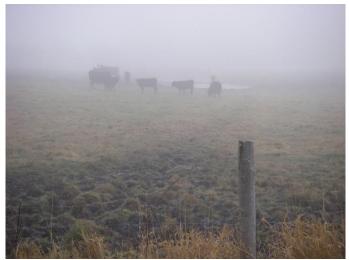
Photo 16: Gran-f (tile 1) - Looking downstream (east) at low lying damp area, from culvert at Kohler Road, south of Highway 3.

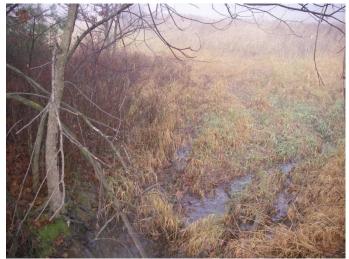
Photo 21: Gran-f (tile 1) - Looking upstream (west) from culvert at Kohler Road, south of Highway 3

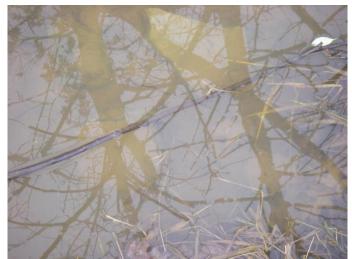
Photo 22: Gran-f (tile 1) - Looking at substrate at culvert at Kohler Road, south of Highway 3.

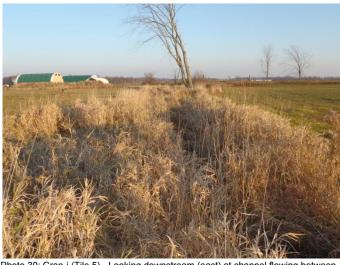
Photo 30: Gran-i (Tile 5) - Looking downstream (east) at channel flowing between two agricultural fields. Site is located north of Haldimand Road 20 between Kohler Road and Link Road.

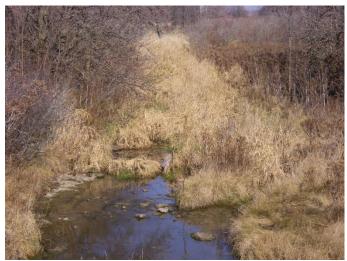
Photo 33: Gran-i (tile 5) - Looking upstream (northeast) from Richert Road

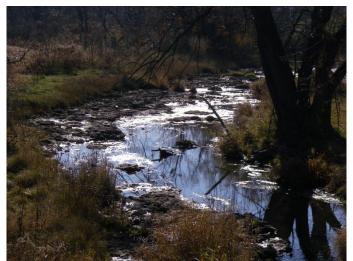
Photo 34: Gran-i (tile 5) - Looking downstream (southwest) from Richert Road

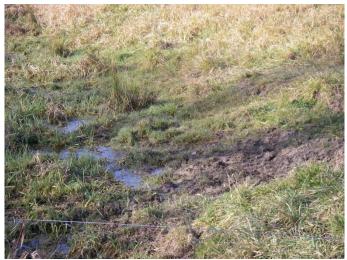
Photo 36: Gran-j (tile 5) - Looking at substrate in ephemeral water feature at culvert on Richert Road, between Haldimand Road 20 and Link Road.

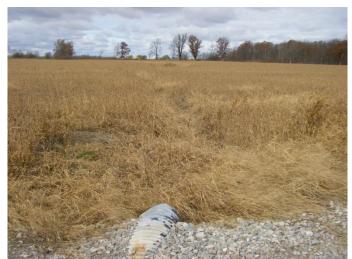
Photo 42: Gran-j (tile 5) - Looking upstream (west) from CSP culvert in laneway at plowed-through, ephemeral feature that flows through an agricultural field. Site is located east of Haldimand Road 20, between Richert Road and Kohler Road.

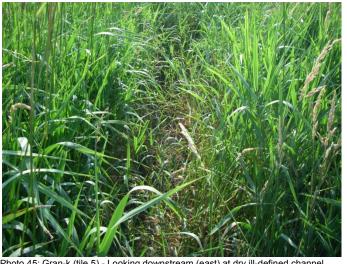
Photo 45: Gran-k (tile 5) - Looking downstream (east) at dry ill-defined channel through agricultural field. Site is located on Meadows Road between Wilson Road and Mount Olivet Road.

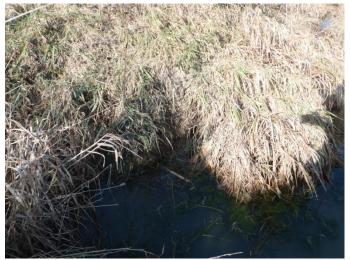
Photo 63: Gran-t (tile 11) - Looking at downstream substrate on south side of Haldimand Road 20, between Haldimand Road 50 and South Cayuga Road.

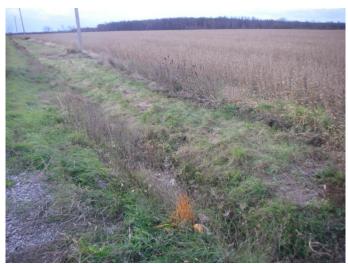
Photo 83: Gran-aa (tile 11) - Looking at roadside ditch upstream of CSP culvert on west side of South Cayuga Road. This site is located on South Cayuga Road between Haldimand Road 20 and Bains Road.

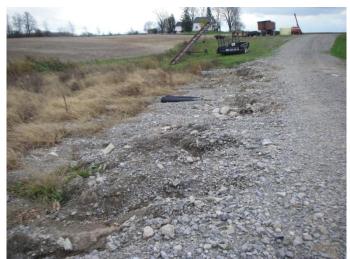
Photo 99: Gran-ee (tile 13) - Looking south at twin CSP culverts and erosion on farm access road caused by water overtopping road. Site is located north of Haldimand Road 20 between Hald-Dunn Townline Road and Old Hines Road.

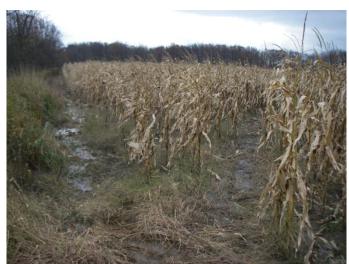
Photo 102: Gran-ff (tile 13) -Looking south at small drain feature flowing along edge of agricultural field. Anthropogenic feature formed at edge of plowed area. Site is located east of Hald-Dunn Townline Road between Haldimand Road 20 and Rainham Road. Note: path on right side of photo contained small amounts of water but no defined channel characteristics.

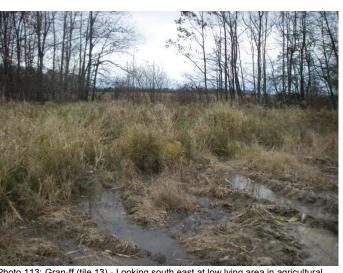
Photo 113: Gran-ff (tile 13) - Looking south east at low lying area in agricultural field holding water. Site is located east of Hald-Dunn Townline Road between Rainham Road and the lakeshore.

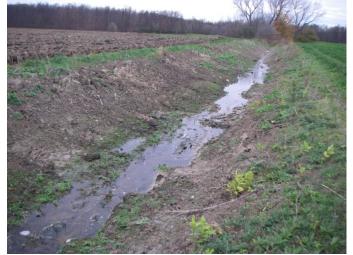
Photo 135: Gran-ii (tile 14) - Looking downstream (north) at newly excavated agricultural drain south of the small wooded area in the middle of an agricultural field. Site is located west of Aikens Road between Haldimand Road 20 and Rainham Road. Note: all water in this channel flows into a hole, with no overland connection to downstream areas.

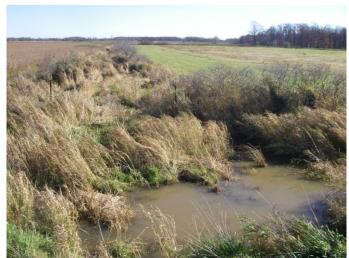
Photo 150: Gran-mm (tile 14) - Looking downstream (east) at water course flowing through CSP culvert and adjacent to agricultural land uses. This site is located on Haldimand Road 49 between Rainham Road and Ramsey Road.

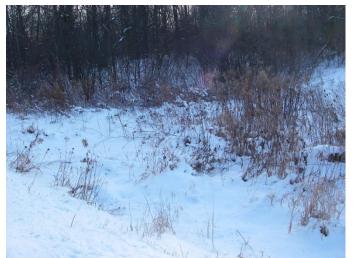
Photo 154: Gran-pp (tile 7) - Looking upstream (southwest) from Sutor Road at channel flowing through a wooded area. Site is located on Sutor Road, between River Road and Meadows Road.

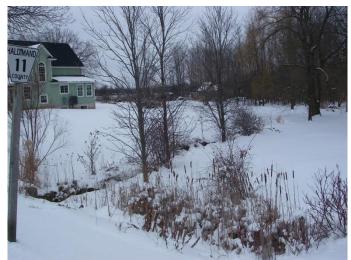
Photo 156: Gran-qq (tile 17) - Looking downstream (east) at channel flowing through residential property. Site is located on Port Maitland Road between Kings Row and Ramsey Road.

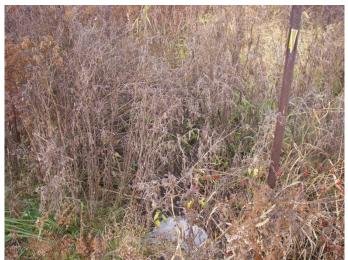
Photo 1: Holm-a (tile 2) - Looking upstream (north) from culvert on Irish Line, west of Kohler Road and east of Little Road.

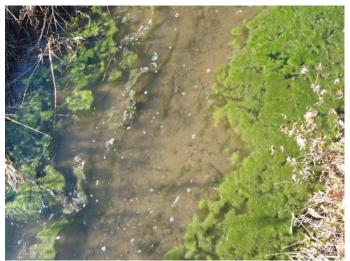
Photo 4: Holm-a (tile 3) - Existing in-stream and substrate conditions in channel. Site is located south of Irish Line between Kohler Road and Little Road.

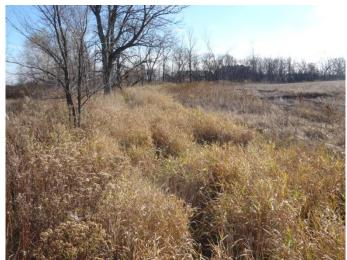
Photo 7: Holm-a (tile 3) - Looking downstream (east) at channel flowing adjacent an agricultural field. Site is located south of Irish Line between Kohler Road and Little Road.

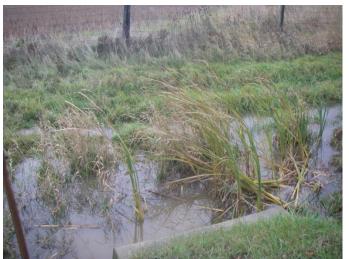
Photo 29: Holm-f (tile 3) - Looking upstream (west) at existing conditions and vegetation at concrete box culvert of small water feature flowing into agricultural lands located along Kohler Road between Irish Line and Link Road.

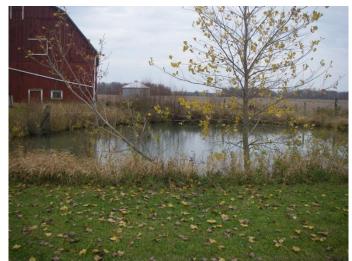
Photo 30: Vicinity of Holm-g (tile 3) - View of isolated pond located along Kohler Road between Irish Line and Link Road.

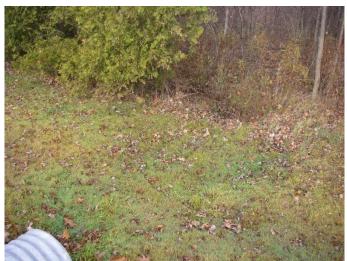
Photo 36: Holm-i (tile 3) - Looking upstream (north) from CSP culvert on Irish Line, west of Kohler Road and east of Little Road.

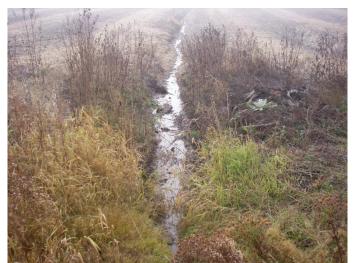
Photo 39: Holm-j (tile 3) - Looking downstream (south) from culvert on Irish Line, west of Kohler Road and east of Little Road.

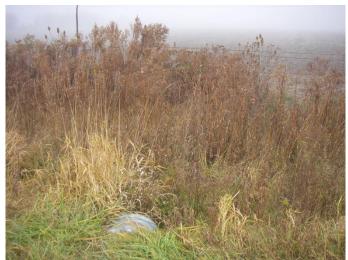
Photo 44: Holm-k (tile 3) - Looking upstream (north) from CSP culvert on Irish Line, west of Kohler Road and east of Little Road.

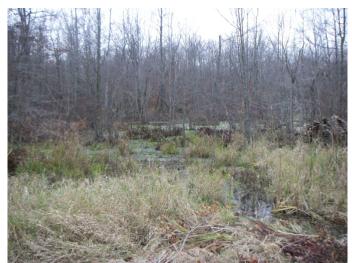
Photo 1: Lake-a (tile 12) - Looking west at flooded wooded area. Site is located on South Cayuga Road between Bains Road and Rainham Road.

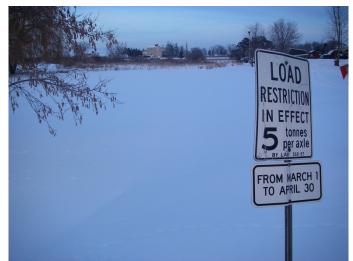
Photo 4: Lake-b (tile 12) - Looking upstream (east) from South Cayuga Road at location where channel is mapped. Site is located on South Cayuga Road, between Bains Road and Rainham Road.

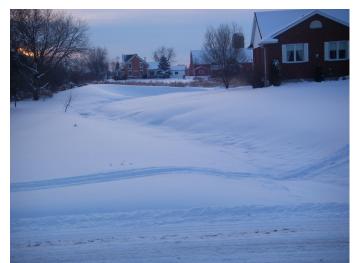
Photo 5: Lake-b (tile 12) - Looking downstream (west) from South Cayuga Road at adjacent residential location and location where channel is mapped and properties. Site is located on South Cayuga Road, between Bains Road and Rainham Road.

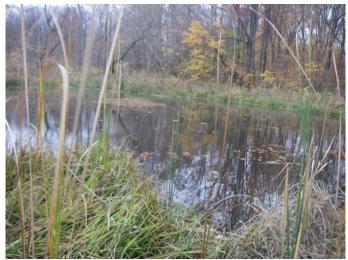
Photo 6: Lake-c (tile 12) - Looking south at man-made pond. Site is located south of Rainham Road between South Cayuga Road and Hald-Dunn Townline Road.

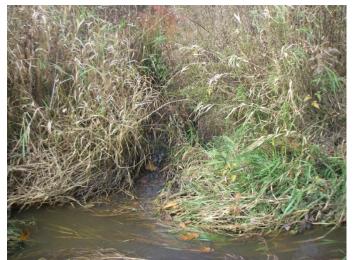
Photo 11: Lake-d (tile 15) - Looking at confluence of two channels in low-lying area near interface with adjacent wooded area. Site is located east of Hald-Dunn Townline Road between Rainham Road and the lakeshore.

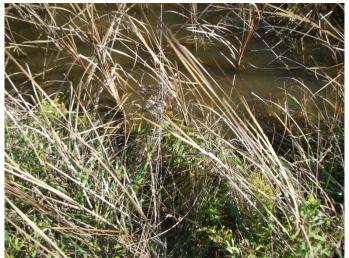
Photo 22: Lake-d (tile 15) - Looking at substrate at culvert on Hald-Dunn Townline Road, south of Rainham Road.

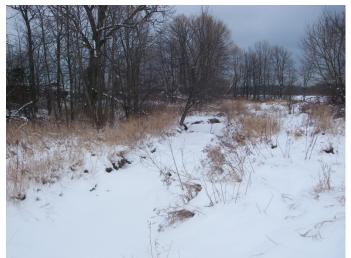
Photo 38: Lake-i (tile 15) - Looking at downstream (southwest) from concrete culvert at channel flowing through wooded area. Site is located on Kings Row, between Haldimand Road 49 and Myrnam Beach Road.

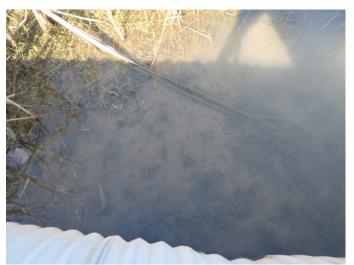
Photo 42: Lake-j (tile 10) - Looking at substrate at CSP culvert on Haldimand Road 50, approximately 300 m north of the lake shore.

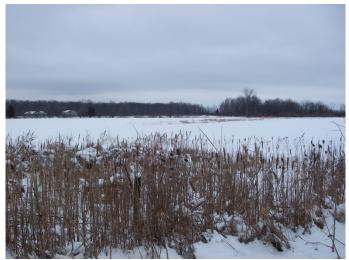
Photo 45: Lake-I (tile 16) - Looking north at swale on Haldimand Tract Road. Site is located on Haldimand Tract Road between Marshall Road and Haldimand Trail.

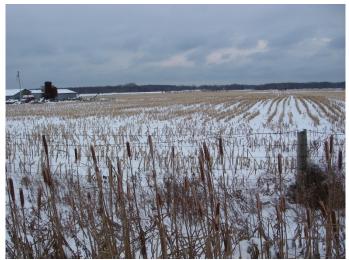
Photo 46: Lake-m (tile 16) - Looking south at feature location. Site is located on Kings Row between Marshall Road and Johnson Road.

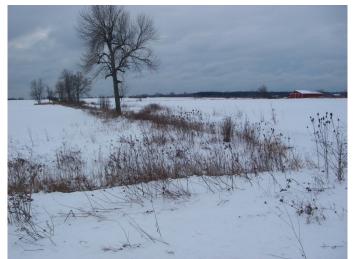
Photo 52: Lake-p (tile 16) - Looking downstream (southeast) at channel flowing between two agricultural fields. Site is located on Kings Row between Marshall Road and Johnson Road.

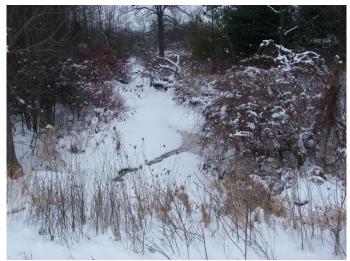
Photo 3: Mazi-b (tile 17) - Looking downstream (east) at channel flowing through woodlot. Site is located on Port Maitland Road between Kings Row and Ramsey Road.
